Inspected for:
Ford Prefect
Arthur Dent
3316 Golgafrincham Dr.
Magrathea, CA

Re: 3316 Golgafrincham Dr.
Magrathea, CA

Full Circle Inspections, Inc.
122 Calistoga Rd. #196
Santa Rosa, CA 95409
(707) 528-7010

Report Highlights

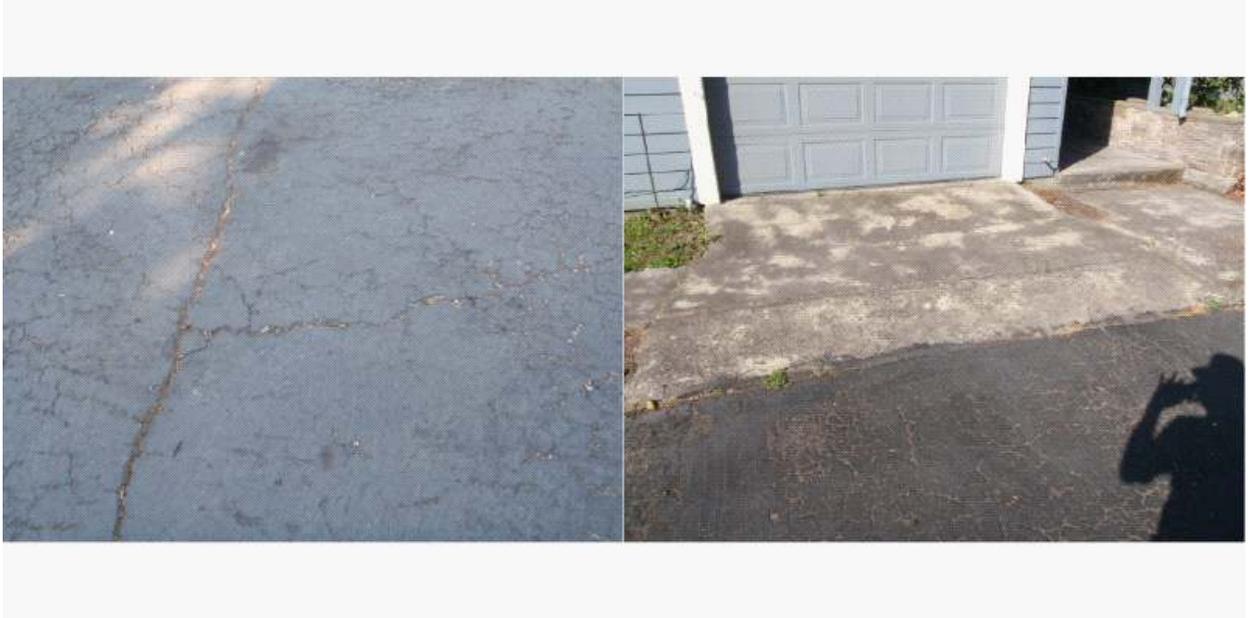
Driveway:

Driveway surface is uneven and deteriorated. Patching the surface and resealing or application of a top coat is advised.

The apron at the front of the garage is rather abrupt/steep. This could cause a vehicle to scrape as it enters or leaves the garage. Caution is advised. It may be necessary to correct the slope of the apron.

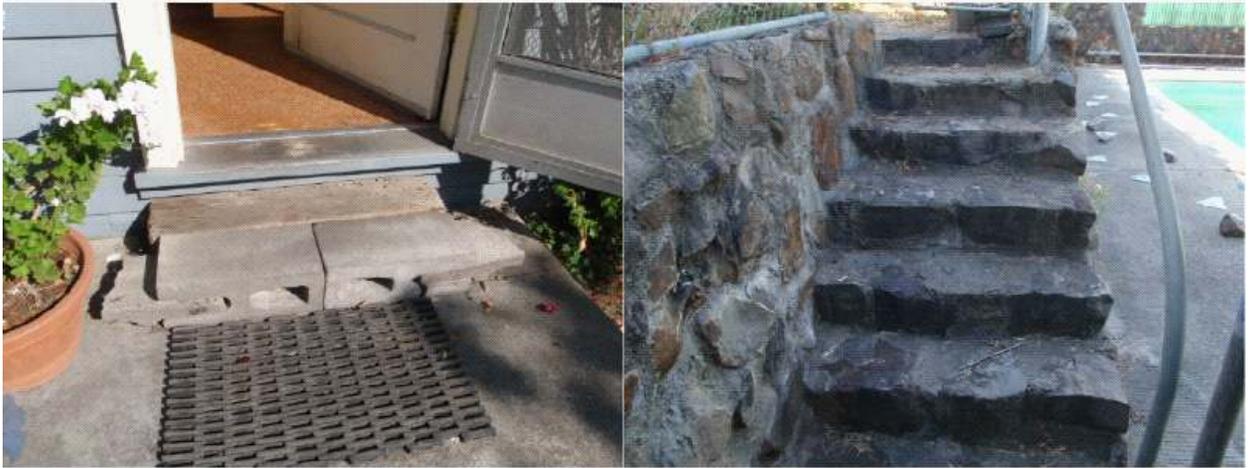
Steps:

Steps into the house are higher than standard. In some cases, loose blocks have been set in front of the doors, but these are likely to move and are potentially hazardous. I recommend installation of proper steps at all exterior doors. Ideally, all steps would have easily gripped handrails.

Pool step treads/risers are inconsistent. Typically, the maximum difference in riser height or tread depth for any stairway is 3/8". This is a possible trip hazard and should be corrected.

Spacing between railing members at the pool steps is greater than allowed by current construction standards and the treads are uneven. This spacing was acceptable at time of construction and is not required to be corrected, however it does present a potential hazard to small children. Client is advised to take precautions, as needed.

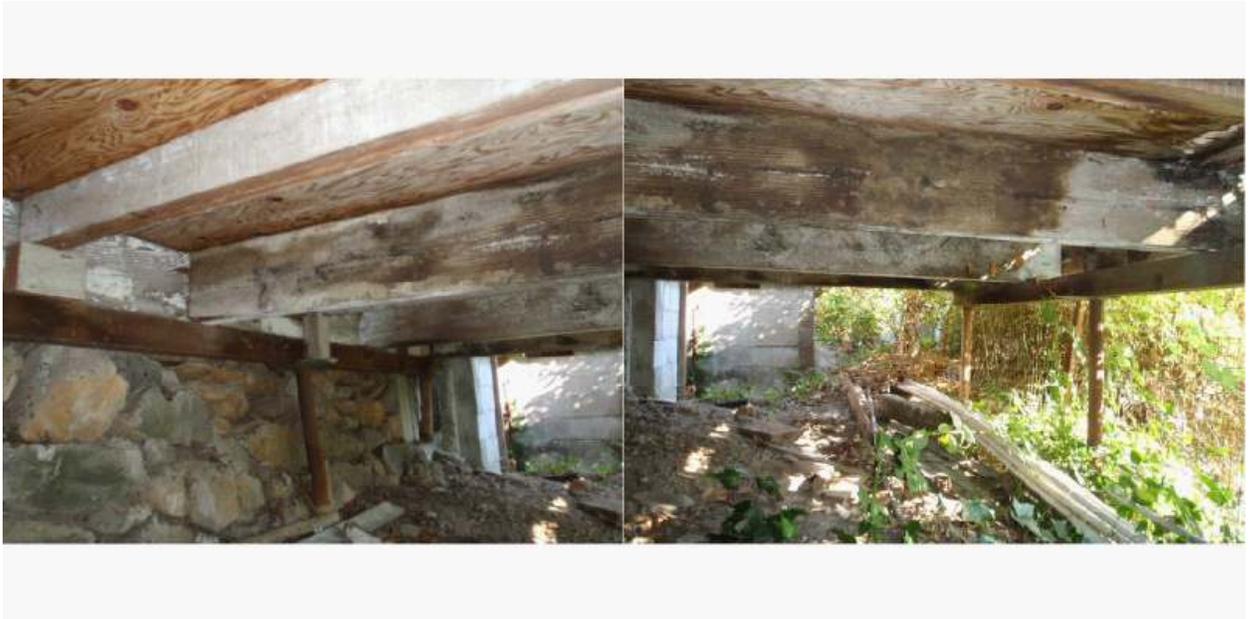
Attached Shed:

The shed structure is not well supported/constructed. The metal support posts are leaning. I recommend removal or resupport of this structure.

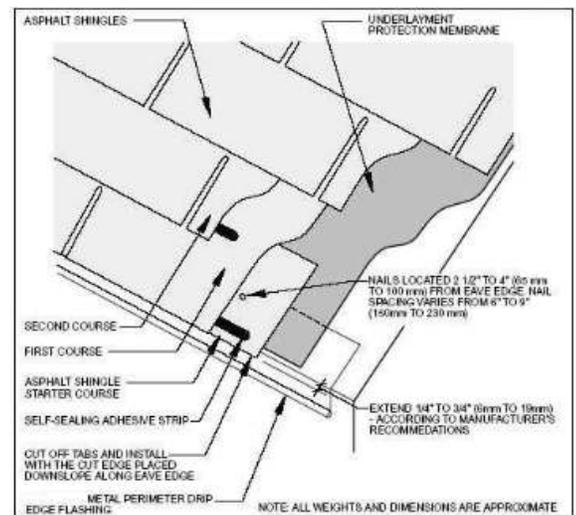
Roof/Wall
Flashings:

Roof/wall flashing at the garage/house connection is not complete. This installation will allow water to flow down the exterior siding. While this may not allow leaking to the interior of the house, it is likely to lead to moisture damage over time. Flashing should direct water away from the wall.

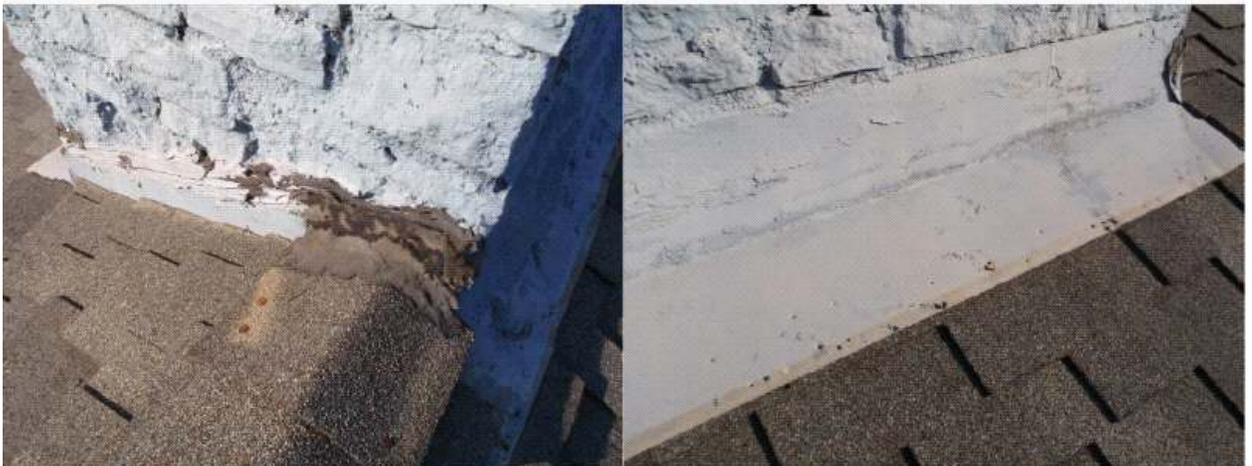
Chimney Flashings:

Asphalt patching compound (mastic) has been applied to the chimney flashing. In addition, this flashing is older and nail holes are present. Decayed wood and evidence of leaking was found in the attic adjacent to the chimney. This flashing is likely to leak and I recommend replacement by a licensed roofing contractor.

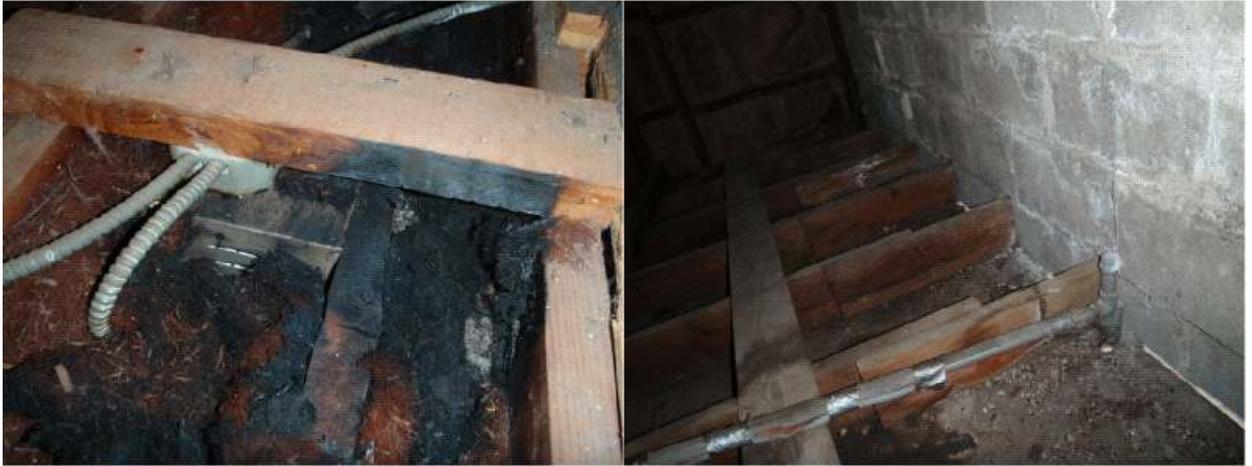
Framing:

Charred areas of framing were found above the hallway. This is located adjacent to a light fixture and was likely due to excess heat or arcing from the fixture. While the ceiling framing does not appear to be significantly weakened, I recommend replacement of any charred lumber. (Left photo) **(Continued on the following page)**

Ceiling joists and mid-span beam are being supported by the masonry fireplace. Specific separations are typically required between masonry fireplaces and wood framing. I recommend independently supporting the wood framing from the masonry fireplace structure. (Right photo)

Charred insulation was found above the hallway. This material is likely not fire retardant. Ideally, the current insulation would be removed and replaced with a fiberglass or other fire retardant insulation material. I suggest a minimum of R-30 insulation.

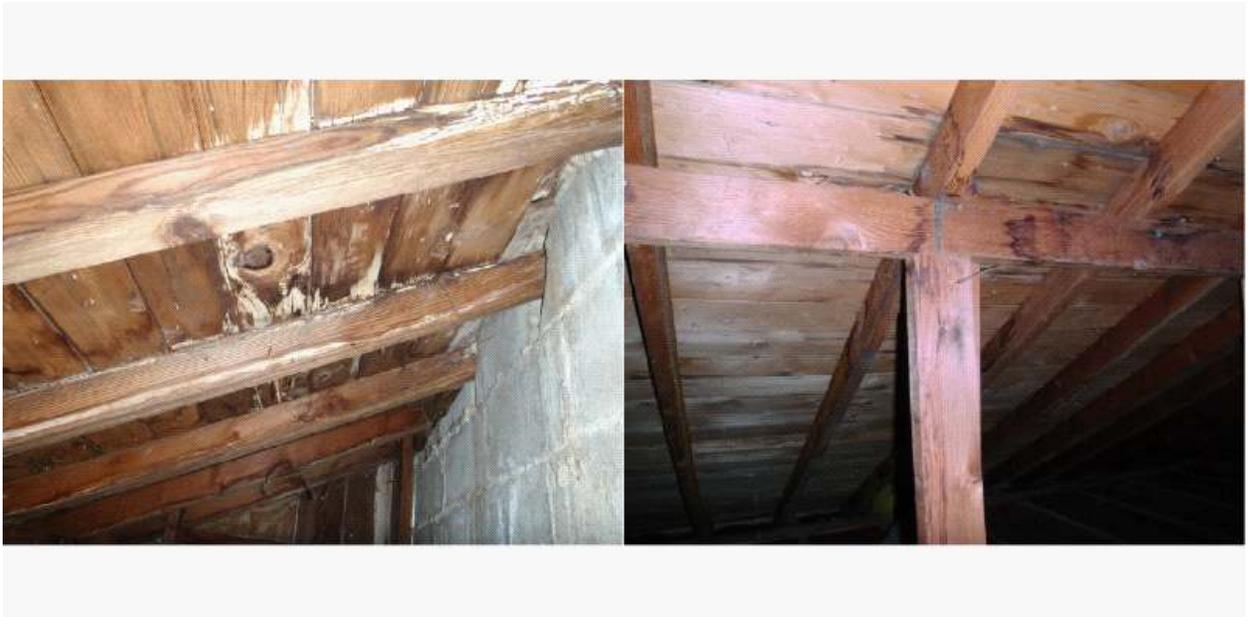
Leaks:

Moisture staining was found on the roof sheathing at various areas throughout the attic. While it is likely that most of the leaking has been corrected with installation of the current roof covering, the area adjacent to the chimney has some damage and may have more current leaks. Please refer to the roof/flashing section of this report for related information.

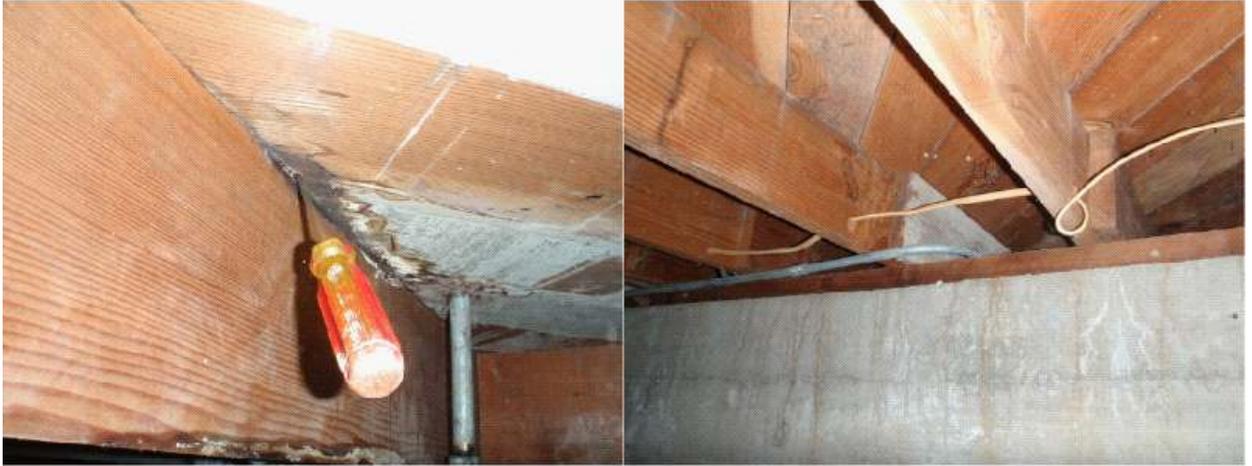
Floor System:

Decayed/damaged wood sub floor sheathing found under the tub. Damaged wood should be removed and resupported. A licensed pest inspection company should review this area for other damage and make recommendations and repairs, as needed.

No blocking present at some mid-span supports. Current construction standards typically require blocking or bridging to prevent the joists from "rolling". I recommend installation of blocking or bridging, as needed.

Openings were found in the subfloor sheathing. These openings can allow rodents access into areas under bathtubs and into wall cavities. While not required at time of original construction, I suggest screening any openings with a metal mesh.

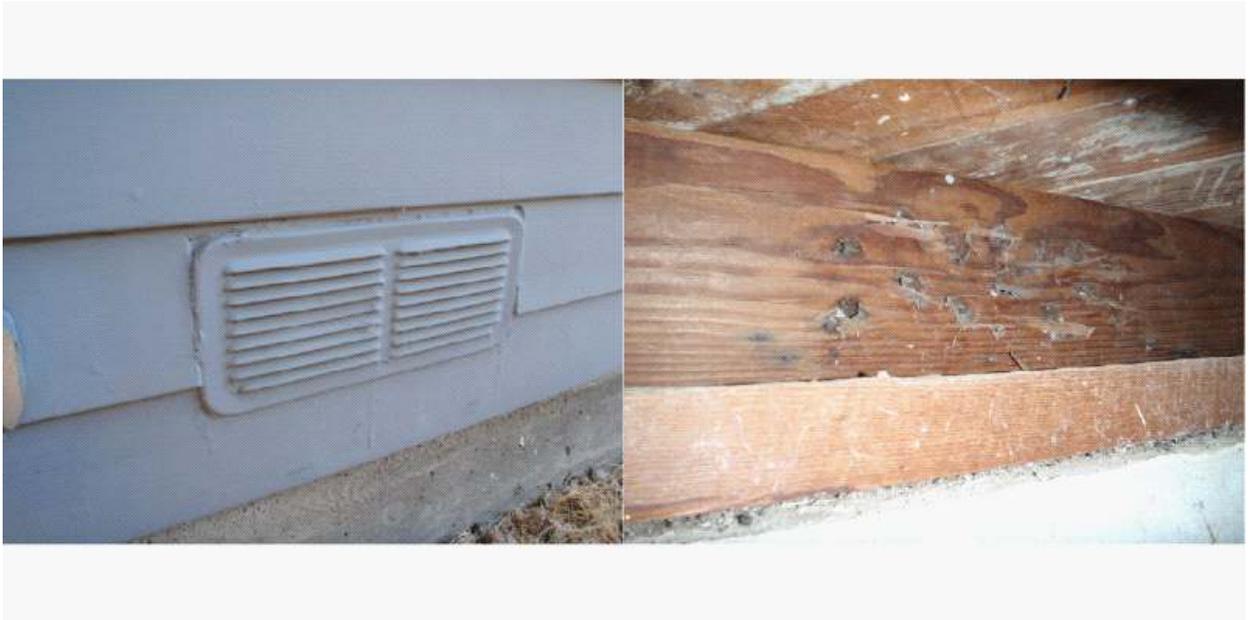
Ventilation:

Ventilation of crawspace is limited. Louvered vent screens have been used at the perimeter of the house and some venting has been provided by small holes drilled through the rim joist. While no evidence of moisture damage could be found at time of inspection, increasing ventilation should be considered. Increasing ventilation can be achieved with a few different methods. Adding perimeter vents will often provide increased air flow. Where vents are not practical, installation of a vapor/moisture barrier or retarder on the soil can help to contain much of the moisture in the soil, thereby permitting the existing vents to function more effectively. Or, a mechanical vent/fan can be used to provide increased air flow to specific areas.

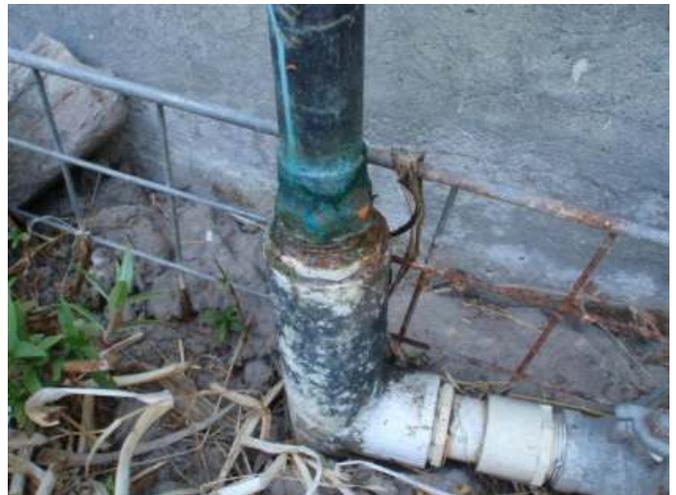
A slow leak was found at the supply pipe at the right side of the house. A licensed plumbing contractor should be hired to make repairs or corrections, as needed.

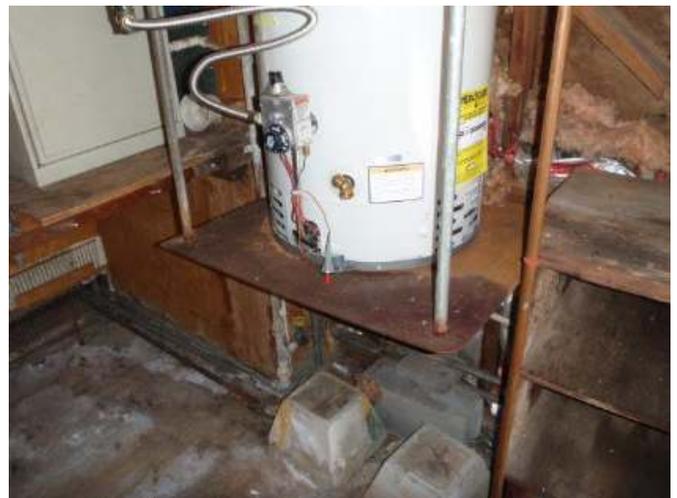
The water heater is supported on a platform that is suspended from the roof framing. This is nonstandard support and I cannot determine if it is adequate. I recommend construction of a wood framed platform under the water heater.

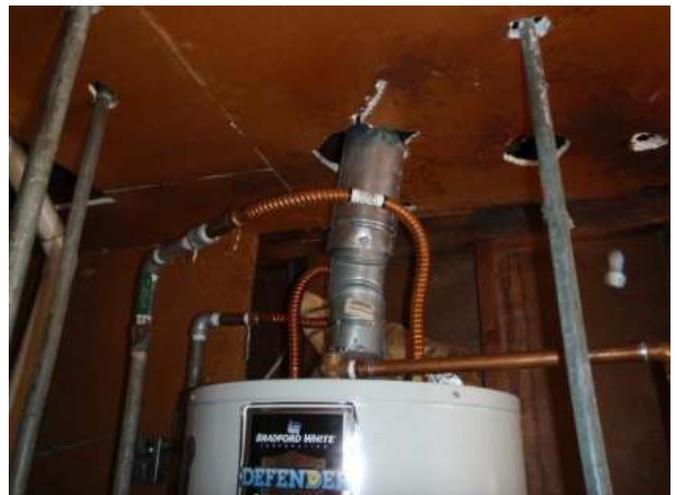
Normally, a minimum clearance of 1 inch to combustible material is required. While no evidence of scorching or charring was observed at time of inspection, isolating the flue from contact with the ceiling is suggested. This is typically achieved by cutting away some of the ceiling material and installation of a metal collar to close the gap.

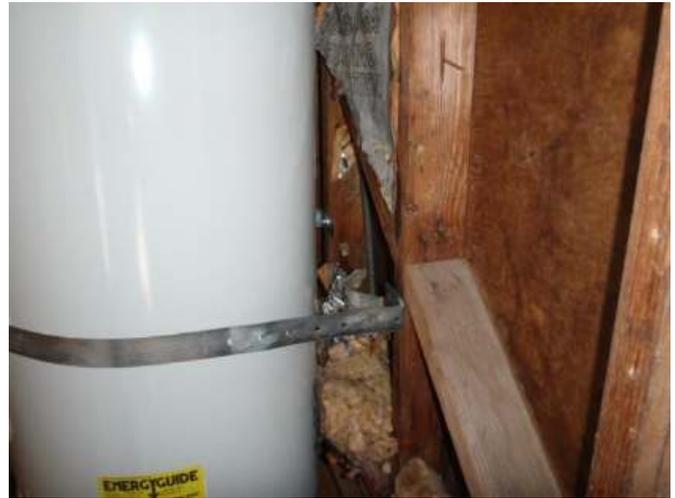
Two straps present. While these straps are attached to the wall framing and will provide some resistance to seismic movement, they do not appear to have been installed as specified and may not perform as intended. The intent of seismic bracing is to restrict the water heater from falling over in the event of an earthquake. The distance from the tank to the wall is greater than 1 inch, which will allow the tank to move laterally during an earthquake. Most manufacturers' instructions require this space be filled or a cradle installed to prevent movement. Complete instructions can be obtained from the manufacturer of the kit. These should be reviewed and corrections made, as needed.

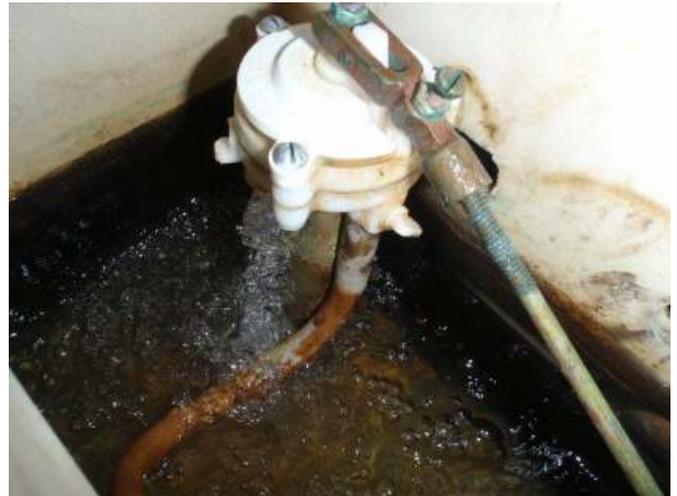
There is a leak at the half bathroom toilet flush valve. Adjustment or repair of the valve is advised to restore proper operation.

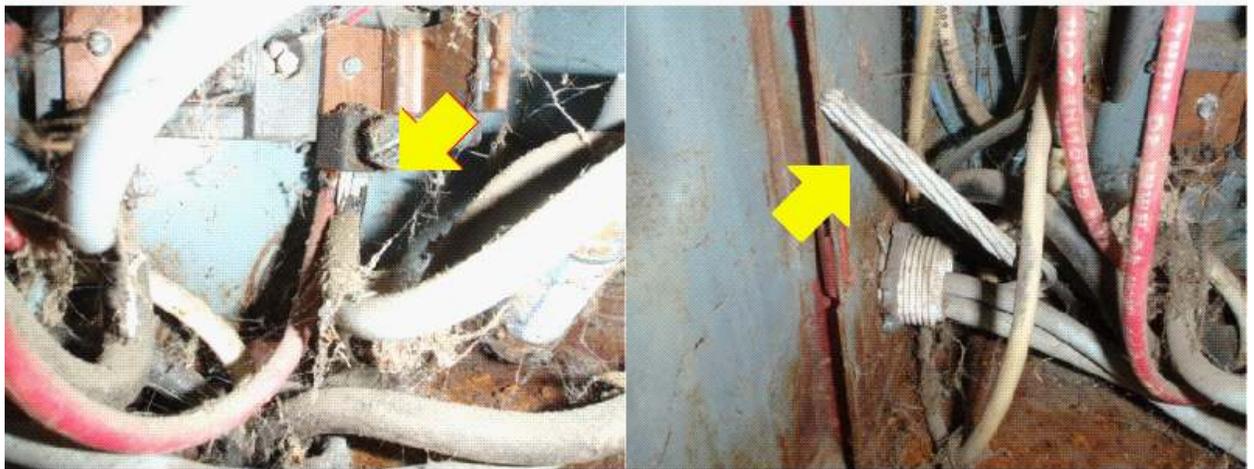
Conductors:

Multiple wires are connected to a single circuit breaker terminal connection where only one wire should be connected. This can prevent the wires from having positive contact with the connector which could lead to arcing or shorting. This is normally corrected by installing additional circuit breakers. Any corrections should be made by a licensed electrical contractor.

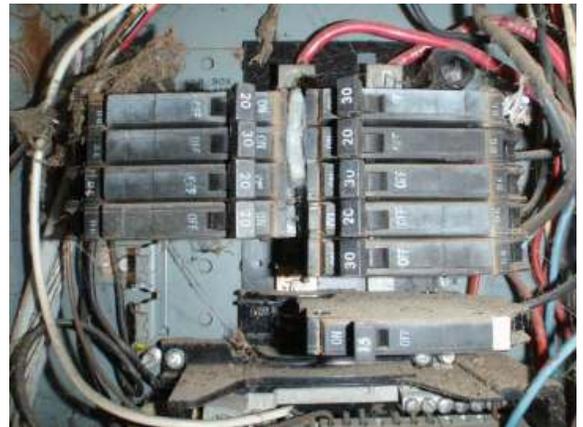
Individual 30 amp, single pole circuit breakers have been used. 30 amp, 120 volt circuits are unusual in residential construction. I believe that these breakers provide 240 volt power to outlets in the carport area. Double-pole, 240 volt circuit breakers should be connected together to allow both breakers to "trip" off should an overload occur. This should be corrected by a licensed electrical contractor concurrently with other repairs noted in this report.

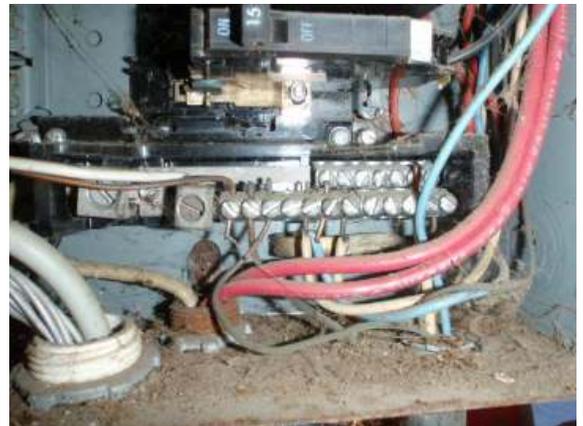
Wires are undersized for the breaker size. #12 wires are connected to 30 amp breakers. This sized wire should not be connected to a circuit breaker that exceeds 20 amps. This installation can allow the wire to carry excess current which could permit the wires to overheat. This should be corrected by a licensed electrical contractor concurrently with other repairs noted in this report.

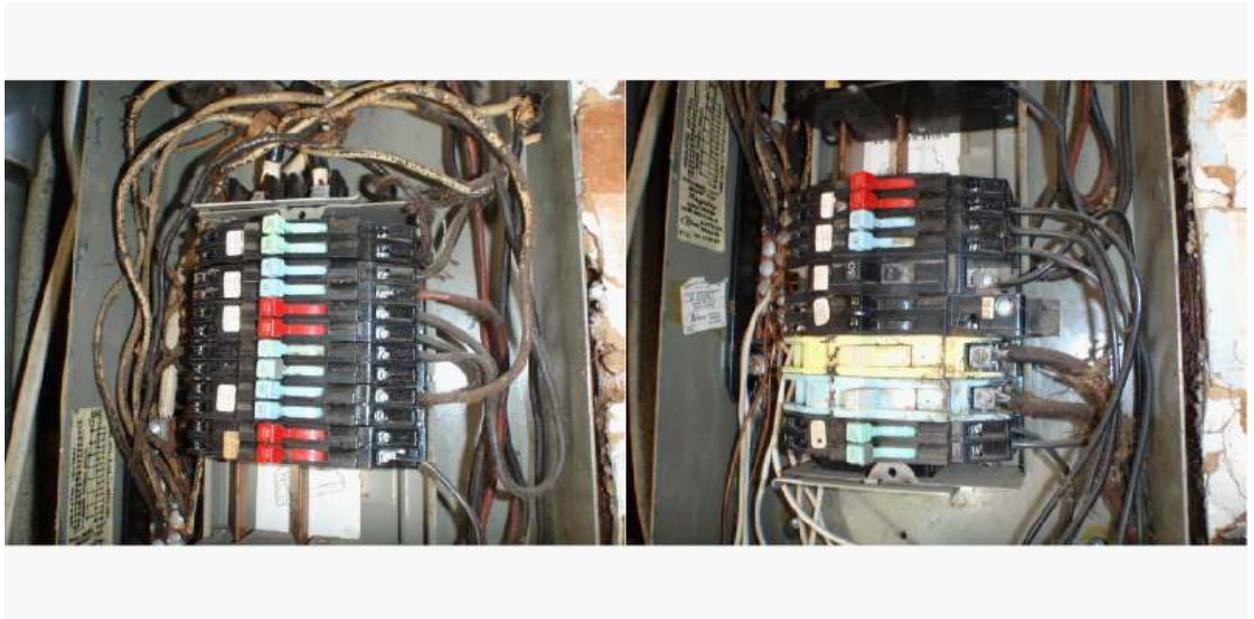
Over Current Protection:

Neutral and ground wires are connected together in this panel. Current electrical standards require that the grounding circuit be separated from the "neutral" circuit. A separate grounding circuit should be provided back to the service equipment (main panel). Corrections should be made by a licensed electrical contractor.

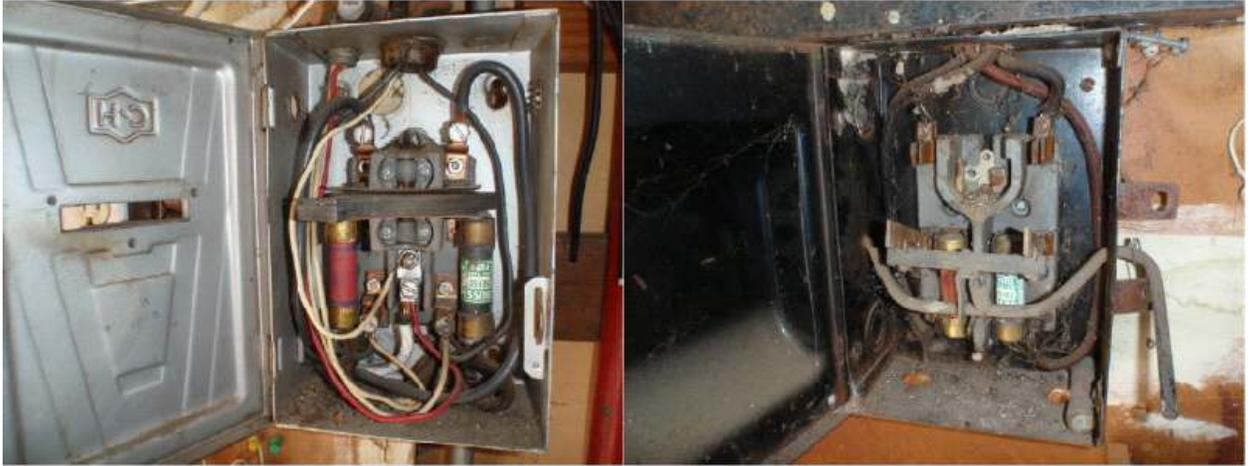
General:

Other, older fuse panels are present in the garage. I recommend removal of these panels and properly removing/terminating the wiring/conductors.

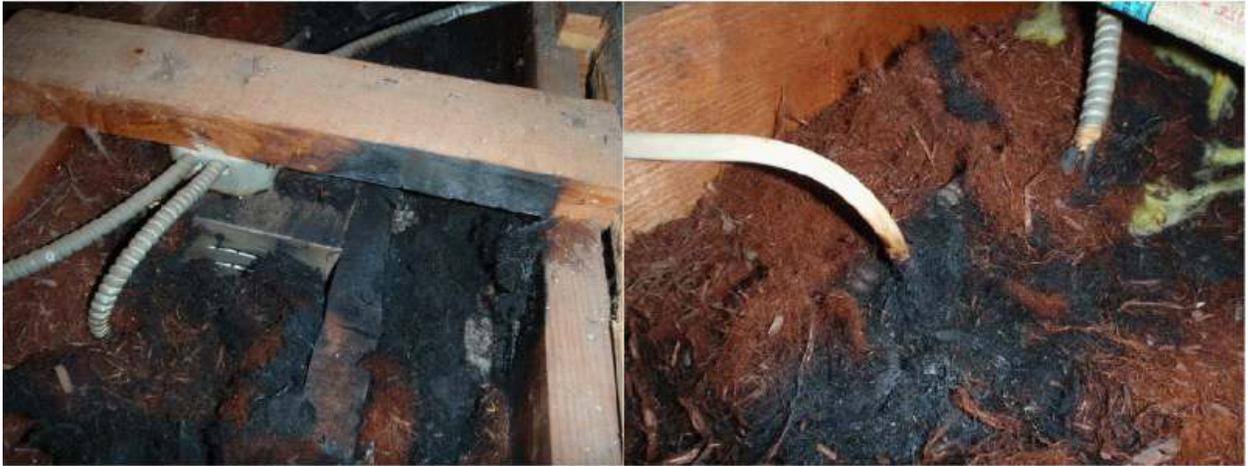
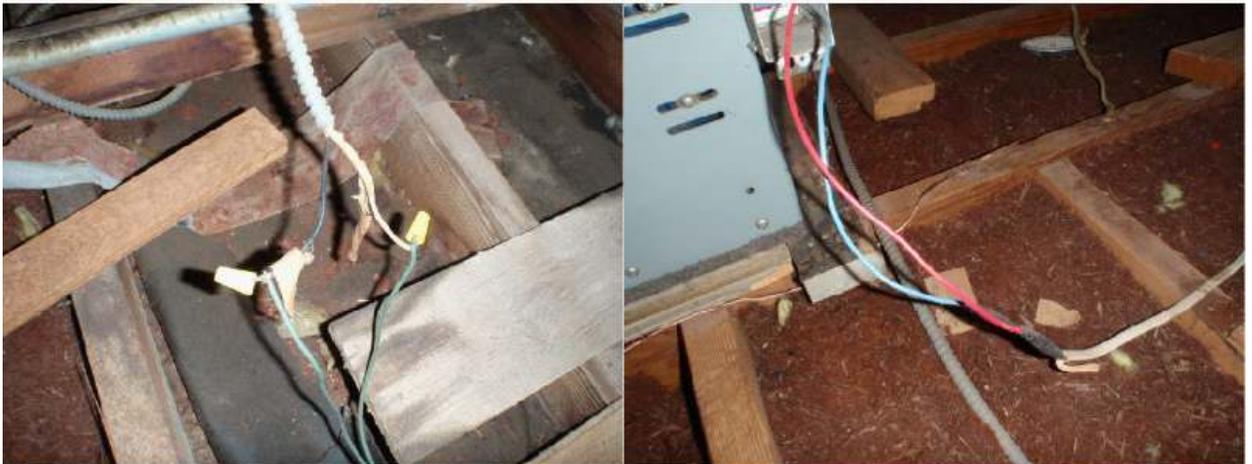
Attic Area
Conditions:

Improper and unsafe wiring was found at areas throughout the attic. Terminated electrical cable with exposed leads, unprotected electrical splices, open junction boxes and individual conductors were observed at areas throughout the attic space. A licensed electrical contractor should be hired to make any needed repairs or corrections.

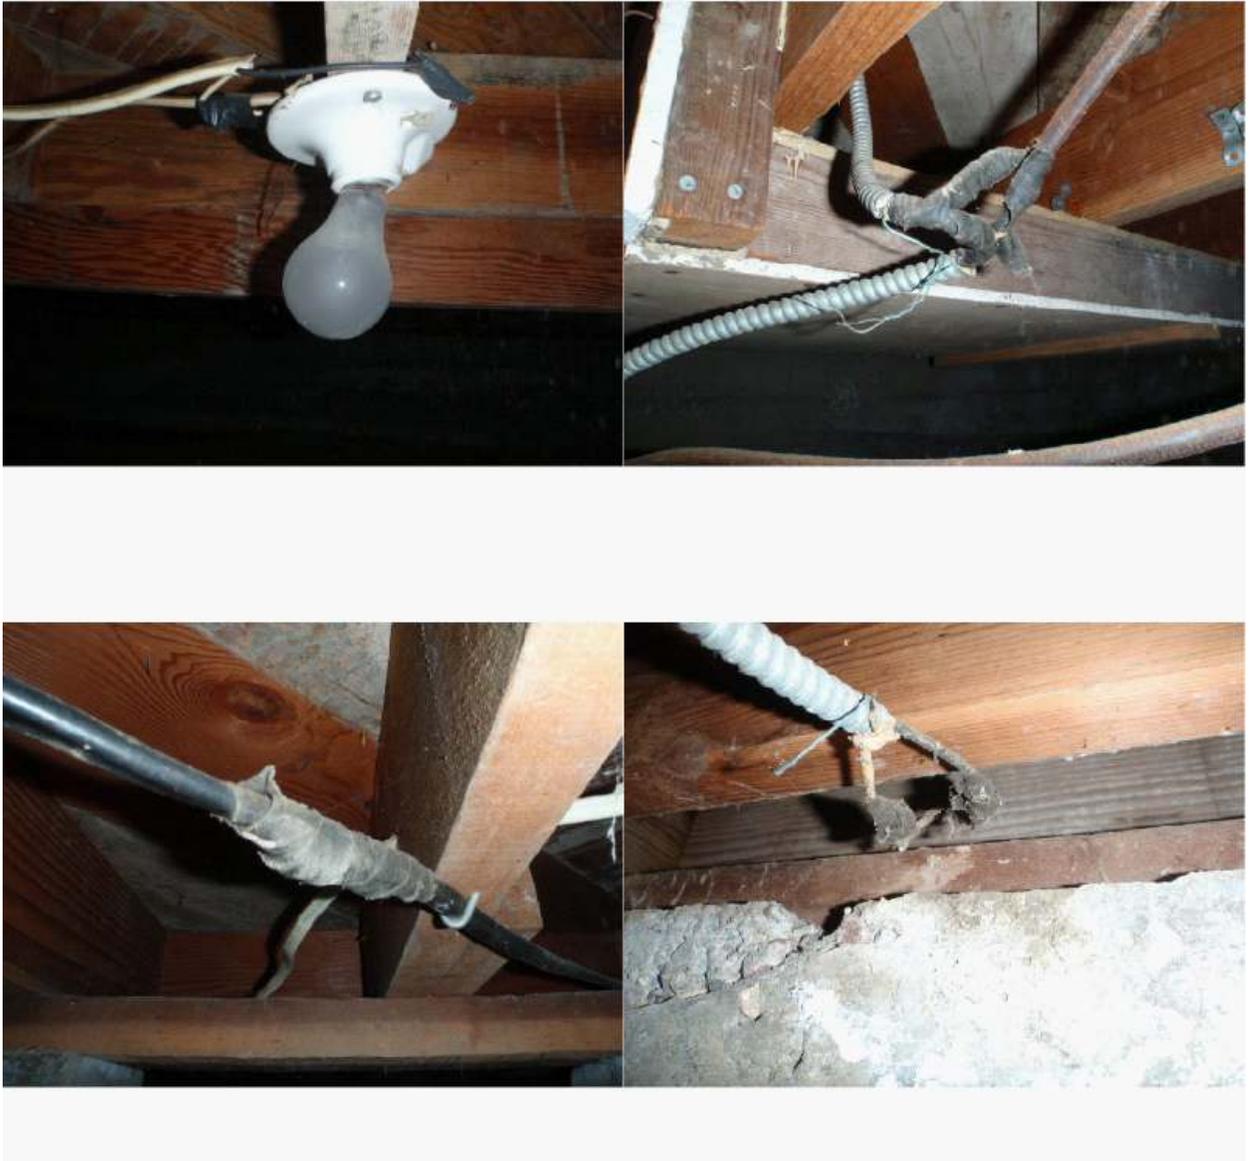
Foundation Area
Conditions:

Improper wiring was found in the crawlspace area. Porcelain light fixtures are not secured to junction boxes and electrical splices are not enclosed in junction boxes. Corrections should be made by a licensed electrical contractor concurrently with other repairs noted in this report.

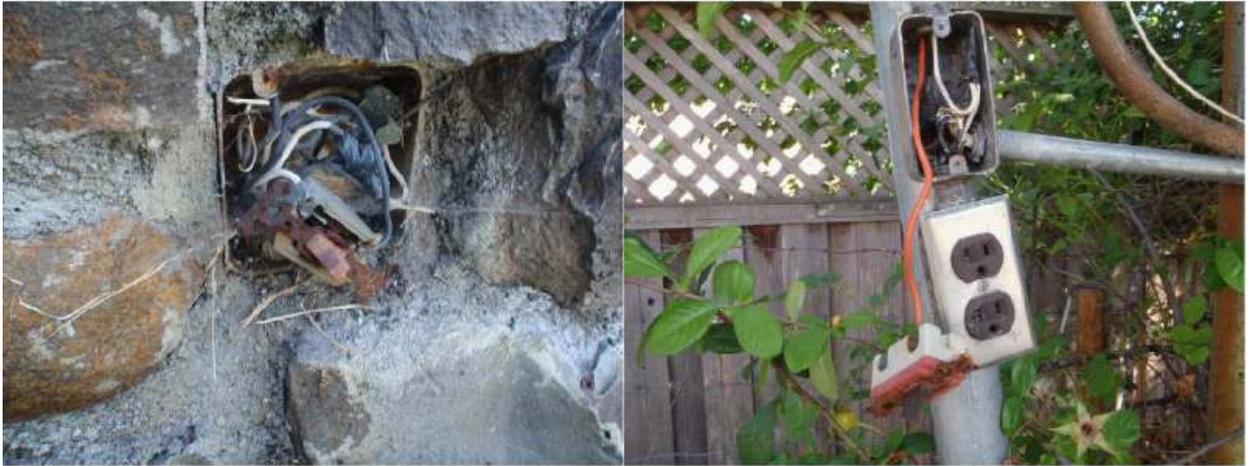
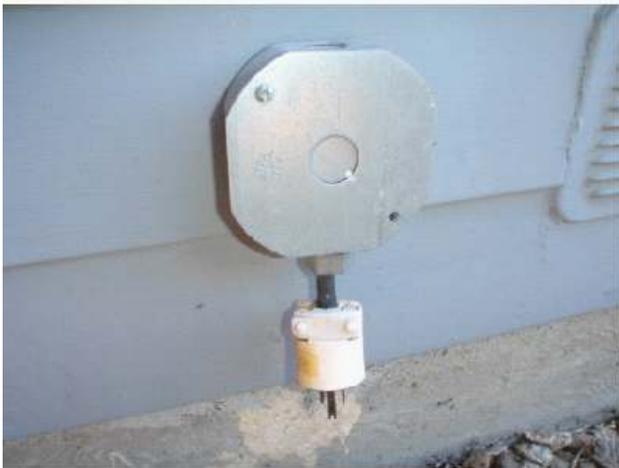
Exterior Fixtures:

Switches and wiring have been pulled-out of electrical boxes adjacent to the tall carport and the pool steps. I suspect other unsafe and nonstandard wiring is present as well. A licensed electrical contractor should make repairs or corrections concurrently with other electrical repairs.

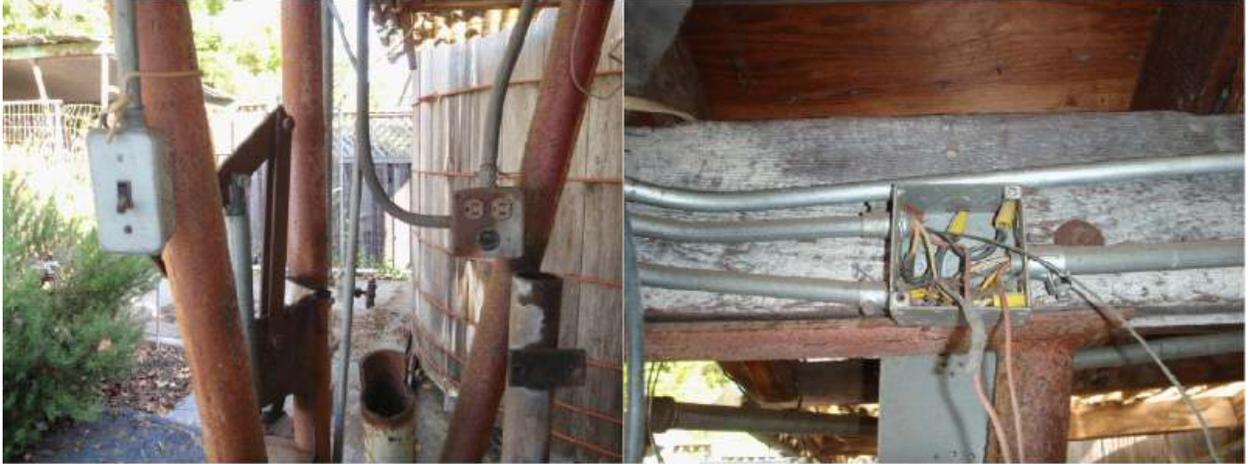
Carport Fixtures:

Electrical wiring is unsafe and nonstandard. No cover plates present on some junction boxes, nonmetallic sheathed cable has been used, loose wiring is not secured/hanging down and receptacle outlets are not GFCI protected. In addition, receptacle outlets do not have waterproof exterior covers. A licensed electrical contractor should be hired to make any needed repairs or corrections.

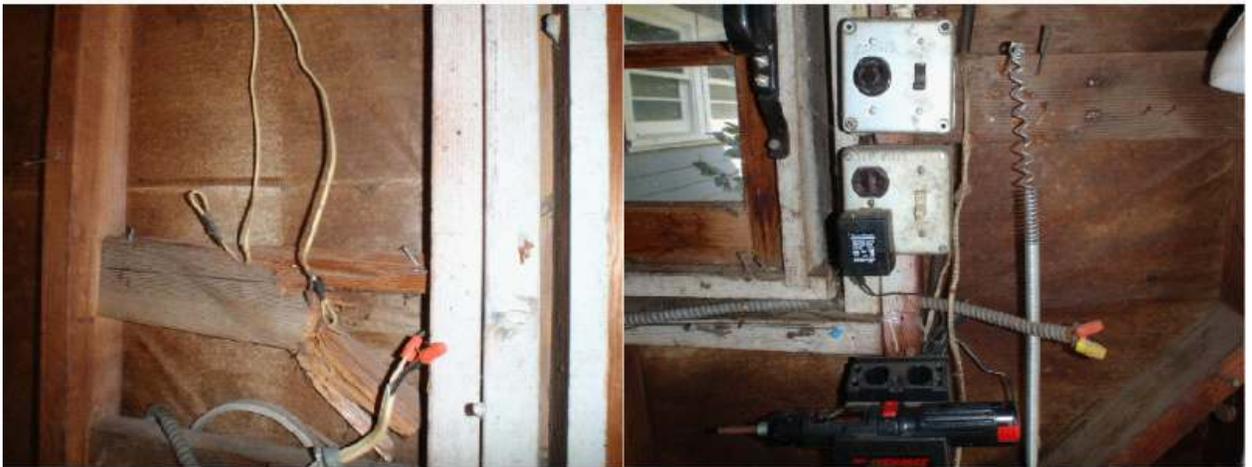
Garage Fixtures:

Electrical wiring is unsafe and nonstandard. Terminated wiring and open junction boxes are present. Corrections should be made by a licensed electrical contractor concurrently with other repairs noted in this report.

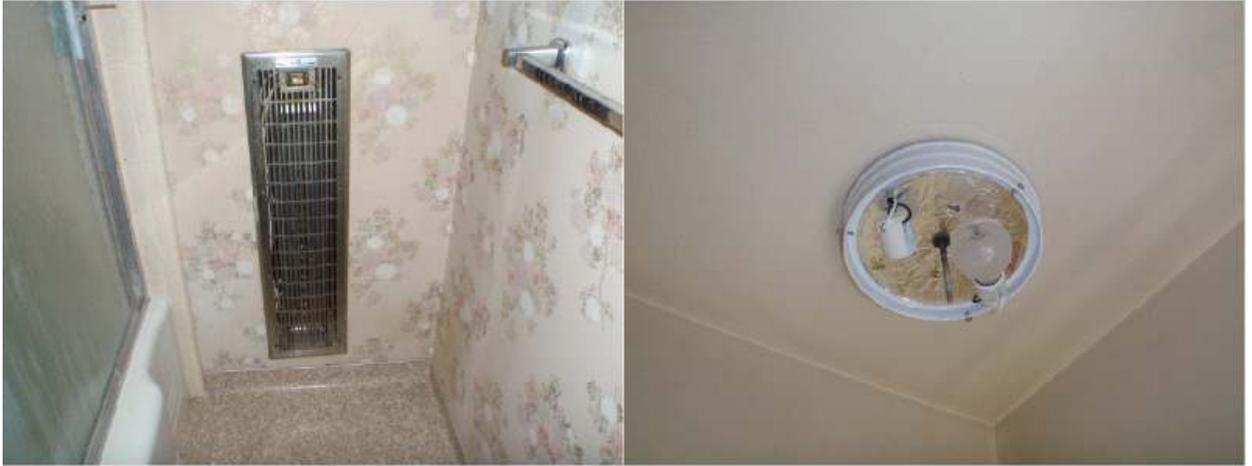
Bathroom Fixtures:

Receptacle outlets are not GFCI (ground fault circuit interrupter) protected. For more information, please refer to the GFCI notes above.

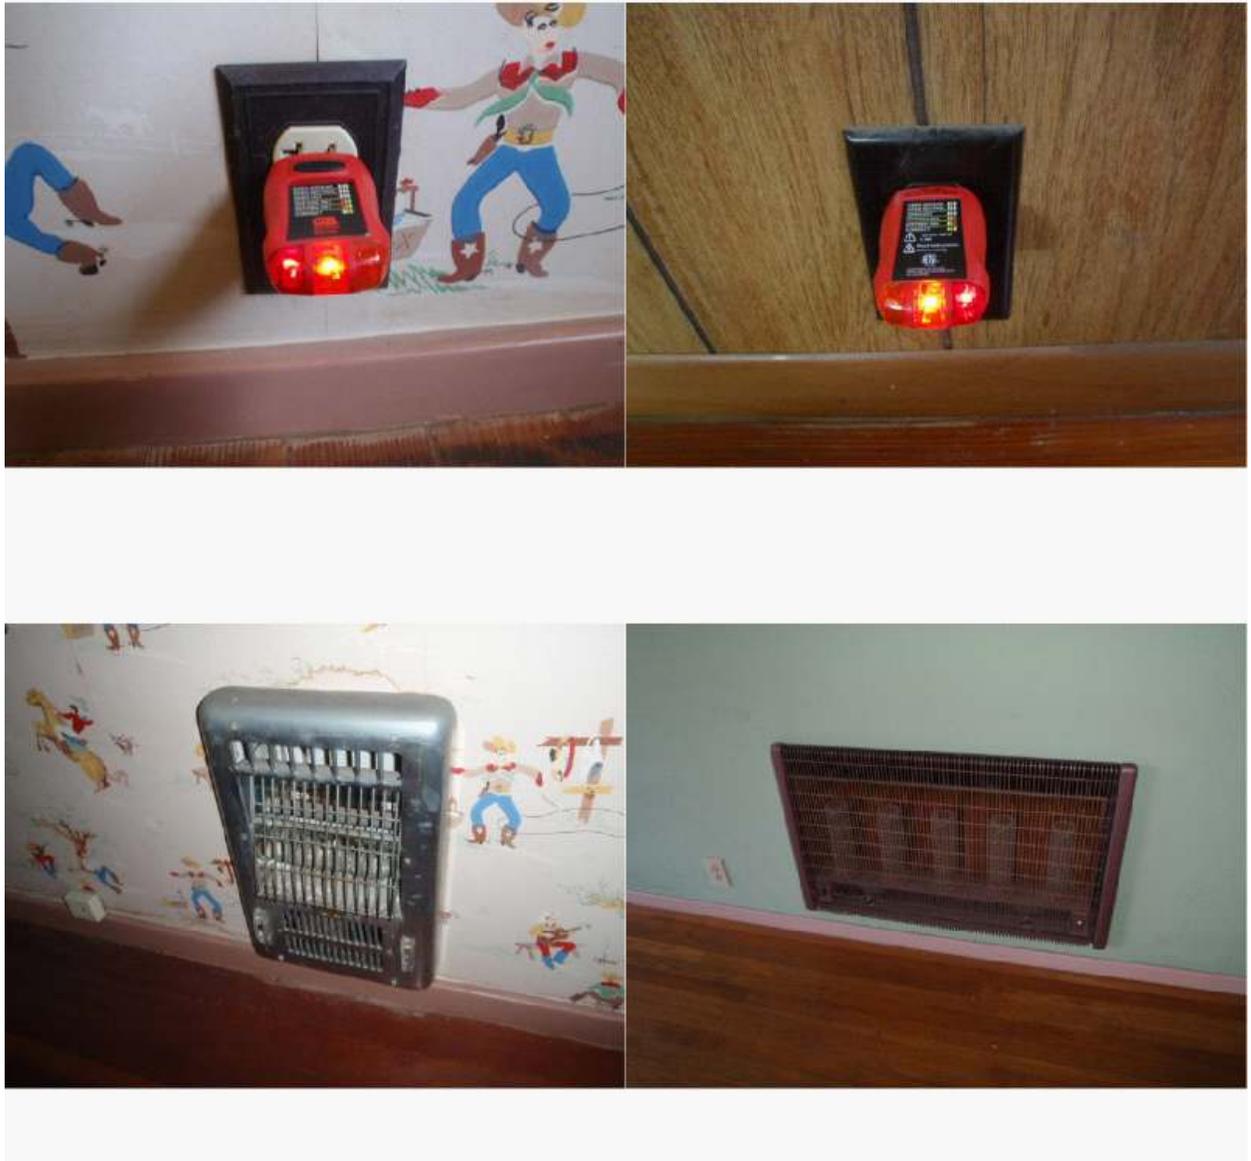
Interior Fixtures:

Polarity was reversed at receptacle outlets at the north and south bedrooms. Reversed polarity in an outlet is usually the improper connection of wires to the receptacle itself. Many appliances have "polarized" plugs (the neutral prong is wider than the "hot" prong) and may not function properly if the wiring is reversed. This is typically corrected by switching the wiring on the receptacle (white to silver colored connection and black to brass colored connection). However, due to the hazards associated with electricity, a licensed electrician should make these corrections.

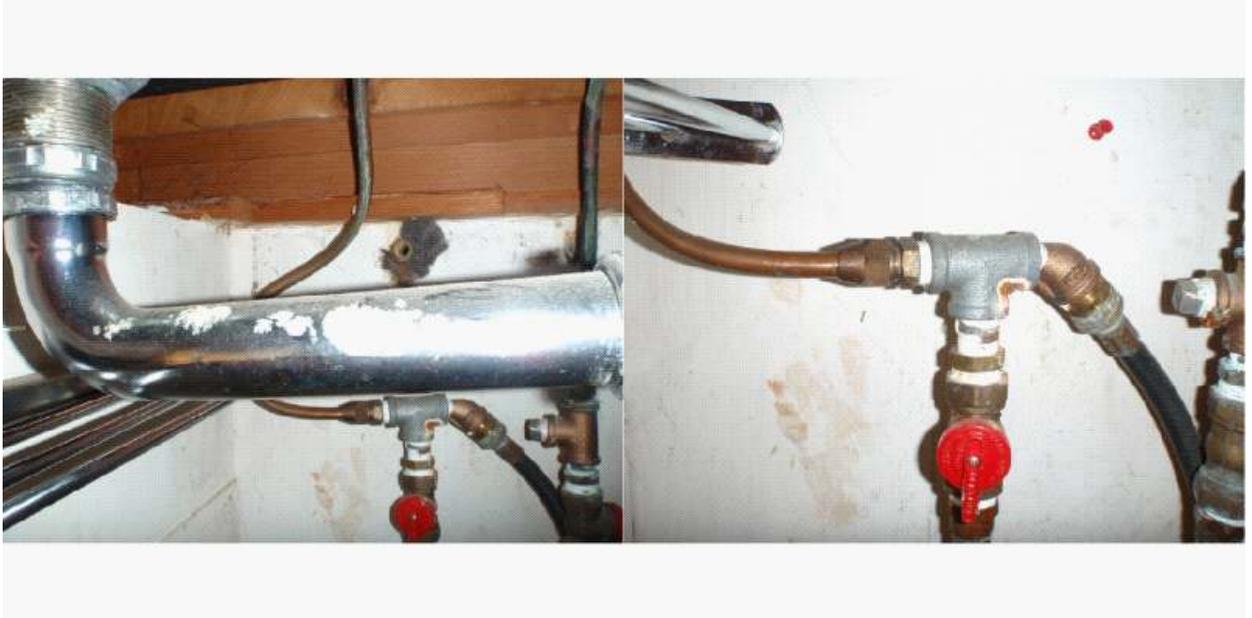
Supply & Drain:

Plumbing under the sink is deteriorated. No leaking noted at time of inspection. Please refer to the plumbing section of this report for related information.

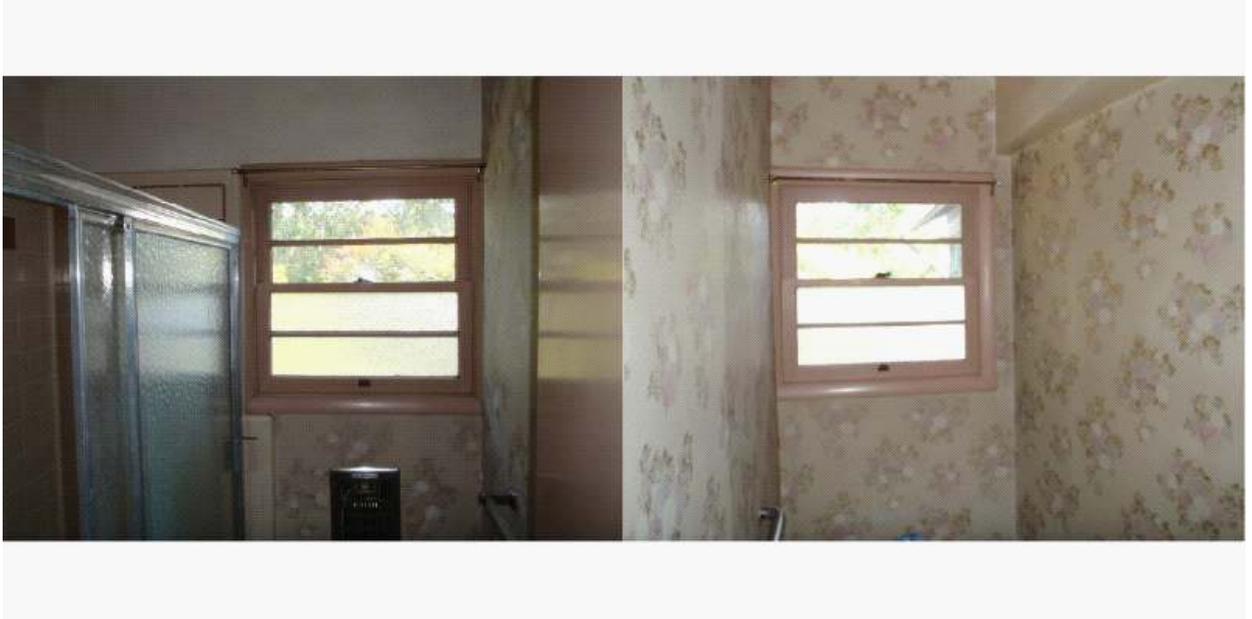
Windows:

Windows are stuck shut.

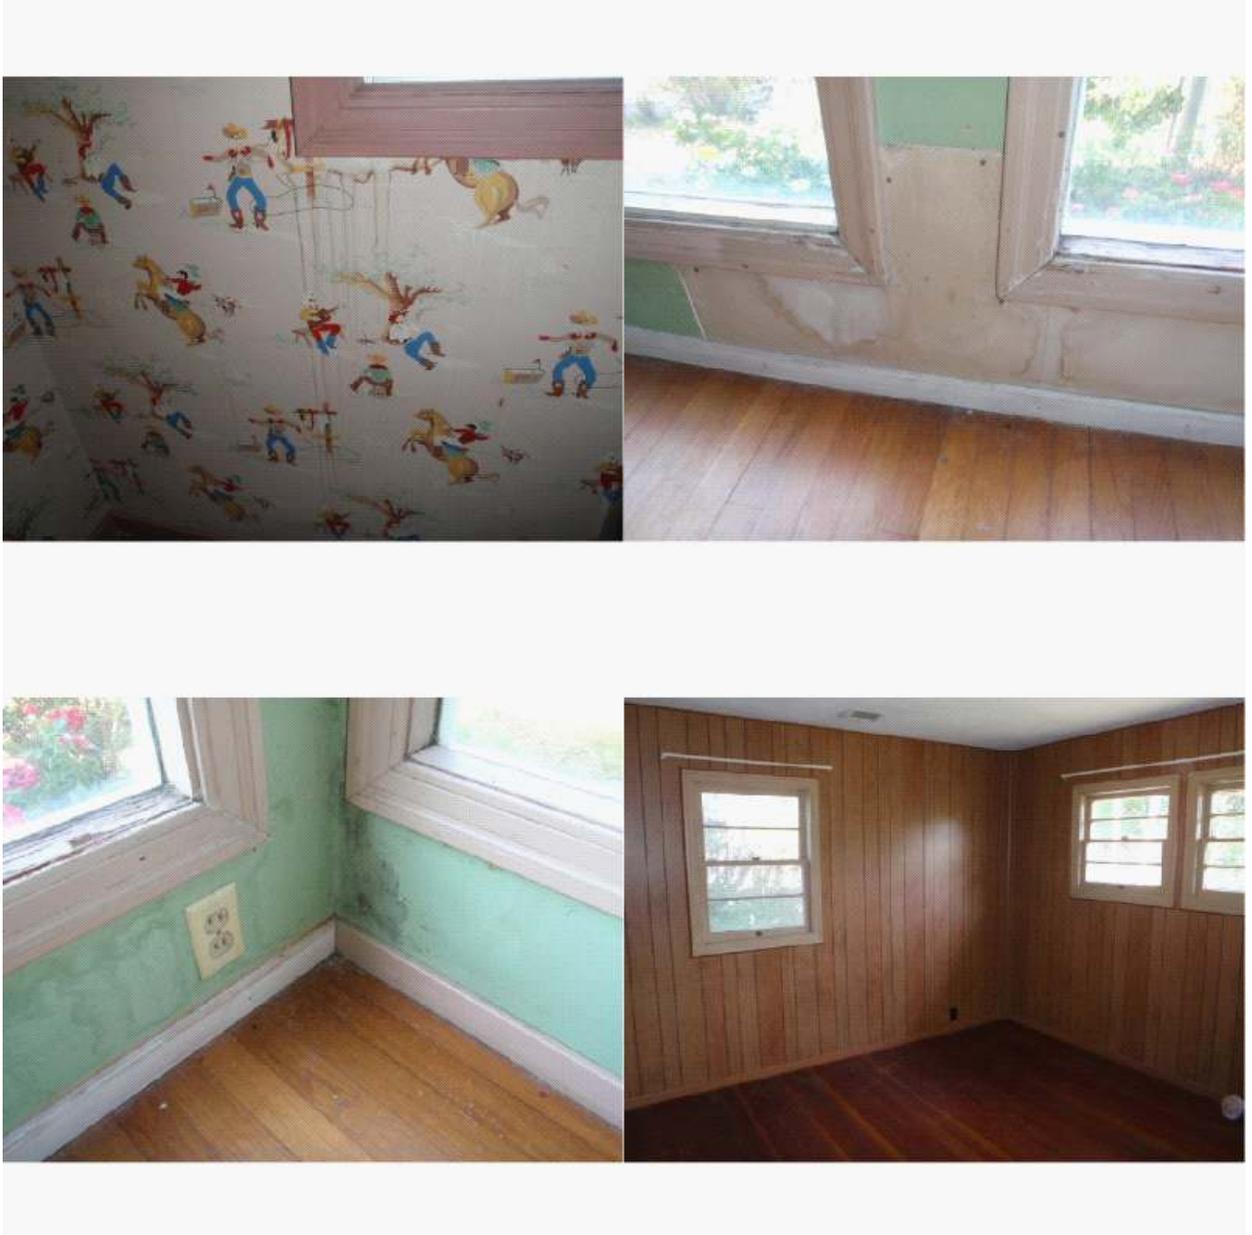
Windows:

Evidence of leaking was observed adjacent to the living room and south bedroom windows. This is likely due to active leaking. The exterior of this window should be reflashed or resealed, as needed. Unable to determine the condition of enclosed framing without destructive testing. This should be reviewed by a licensed pest inspector for any wood damage.
