Inspected for:
Arthur Dent
3316 Golgafrincham Dr.
Santa Rosa, CA

Report Highlights

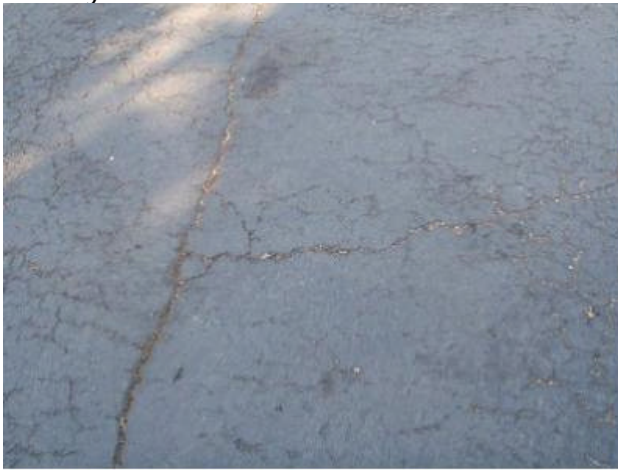
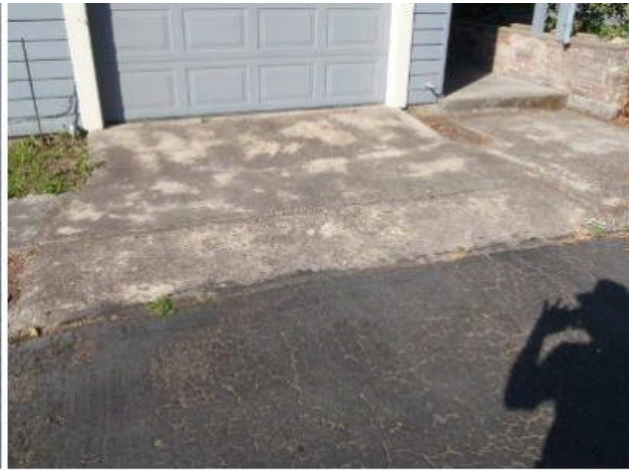
Driveway:

Driveway surface is uneven and deteriorated. Patching the surface and resealing or application of a top coat is advised.

The apron at the front of the garage is rather abrupt/steep. This could cause a vehicle to scrape as it enters or leaves the garage. Caution is advised. It may be necessary to correct the slope of the apron.

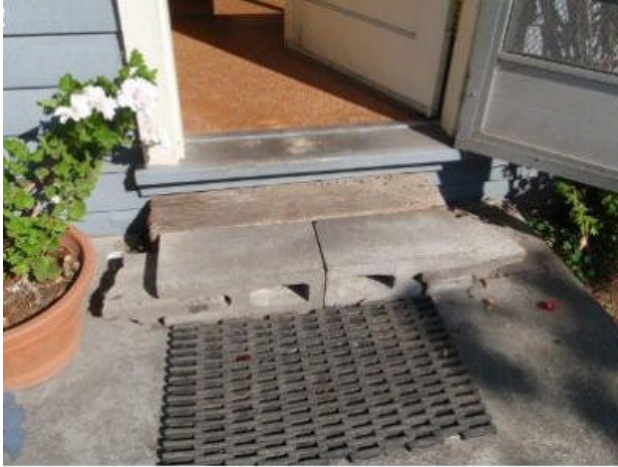
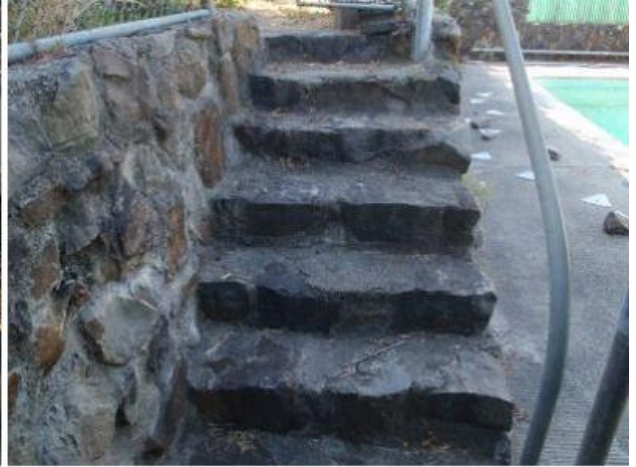
Steps:

Steps into the house are higher than standard. In some cases, loose blocks have been set in front of the doors, but these are likely to move and are potentially hazardous. I recommend installation of proper steps at all exterior doors. Ideally, all steps would have easily gripped handrails.

Pool step treads/risers are inconsistent. Typically, the maximum difference in riser height or tread depth for any stairway is 3/8". This is a possible trip hazard and should be corrected.

Spacing between railing members at the pool steps is greater than allowed by current construction standards and the treads are uneven. This spacing was acceptable at time of construction and is not required to be corrected, however it does present a potential hazard to small children. Client is advised to take precautions, as needed.

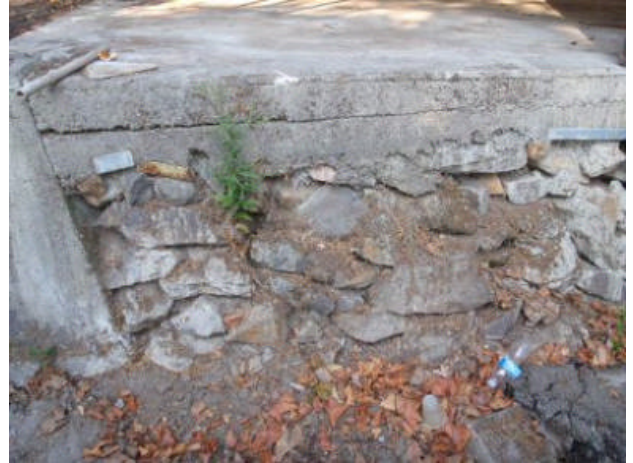
The rear of the slab has been supported on rock (rip-rap). This is more likely to settle than compacted fill. No evidence of excessive settling observed at time of inspection. Ideally, this rock would be replaced or supported with concrete.

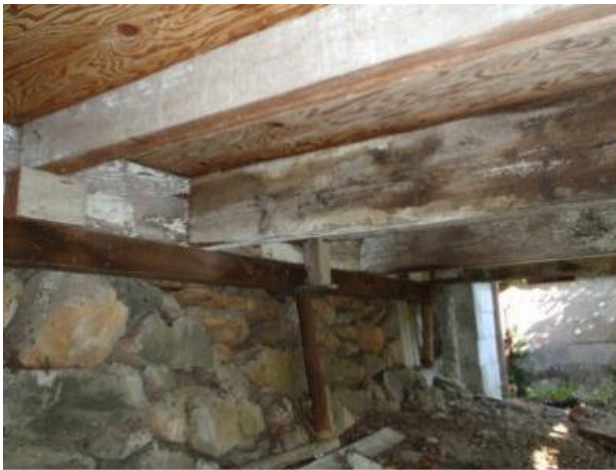
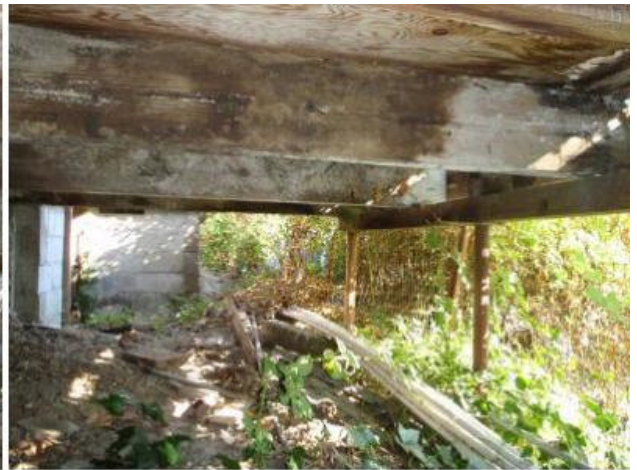
**Attached Shed:**

The shed structure is not well supported/constructed. The metal support posts are leaning. I recommend removal or resupport of this structure.

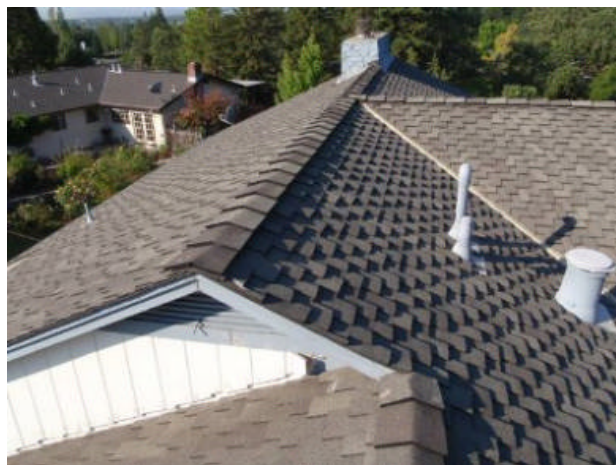
Eaves:

The construction of this roof is such that it has minimal eave protection for some of the exterior walls. As a result, these walls are more vulnerable to the effects of weather. Windows and doors can leak due to wind blown rain. Installation of awnings or covers can help to protect these areas. Keeping siding well sealed and painted is recommended to preserve the condition of the exterior surfaces.

No flashing present at the eave ends. The purpose of flashing at the eave is to direct water from the roof into the gutter. While a flange is present on the gutter, the flange is small and may not be completely effective. Current construction standards require an angle flashing to be installed under the "starter strip" of the shingles and over the top edge of the gutter. While this may not have been required when this roof was installed, I suggest installation of flashing to protect the eaves.

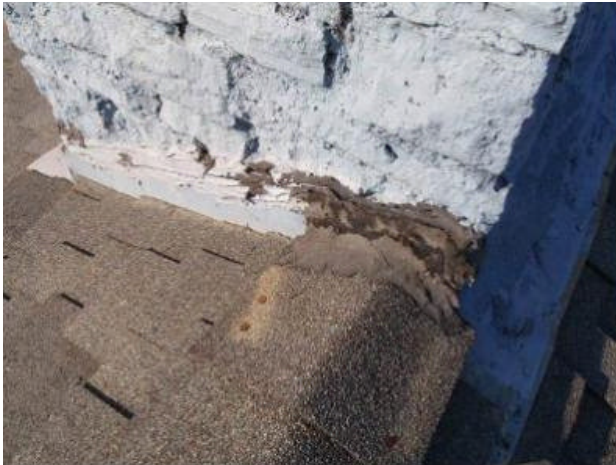
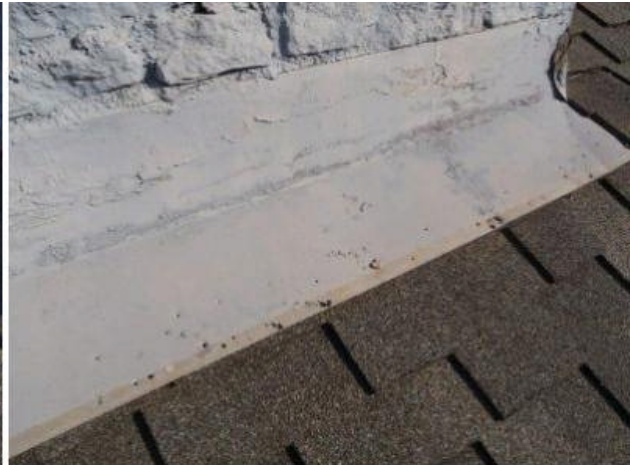
Chimney Flashings:

Asphalt patching compound (mastic) has been applied to the chimney flashing. In addition, this flashing is older and nail holes are present. Decayed wood and evidence of leaking was found in the attic adjacent to the chimney. This flashing is likely to leak and I recommend replacement by a licensed roofing contractor.

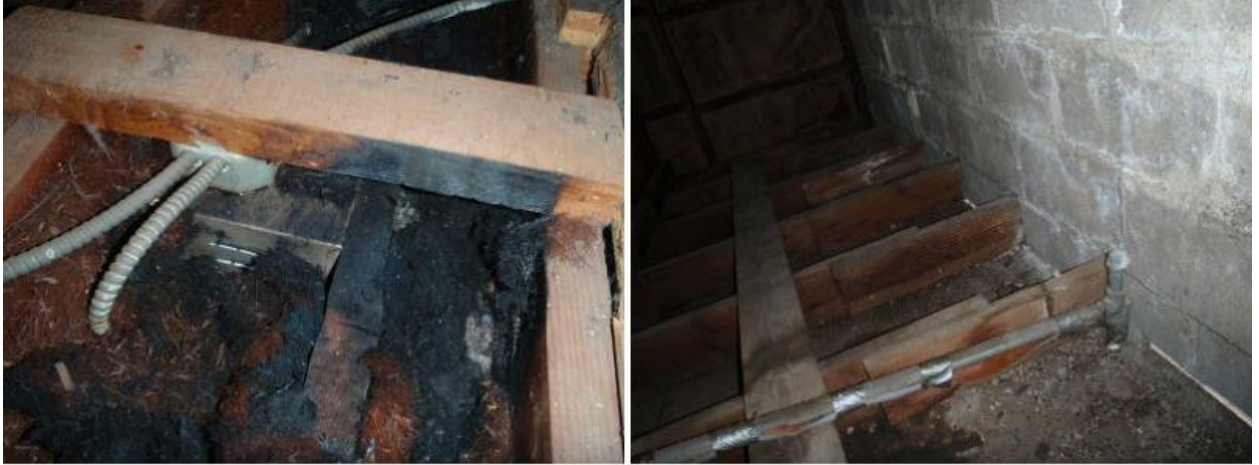
Framing:

Charred wood framing, insulation and wiring was found above the hallway.

Charred areas of framing were found above the hallway.

Charred areas of framing were found above the hallway. This is located adjacent to a light fixture and was likely due to excess heat or arcing from the fixture. While the ceiling framing does not appear to be significantly weakened, I recommend replacement of any charred lumber. (Left photo) (Continued on the following page)

Ceiling joists and mid-span beam are being supported by the masonry fireplace. Specific separations are typically required between masonry fireplaces and wood framing. I recommend independently supporting the wood framing from the masonry fireplace structure. (Right photo)

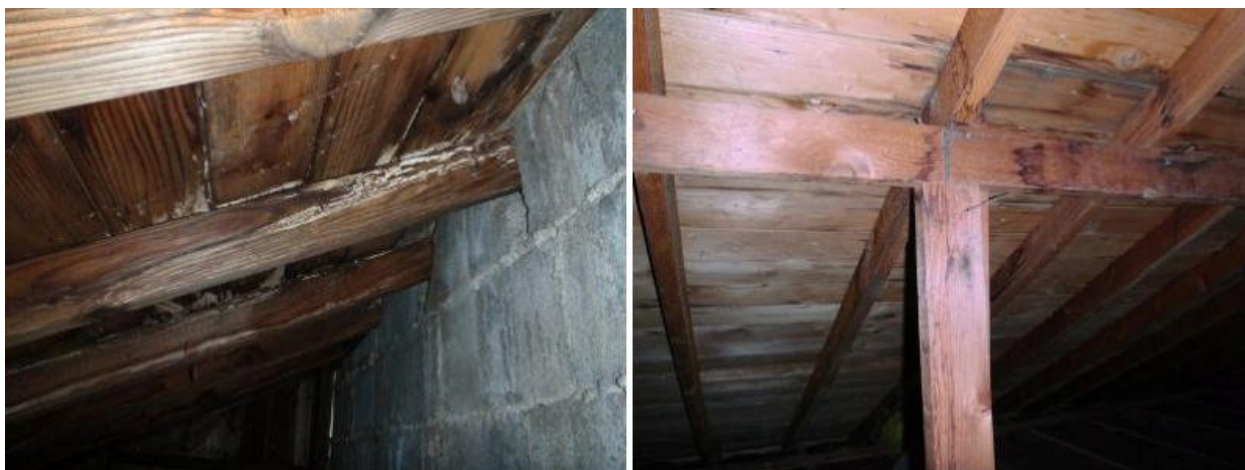
Leaks:

Moisture staining was found on the roof sheathing at various areas throughout the attic.

Moisture staining was found on the roof sheathing at various areas throughout the attic. While it is likely that most of the leaking has been corrected with installation of the current roof covering, the area adjacent to the chimney has some damage and may have more current leaks. Please refer to the roof/flashing section of this report for related information.

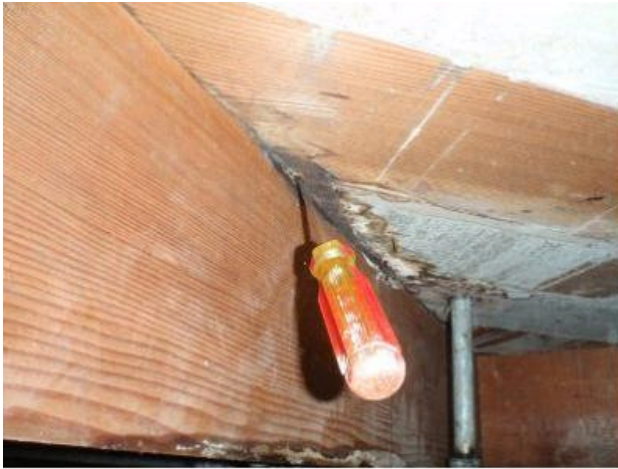
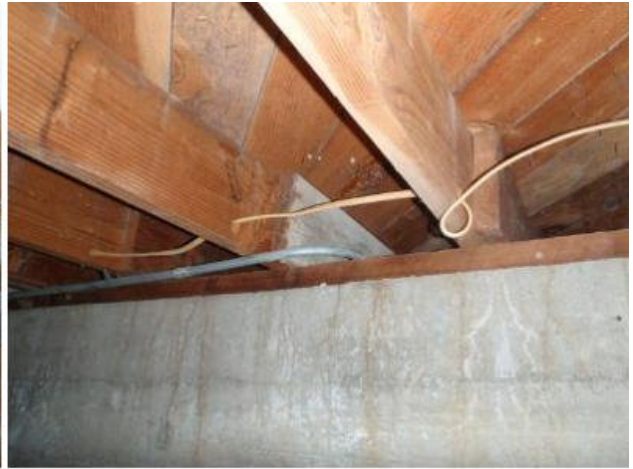
Floor System:

Decayed/damaged wood sub floor sheathing found under the tub.

Decayed/damaged wood sub floor sheathing found under the tub. Damaged wood should be removed and resupported. A licensed pest inspection company should review this area for other damage and make recommendations and repairs, as needed.

No blocking present at some mid-span supports. Current construction standards typically require blocking or bridging to prevent the joists from "rolling". I recommend installation of blocking or bridging, as needed.

Openings were found in the subfloor sheathing. These openings can allow rodents access into areas under bathtubs and into wall cavities. While not required at time of original construction, I suggest screening any openings with a metal mesh.

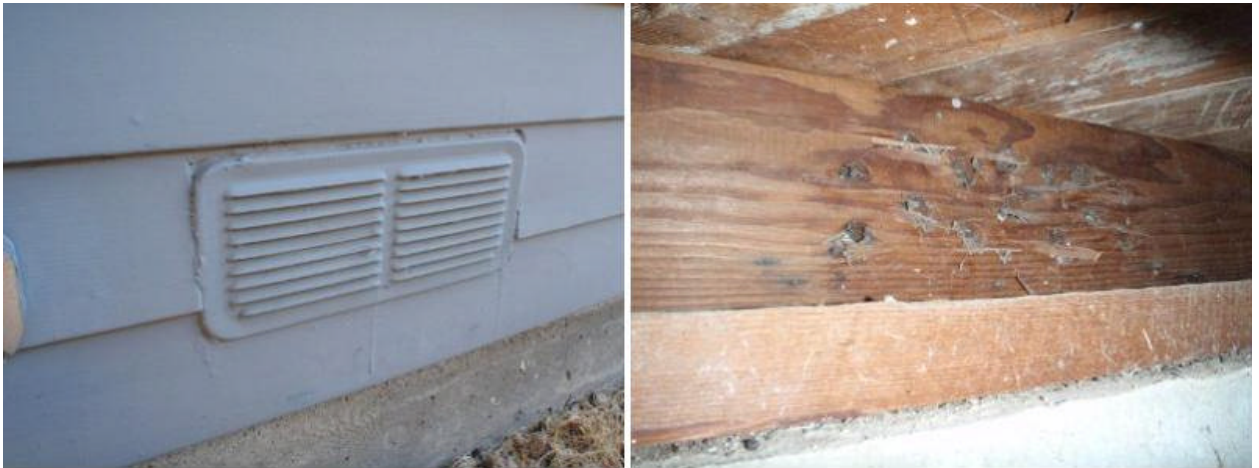
Ventilation:

Ventilation of crawlspace is limited. Louvered vent screens have been used at the perimeter of the house and some venting has been provided by small holes drilled through the rim joist. While no evidence of moisture damage could be found at time of inspection, increasing ventilation should be considered. Increasing ventilation can be achieved with a few different methods. Adding perimeter vents will often provide increased air flow. Where vents are not practical, installation of a vapor/moisture barrier or retarder on the soil can help to contain much of the moisture in the soil, thereby permitting the existing vents to function more effectively. Or, a mechanical vent/fan can be used to provide increased air flow to specific areas.

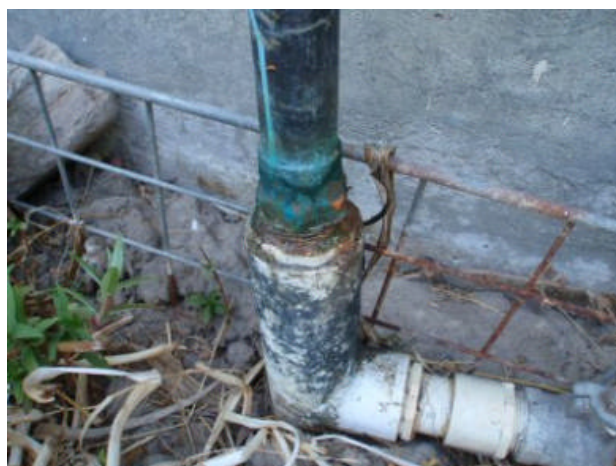
A slow leak was found at the supply pipe at the right side of the house.

A slow leak was found at the supply pipe at the right side of the house. A licensed plumbing contractor should be hired to make repairs or corrections, as needed.

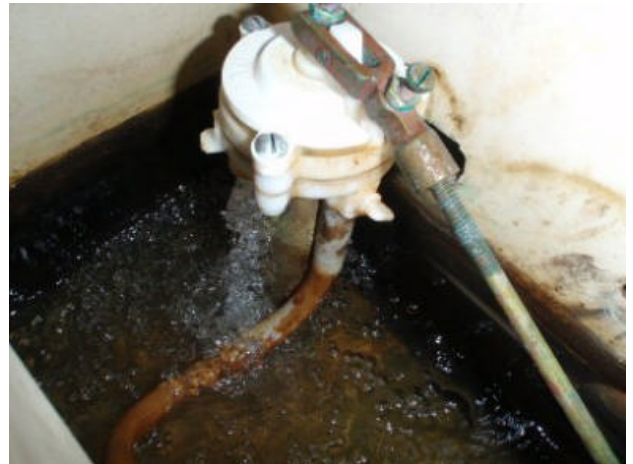
There is a leak at the half bathroom toilet flush valve. Adjustment or repair of the valve is advised to restore proper operation.

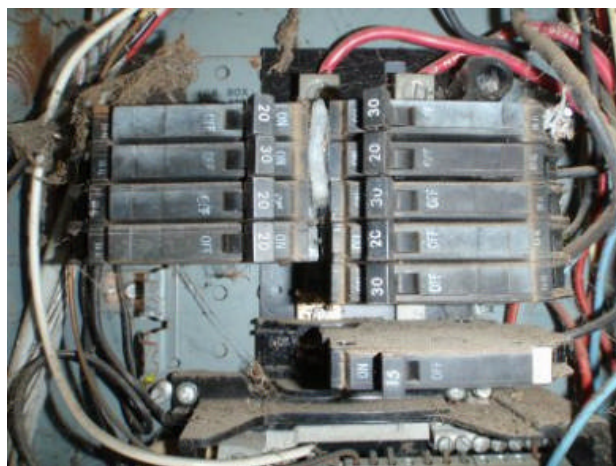
Individual 30 amp, single pole circuit breakers have been used. 30 amp, 120 volt circuits are unusual in residential construction. I believe that these breakers provide 240 volt power to outlets in the carport area. Double-pole, 240 volt circuit breakers should be connected together to allow both breakers to "trip" off should an overload occur. This should be corrected by a licensed electrical contractor concurrently with other repairs noted in this report.

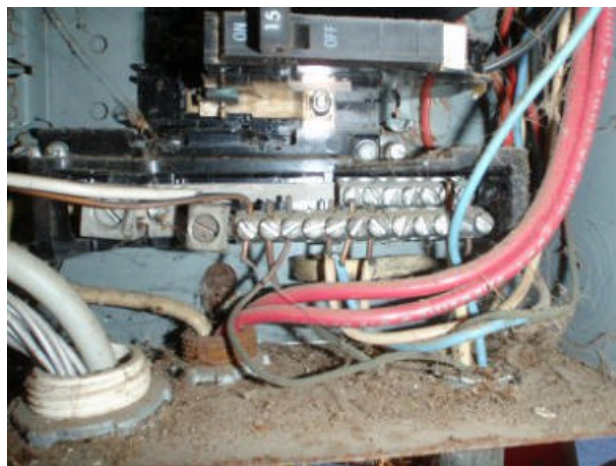
Wires are undersized for the breaker size. #12 wires are connected to 30 amp breakers. This sized wire should not be connected to a circuit breaker that exceeds 20 amps. This installation can allow the wire to carry excess current which could permit the wires to overheat. This should be corrected by a licensed electrical contractor concurrently with other repairs noted in this report.

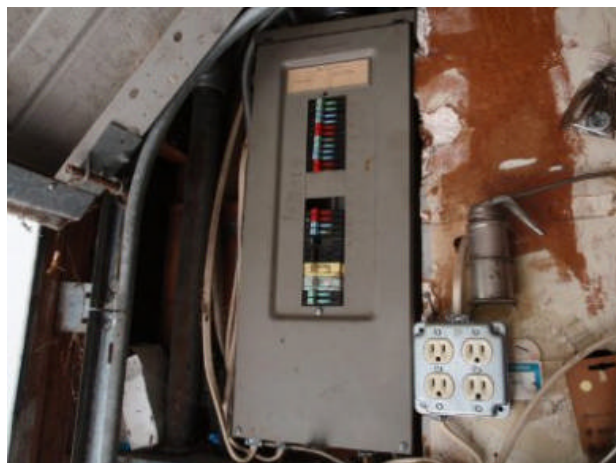
Garage Panel:

The dead-front is not properly secured.

The dead-front is not properly secured. The dead-front is a sheet metal panel that allows access to the circuit breaker handles while covering the live/energized wiring within the panel. I recommend this be attached/secured to the panelbox with proper screws. The screws used should be similar to the screws originally supplied with the panel and should not be pointed/sharp.

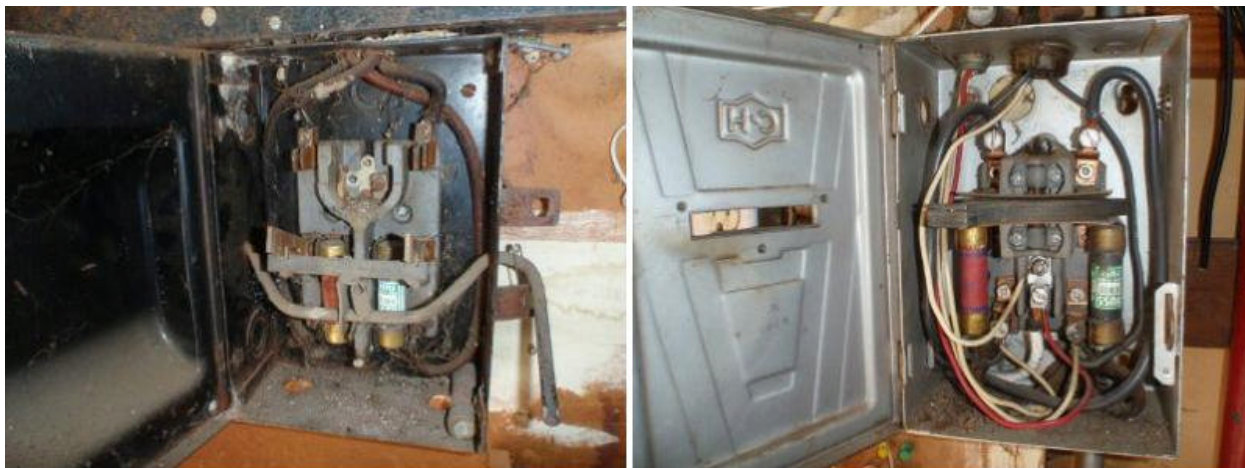
General:

Other, older fuse panels are present in the garage. I recommend removal of these panels and properly removing/terminating the wiring/conductors.

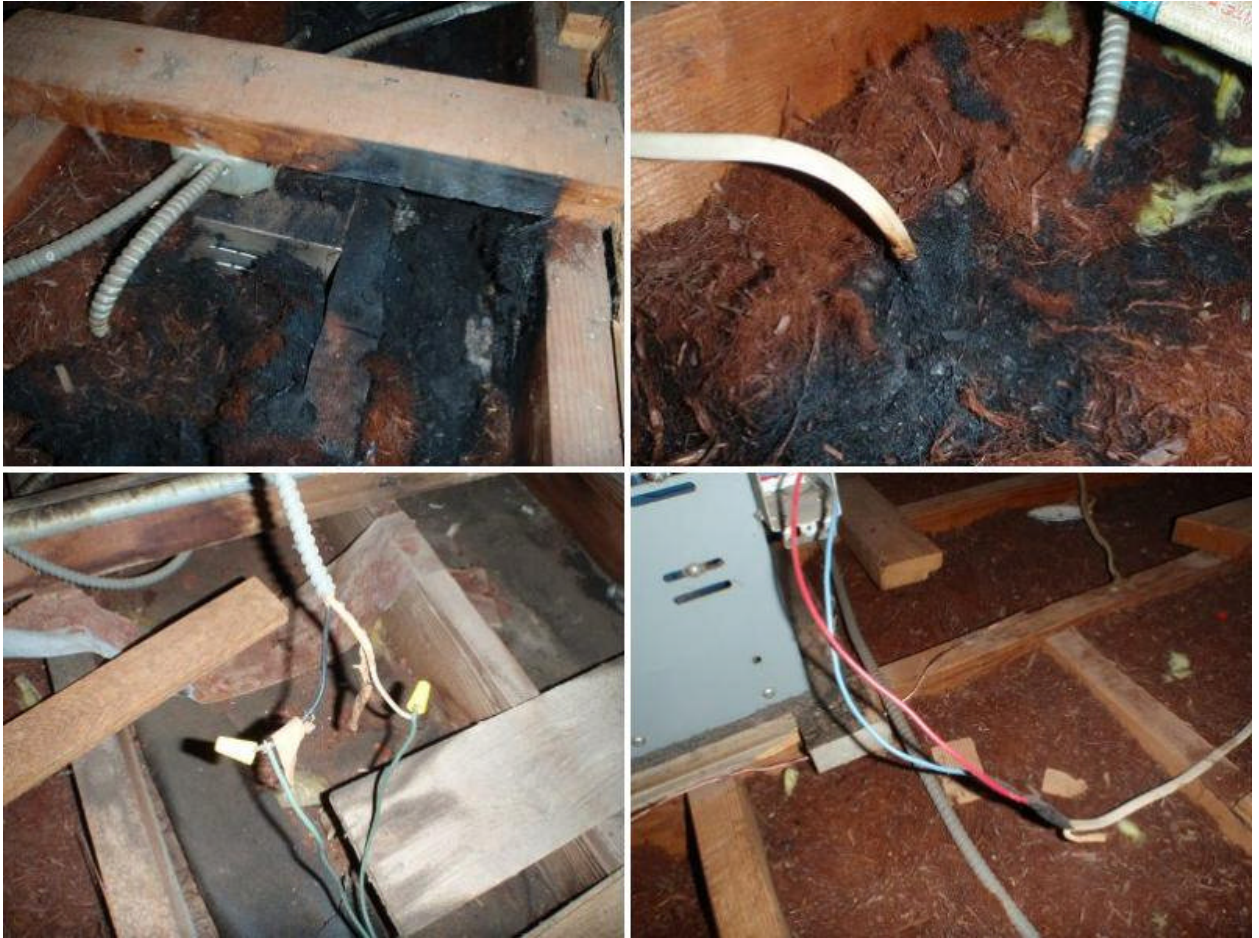
Attic Area
Conditions:

Improper and unsafe wiring was found at areas throughout the attic.

Terminated electrical cable with exposed leads, unprotected electrical splices, open junction boxes and individual conductors were observed at areas throughout the attic space.

Improper and unsafe wiring was found at areas throughout the attic. Terminated electrical cable with exposed leads, unprotected electrical splices, open junction boxes and individual conductors were observed at areas throughout the attic space. A licensed electrical contractor should be hired to make any needed repairs or corrections.

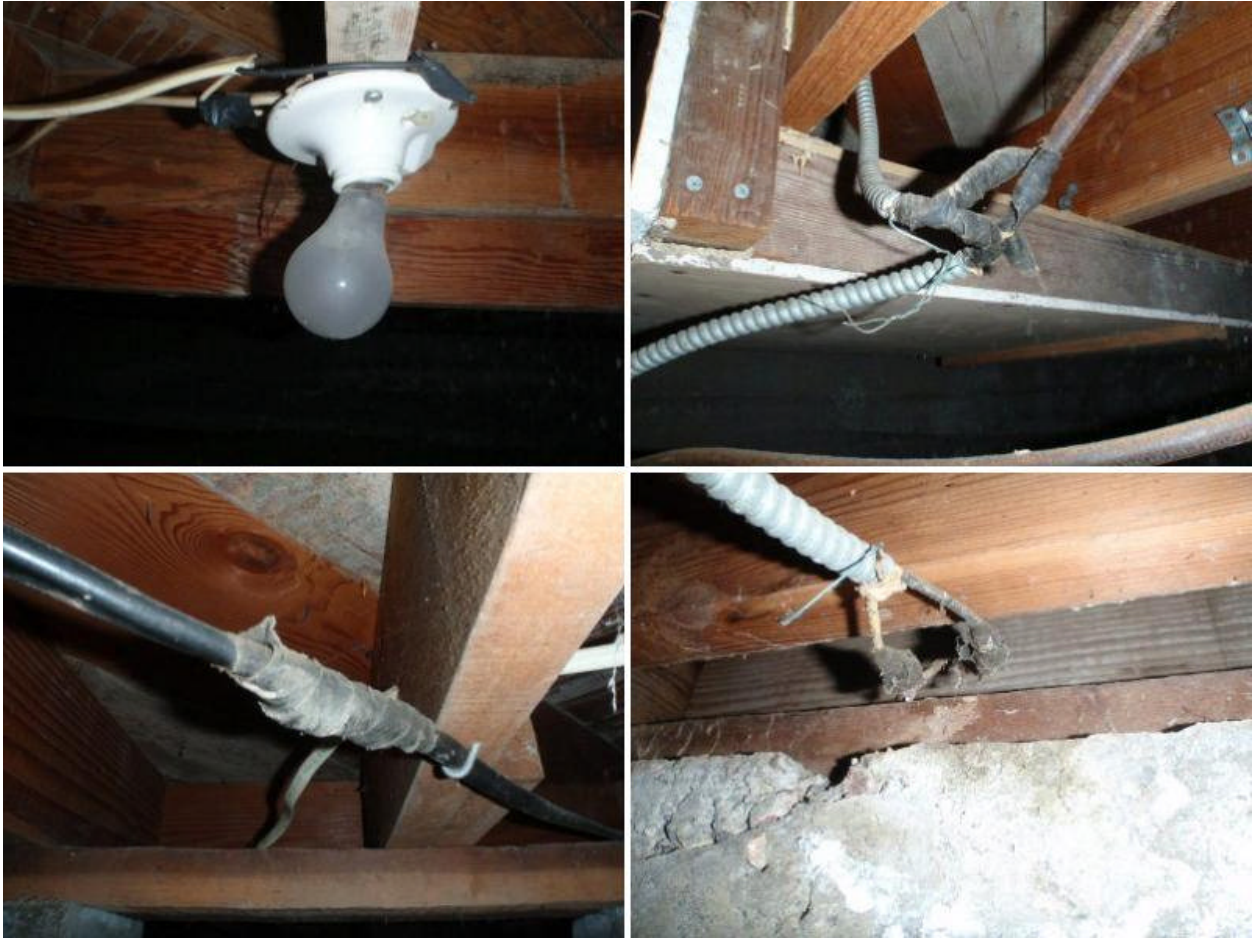
Foundation Area
Conditions:

Improper wiring was found in the crawlspace area.

Improper wiring was found in the crawlspace area. Porcelain light fixtures are not secured to junction boxes and electrical splices are not enclosed in junction boxes. Corrections should be made by a licensed electrical contractor concurrently with other repairs noted in this report.

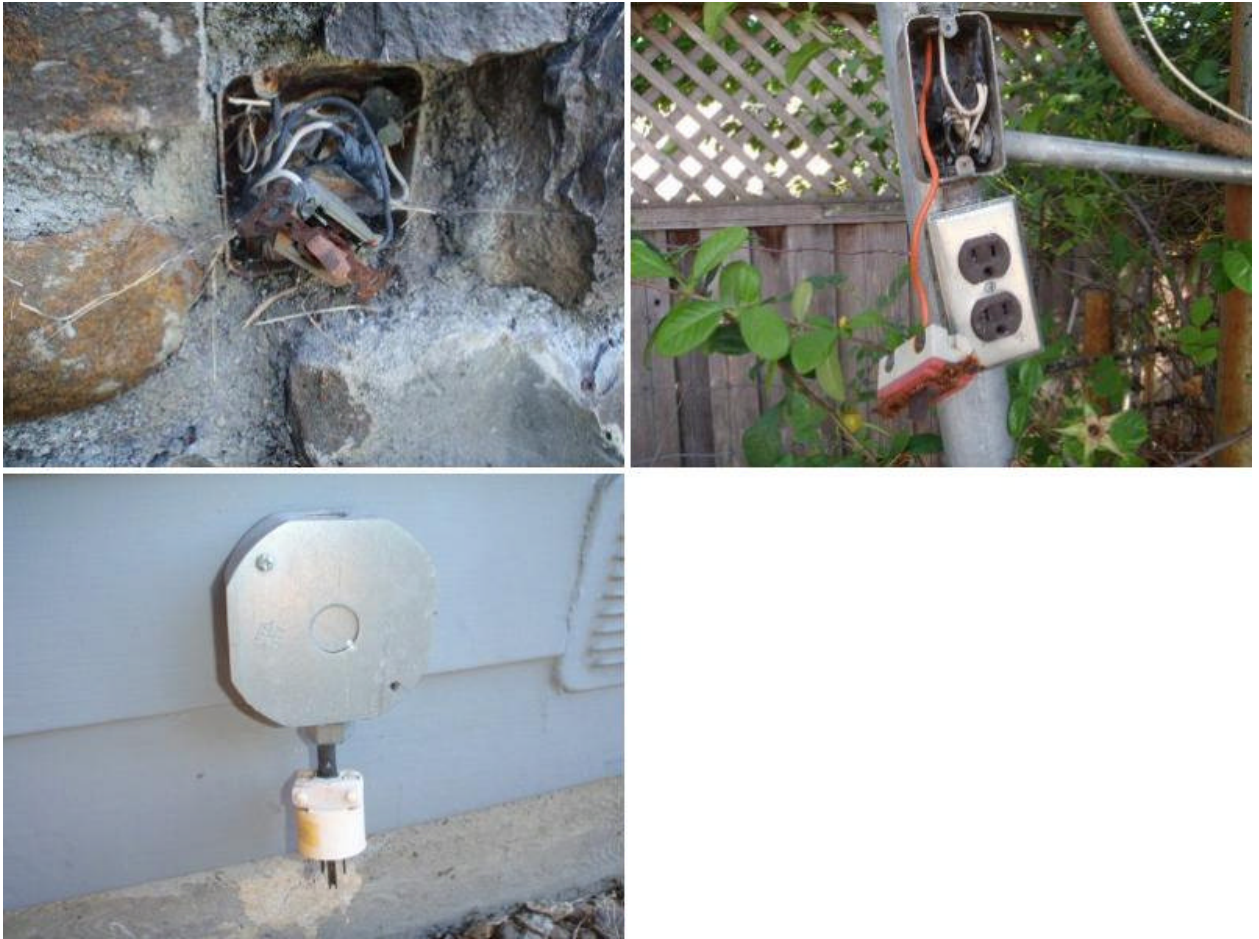
Exterior Fixtures:

Switches and wiring have been pulled-out of electrical boxes adjacent to the tall carport and the pool steps. I suspect other unsafe and nonstandard wiring is present as well. A licensed electrical contractor should make repairs or corrections concurrently with other electrical repairs.

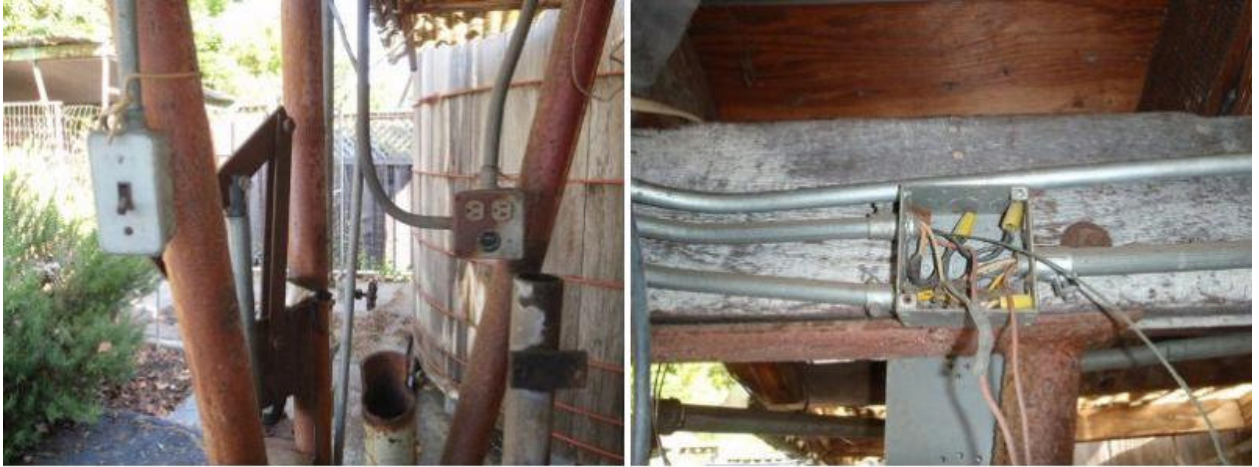
Carport Fixtures:

Electrical wiring is unsafe and nonstandard. No cover plates present on some junction boxes, nonmetallic sheathed cable has been used, loose wiring is not secured/hanging down and receptacle outlets are not GFCI protected. In addition, receptacle outlets do not have waterproof exterior covers. A licensed electrical contractor should be hired to make any needed repairs or corrections.

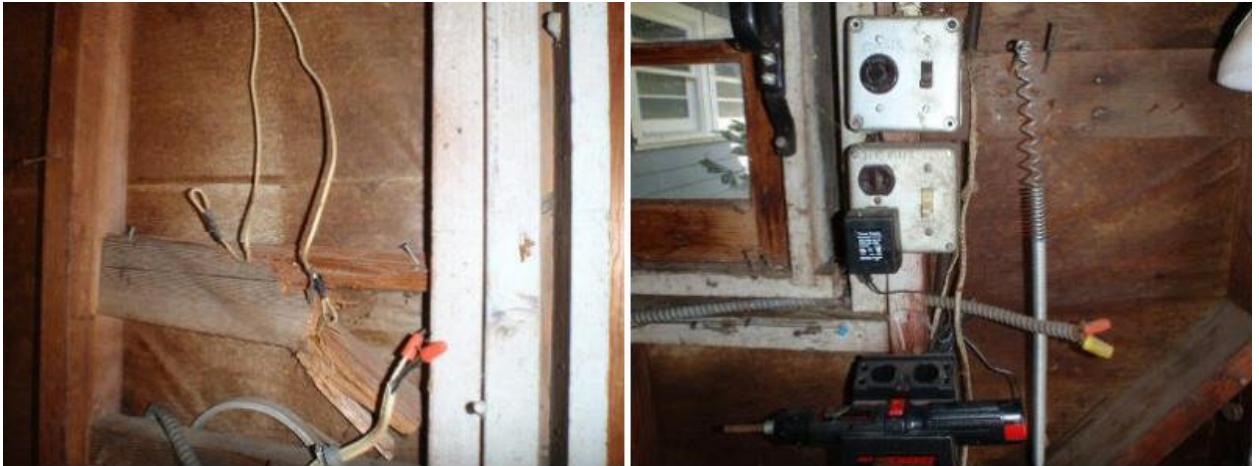
Garage Fixtures:

Electrical wiring is unsafe and nonstandard. Terminated wiring and open junction boxes are present. Corrections should be made by a licensed electrical contractor concurrently with other repairs noted in this report.

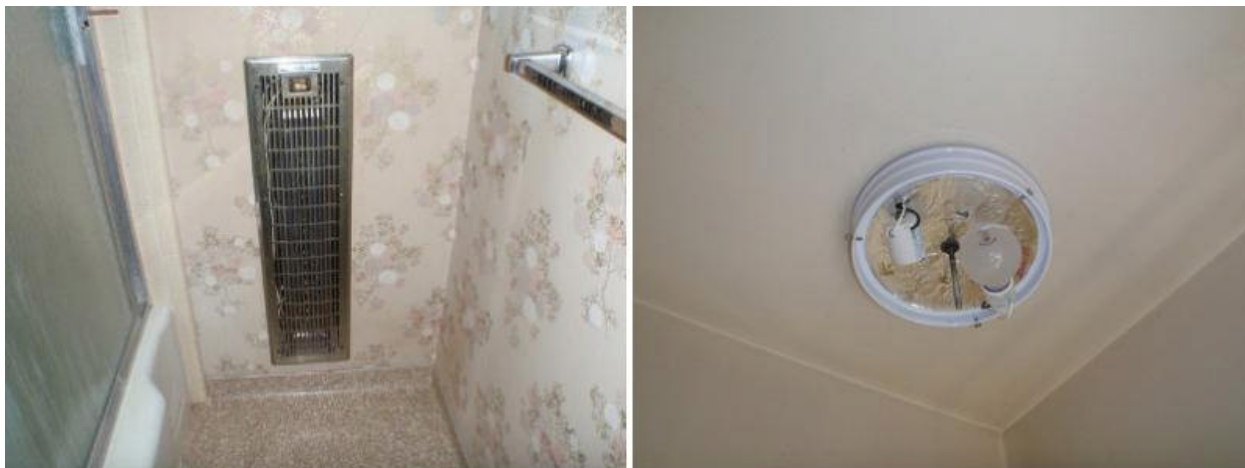
Bathroom Fixtures:

Receptacle outlets are not GFCI (ground fault circuit interrupter) protected. For more information, please refer to the GFCI notes above.

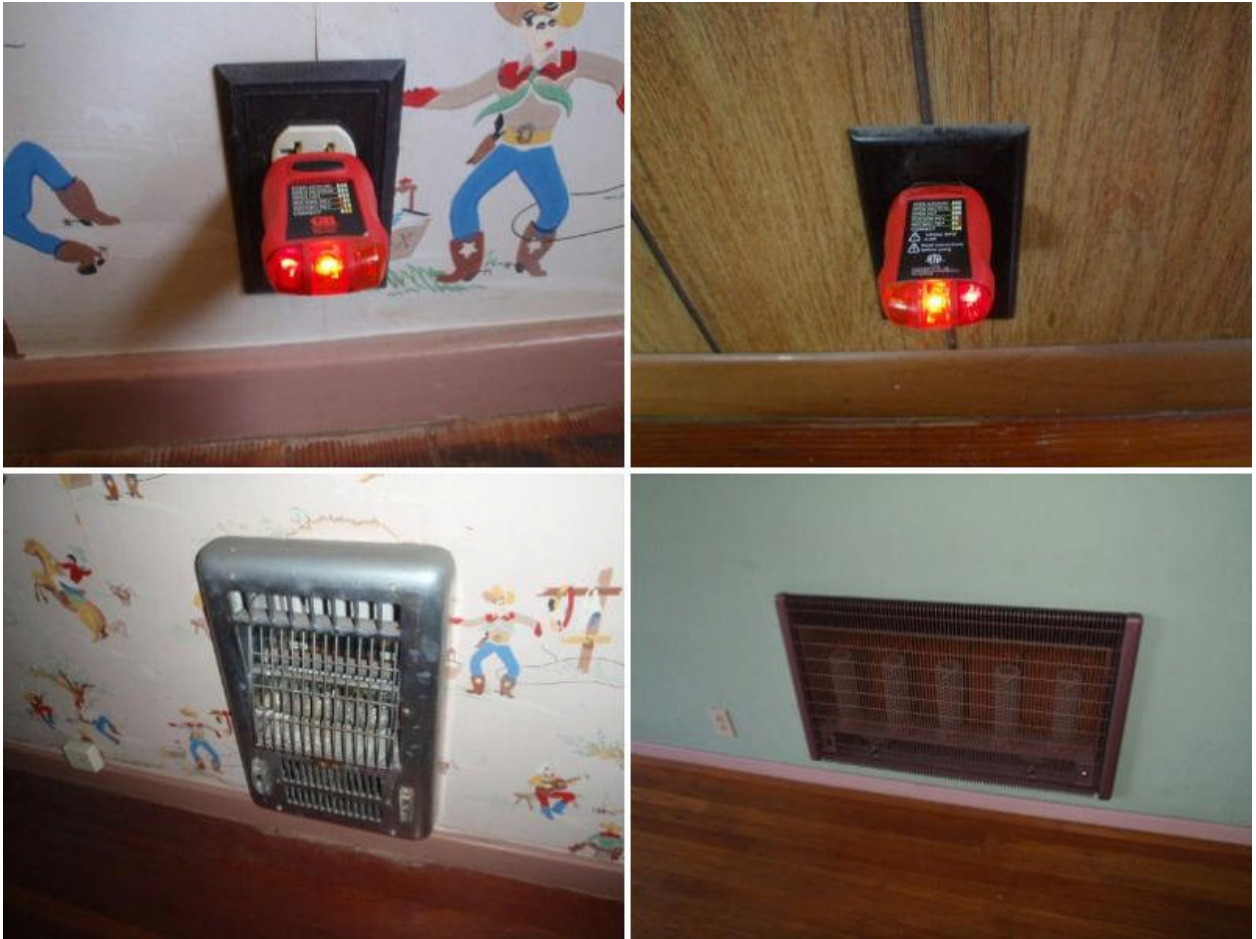
Interior Fixtures:

Polarity was reversed at receptacle outlets at the north and south bedrooms. Reversed polarity in an outlet is usually the improper connection of wires to the receptacle itself. Many appliances have "polarized" plugs (the neutral prong is wider than the "hot" prong) and may not function properly if the wiring is reversed. This is typically corrected by switching the wiring on the receptacle (white to silver colored connection and black to brass colored connection). However, due to the hazards associated with electricity, a licensed electrician should make these corrections.

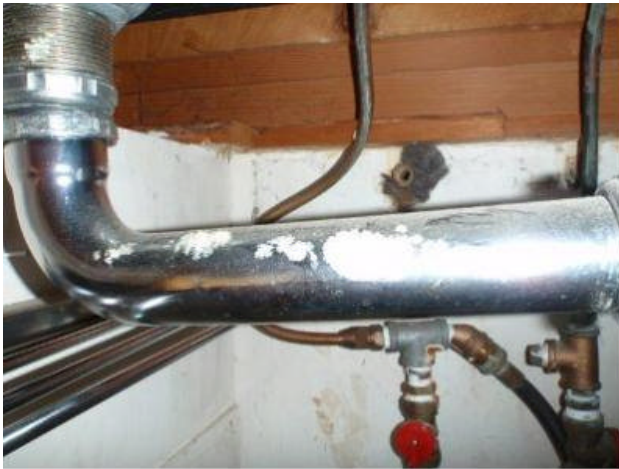
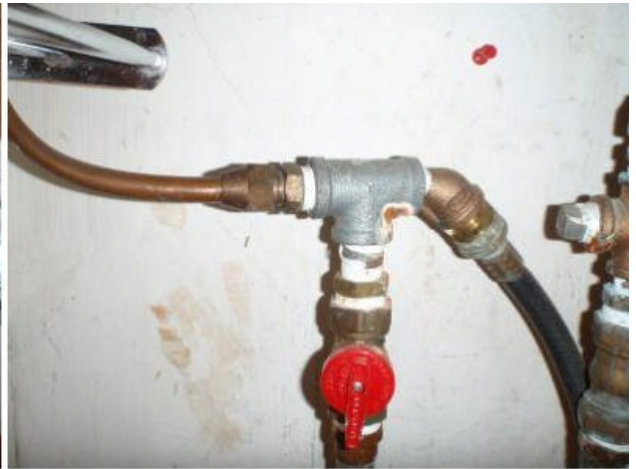
Supply & Drain:

Plumbing under the sink is deteriorated.

Plumbing under the sink is deteriorated. No leaking noted at time of inspection. Please refer to the plumbing section of this report for related information.

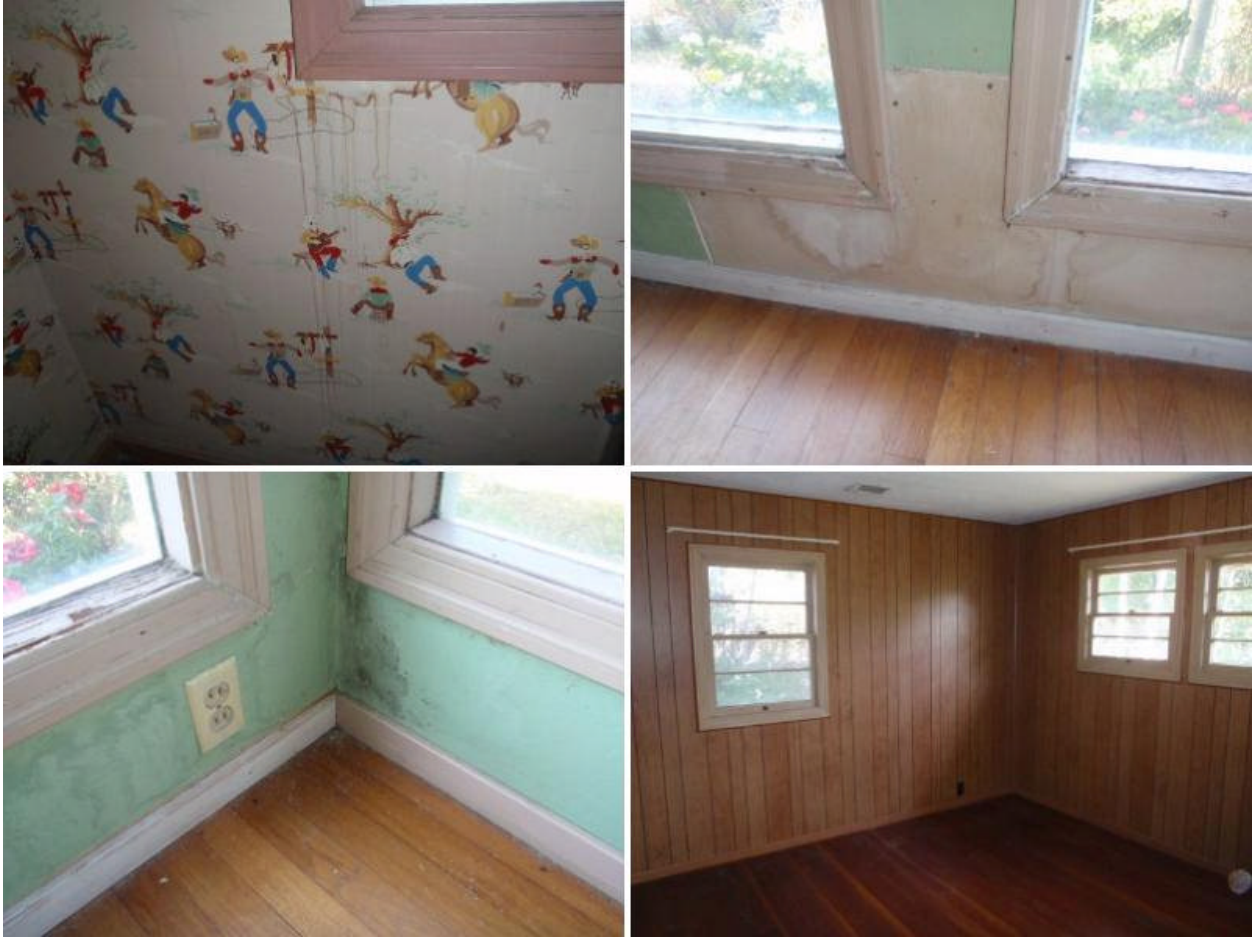
Windows:

Evidence of leaking was observed adjacent to the living room and south bedroom windows.

Evidence of leaking was observed adjacent to the living room and south bedroom windows. This is likely due to active leaking. The exterior of this window should be reflashed or resealed, as needed. Unable to determine the condition of enclosed framing without destructive testing. This should be reviewed by a licensed pest inspector for any wood damage.
