Inspected for:  
Zaphod Beeblebrox  
14 Heart of Gold Drive  
Traal, CA

**06/06/2011**

Scott Wright  
Full Circle Inspections, Inc.  
122 Calistoga Rd. #196  
Santa Rosa, CA 95409  
(707) 528-7010  
[Scott@FullCircleInspect.com](mailto:Scott@FullCircleInspect.com)

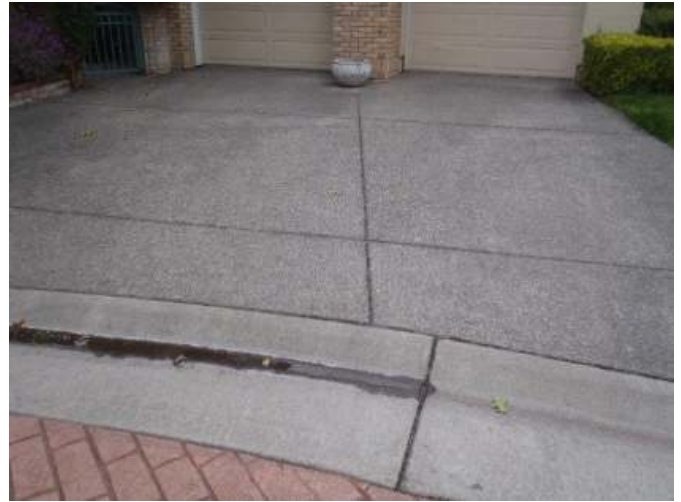
Concrete. Cracks are present in driveway surface. Cracks of this type are not uncommon and usually due to curing, expansion/contraction and/or soil movement/settling. Patching cracks can help to prevent excess moisture from gaining entry under the driveway and causing further cracking. Corrective measures should be taken if surface becomes uneven or damaged.

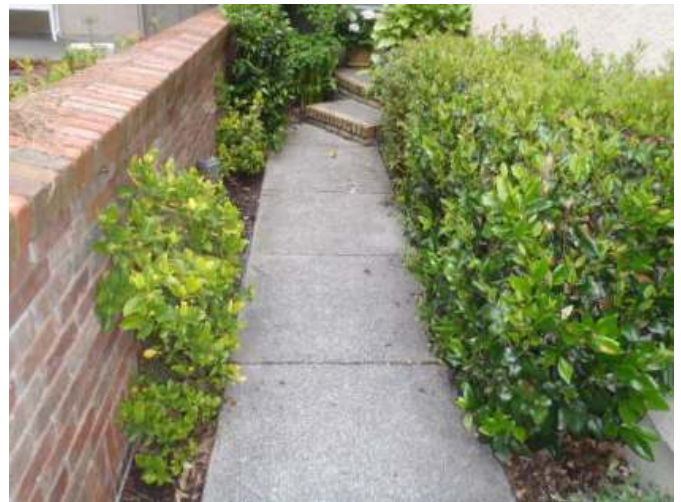
Concrete. Cracks are present in walkway. Please refer to the driveway notes for related information.

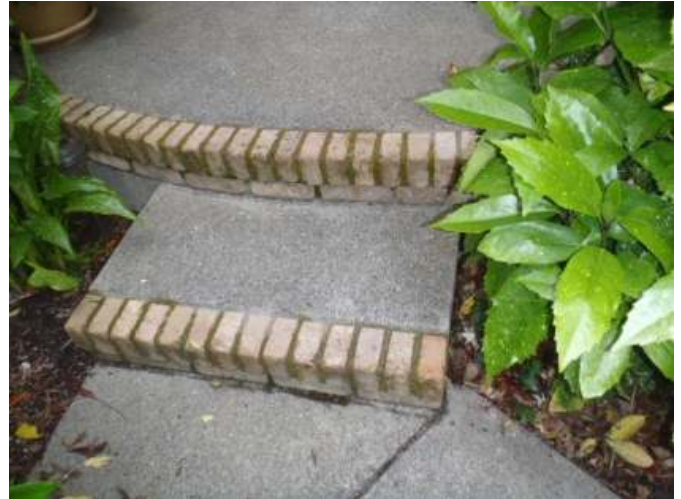
**Steps do not have a handrail.** While not required, I advise installation of an easily gripped handrail as many people need some assistance, even with a single step. Handrails should have a minimum clearance from the wall or guardrail of no less than 1½ inches, should not project into the stairway more than 4½ inches, should be between 34 and 38 inches above the nosing and the ends should "return" back to the wall or newel post. Circular handrails should be between 1¼ and 2 inches in diameter. Handrails are intended to help prevent an individual from falling when ascending or descending.

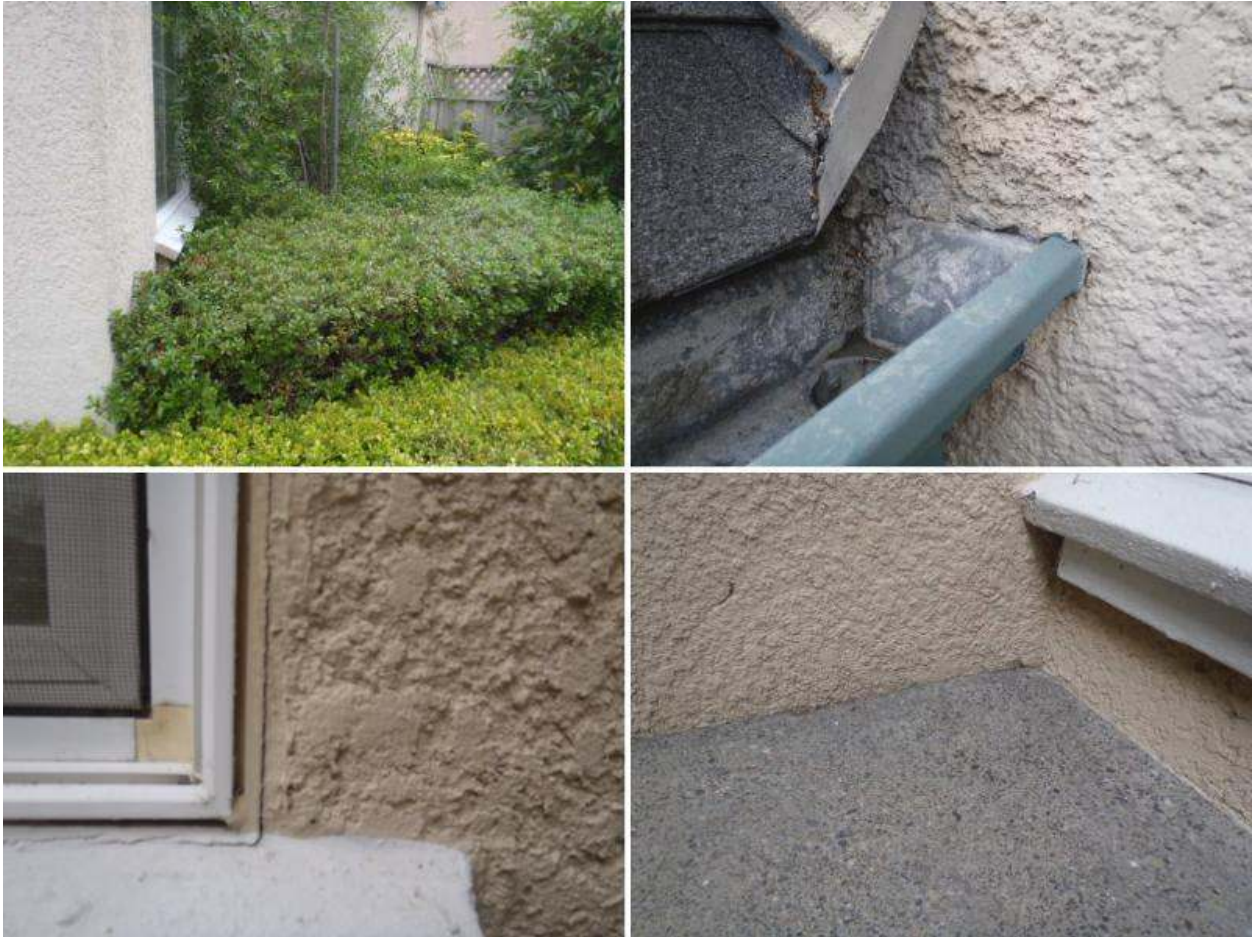
Cracks observed in stucco siding. Stucco is a cementitious material and will crack when the house flexes or moves. Periodic sealing or patching of large cracks and voids is recommended to prevent leaking to the interior surfaces of the walls. This should be done as a part of routine home maintenance.

**Gutters are embedded in the stucco.** This is a possible source for moisture intrusion behind the stucco. I was unable to determine the condition of the moisture barrier behind the stucco. Typically, the gutter is held away from the wall to allow the wall to be fully plastered with stucco. My primary recommendation is to have the gutter shortened to allow the stucco to be patched. At a minimum, the perimeter of the gutter should be kept well sealed with caulking to direct water away from this vulnerable area.

**Stucco has been installed against the concrete slab.** Stucco siding should be installed a minimum of 2 inches above concrete slabs to prevent moisture from penetrating up into the base of the siding and causing damage to the adjacent wood framing.

**Vegetation is in contact with siding.** Plants can cause damage to siding as well as gain entry to wall cavities and attics. In addition, this can allow rodents to gain entry to attics and wall cavities. These plants should be kept trimmed away from the siding as a part of routine maintenance.

**Voids/gaps were found at various areas.** I recommend sealing all cracks/voids between siding and trim as well as at plumbing penetrations to prevent moisture intrusion to the interior surfaces of the wall.

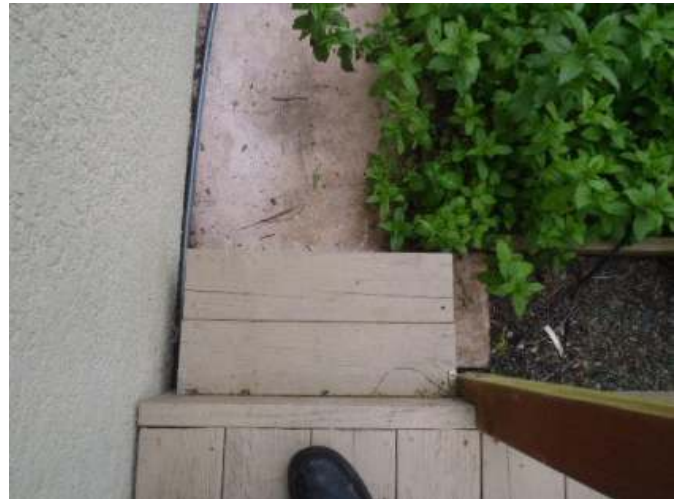
Stairway is rather steep and the tread depth is shallow.

Wood framed steps. **Stairway is rather steep.** Current construction standards require that risers not exceed 7 3/4 inches in height and the minimum tread depth be not less than 10 inches. In addition, the maximum difference in riser height or tread depth for any stairway is 3/8". Although this stairway may have been acceptable at time of original construction, it will likely be more difficult to ascend/descend safely. While no modification or correction is required, my primary recommendation is to construct a new stairway that conforms to current building codes. At a minimum, caution should be exercised when negotiating the stairway.

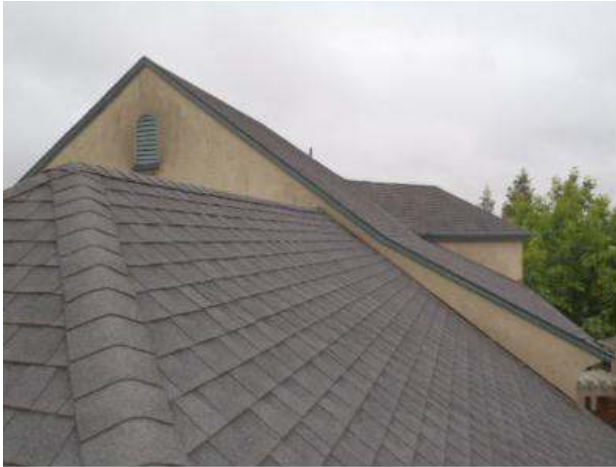
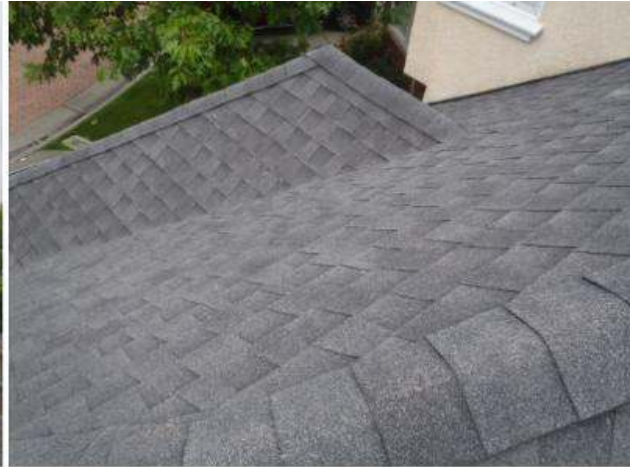
**Limited access due to the steepness of the roof.** Viewed from accessible areas.

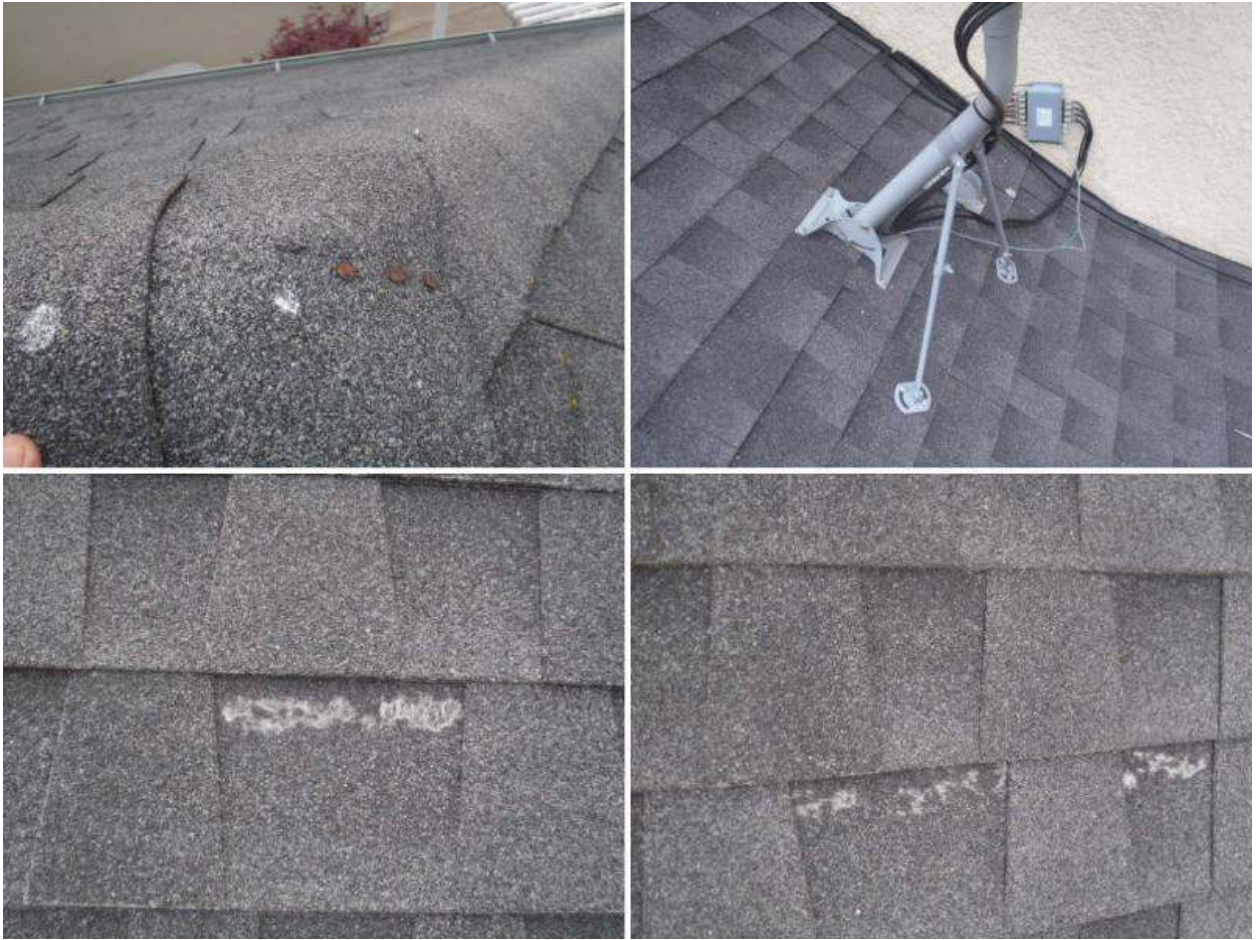
The "dish" antenna has been attached to the roof through the shingles.  
Some shingles are damaged.

The wear observed on the roof shingles is typical of material that is more than 50% through its useful life.

**Some fasteners are exposed.** While not likely to be a significant source of leaking, I recommend sealing with tar or caulking to prevent leaking through the penetrations.

**The "dish" antenna has been attached to the roof through the shingles.** My primary recommendation is to relocate the antenna and repair the roof or to install proper flashing to prevent moisture damage to the roof sheathing. At a minimum, bolt penetrations should be kept well sealed/coated with mastic (asphalt patching compound).

**Some shingles are damaged.** This appears to be from physical damage. The fiberglass is exposed in some areas, allowing water to absorb into the shingles. Any damaged shingles should be replaced.

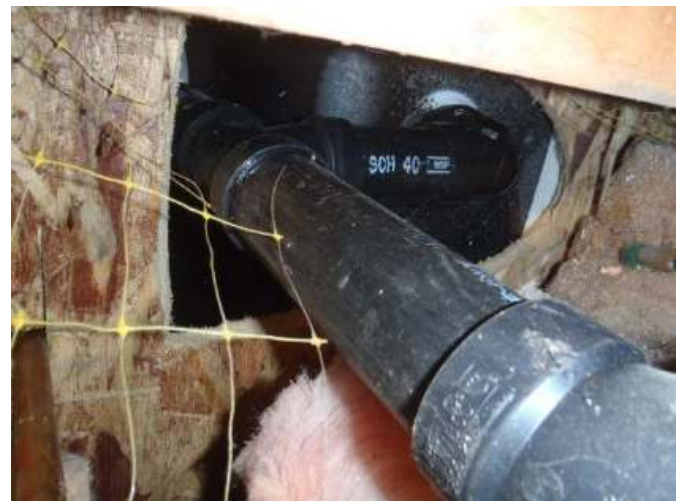
**The opening for the tub drain pipe is not screened.** This can allow animals access to the area under the tub as well as within interior wall cavities. Installation of screening is advised.

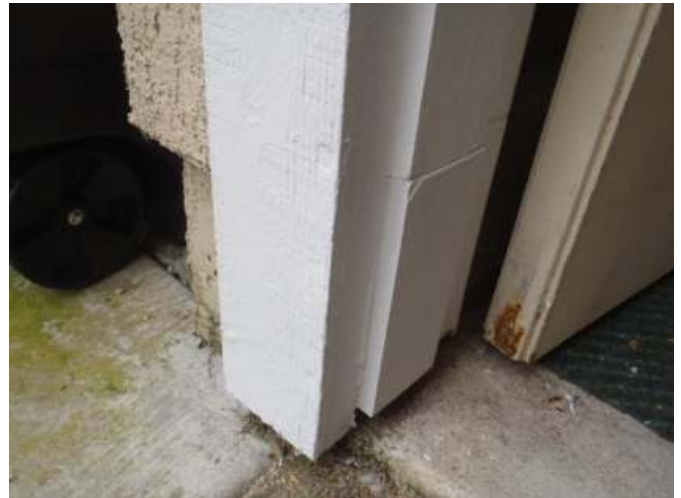
**Bottom of the exterior garage door has been repaired.** The damage noted in the pest report has been cut out and replaced.

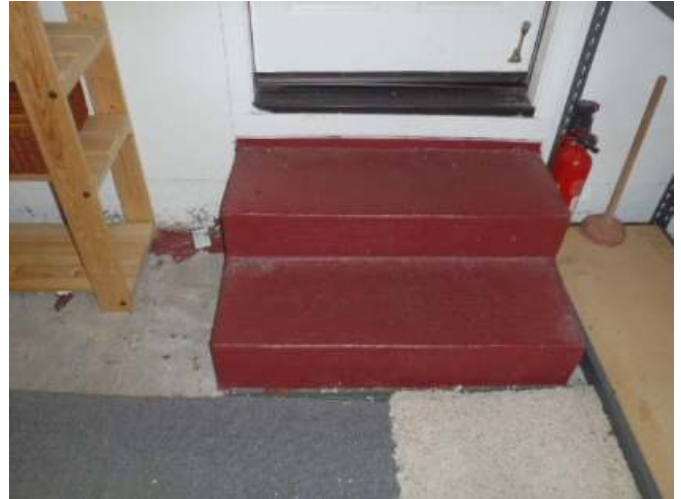
Step treads/risers are inconsistent.

Concrete. **Step treads/risers are inconsistent.**

Typically, the maximum difference in riser height or tread depth for any stairway is  $\frac{3}{8}$ ". Current construction standards require that risers should not exceed  $7\frac{3}{4}$  inches in height and the minimum tread depth is 10 inches. This could cause an individual to trip/fall and should be corrected.

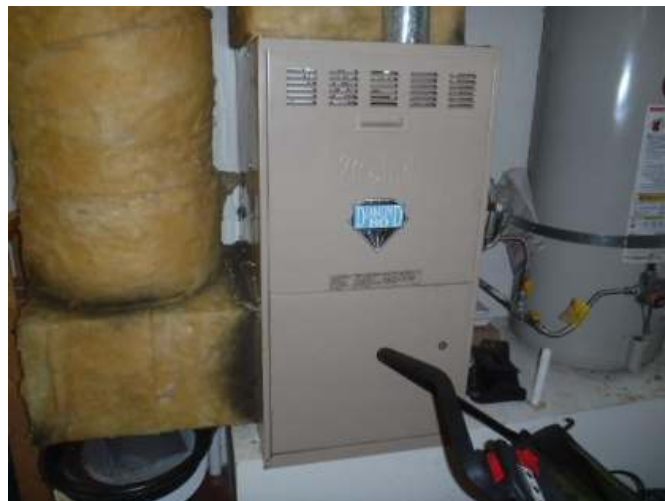
Mineral deposits were found adjacent to connections on the gas vent pipe.

**Mineral deposits were found adjacent to connections on the gas vent pipe.** This indicates moisture has condensed on the interior of the gas vent pipe and may be due to blockage in the gas vent pipe or improper venting of combustion gases. As this can result in corrosion of the inducer fan and/or the gas vent pipe, the heating system should be reviewed and corrections made by a licensed heating contractor.

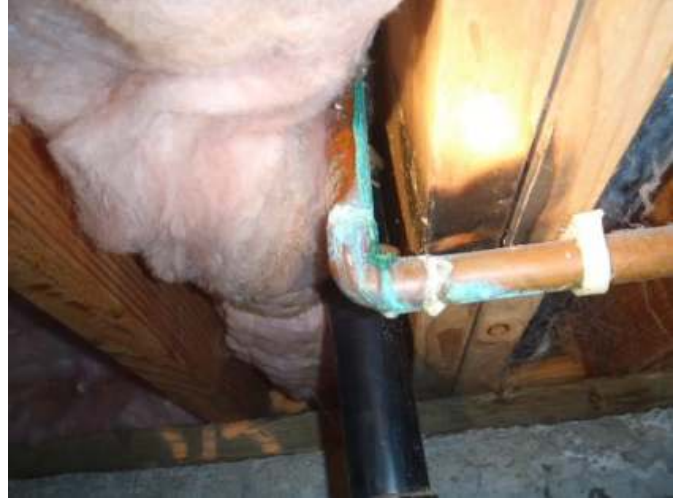
Sections of copper pipe/fittings are oxidized. This oxidation typically occurs as a result of not cleaning the flux off of the pipe after soldering. While no evidence of active leaking was found at time of inspection, ideally, the exterior of these pipes would be cleaned/wiped to prevent continued oxidation.

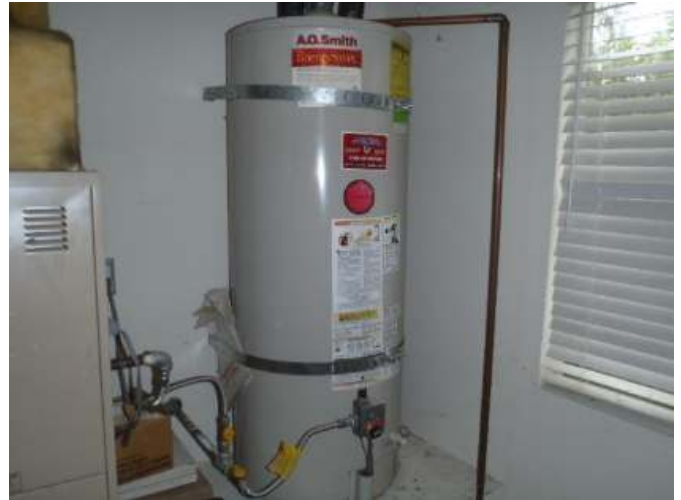
**No drain pan present under this tank.** Although located in a garage and not necessarily required, if the tank were to leak, the water would flood the floor in this area. As many people store personal property on the floor of the garage, I suggest installation of a pan that drains to the exterior.

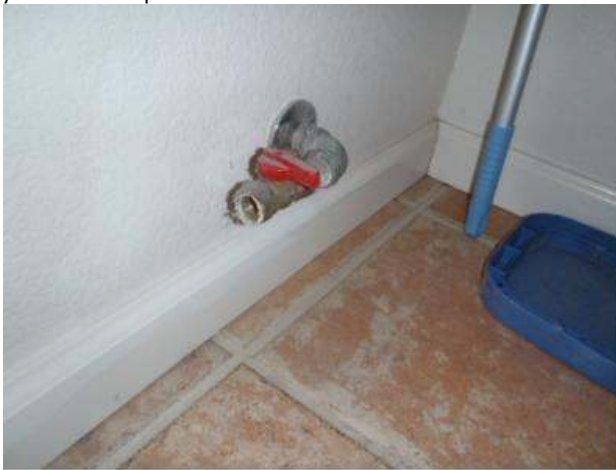
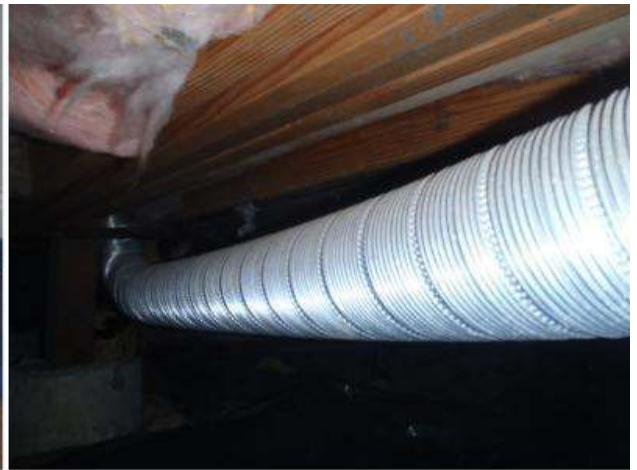
**The end of the gas valve is uncapped.** The gas valve should be capped if not in use to prevent fire or explosion. A cap should be installed by a licensed plumbing contractor.

**A flexible metal exhaust duct has been used to vent the dryer.** While approved for short connectors, this material is more likely to become clogged with lint and to restrict air flow. I recommend replacement with a smooth metal exhaust duct.

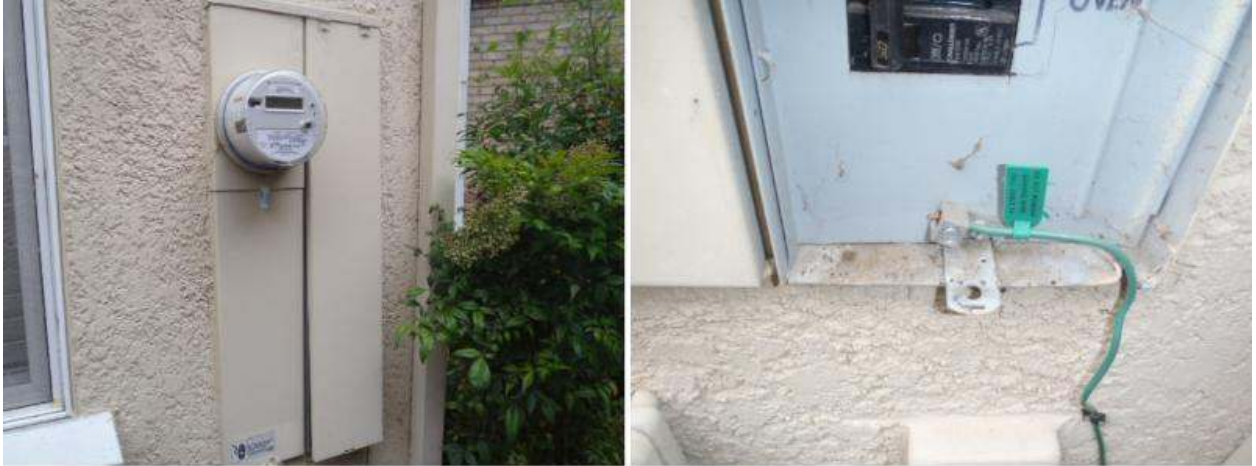
**A grounding clamp has been attached to the exterior of this panel.** This type of clamp is typically used by television cable and telephone companies to provide grounding for their equipment. However, in many cases, these clamps will interfere with access of the breakers and/or the interior of the panel. This type of grounding attachment, in my experience, is not as secure as if it were attached to a grounding terminal that is directly connected to the grounding electrode system within the panel. I recommend removal of this clamp and attaching a properly installed grounding terminal mounted on the exterior of the building. This can be done concurrently with any other electrical work by a licensed electrical contractor.

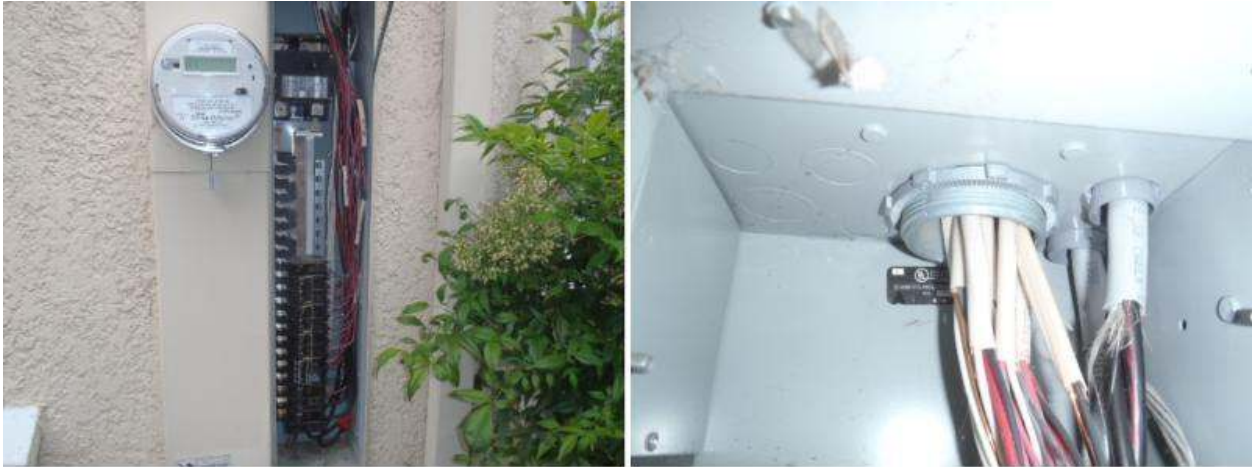
**Multiple nonmetallic sheathed electrical cables (romex type) have been inserted into openings that are intended for 1 - 2 cables.** Nonmetallic sheathed cables are required to be secured where they exit the panel and strain relief clamps are typically approved for a maximum of 2 cables. Inserting multiple cables through an opening limits review of the wiring in this panel. If more information is desired, a licensed electrical contractor should be consulted.

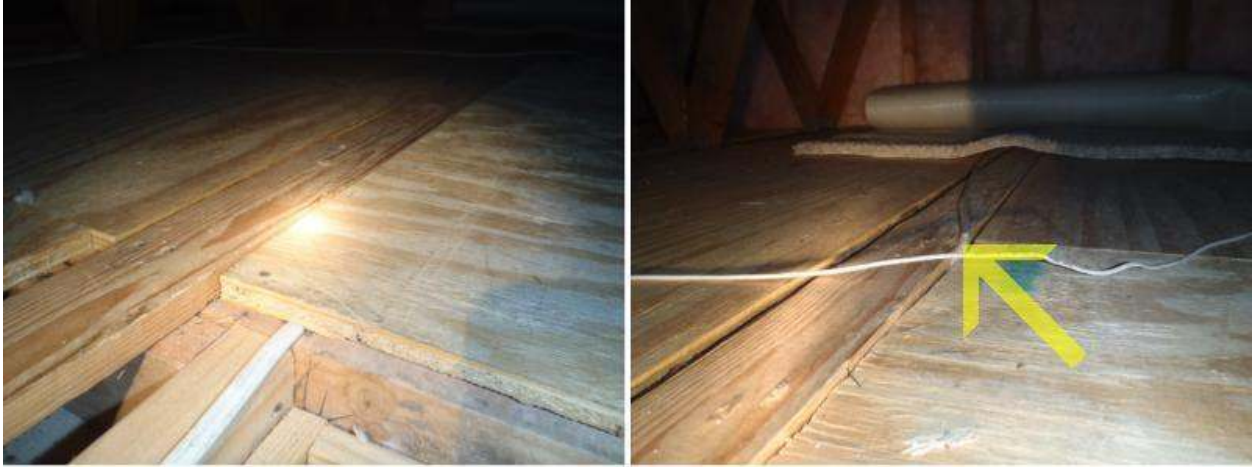
**Electrical cable is present near the attic access opening.** Electrical cable is typically required to be protected when it is within 6 feet of the attic access opening. Cables are not allowed to be run across the opening. Corrections are advised.

**Electrical cable is under the plywood flooring.** This can damage the insulation around the wires causing a fire hazard. I recommend removing the plywood flooring, or moving and protecting the wiring from damage.

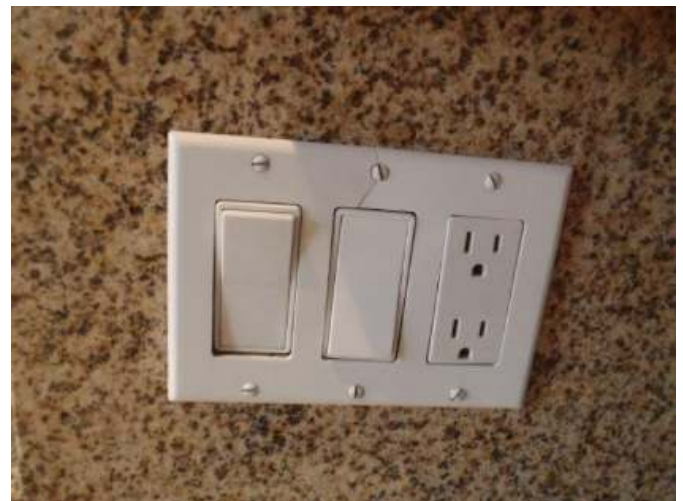
**Switch and cover plate is damaged.** This should be replaced by a licensed electrician.

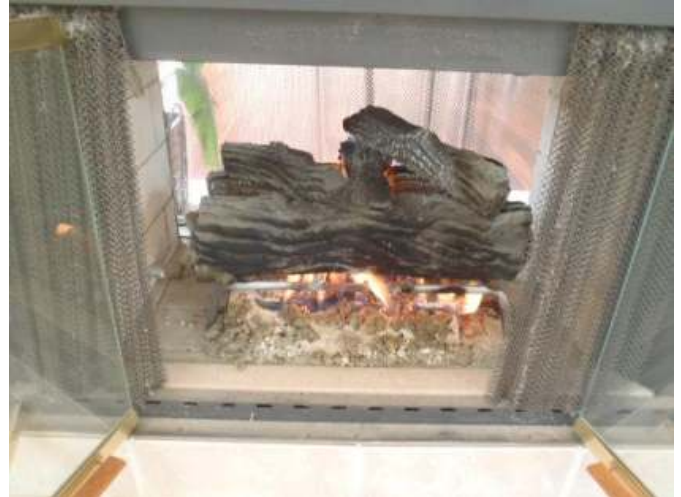
**This fireplace has two opening sides.** This type of fireplace has been known to have drafting problems. Verification of proper drafting is beyond the scope of this inspection.

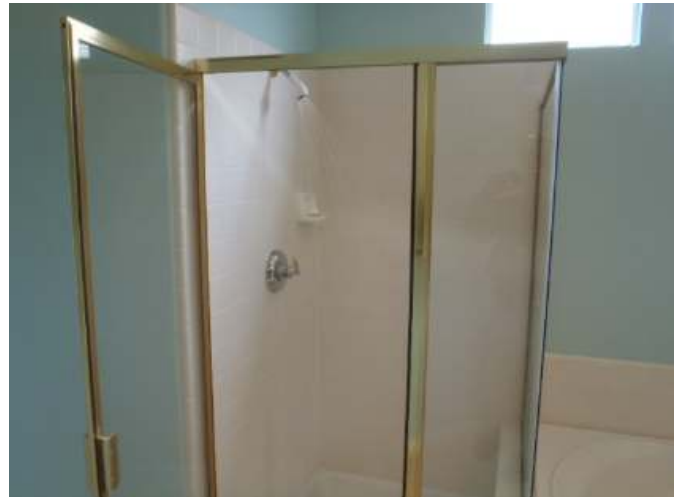
**Shower enclosure door will leak if sprayed directly.** These doors are particularly vulnerable to leaking and this can allow moisture to damage the flooring. The enclosure door should be resealed or reinstalled to stop the leaking and the shower head should be directed away from the door area.

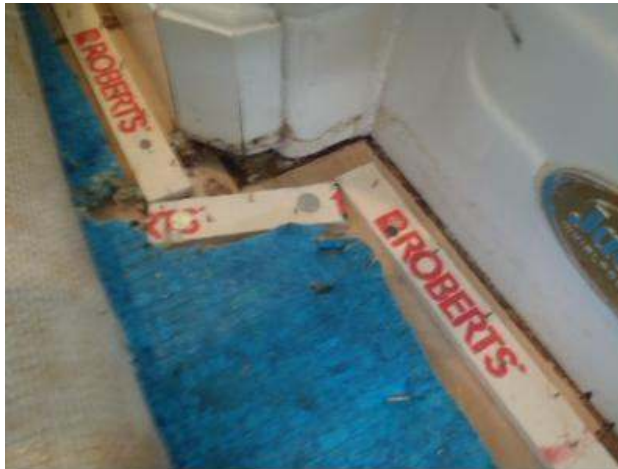
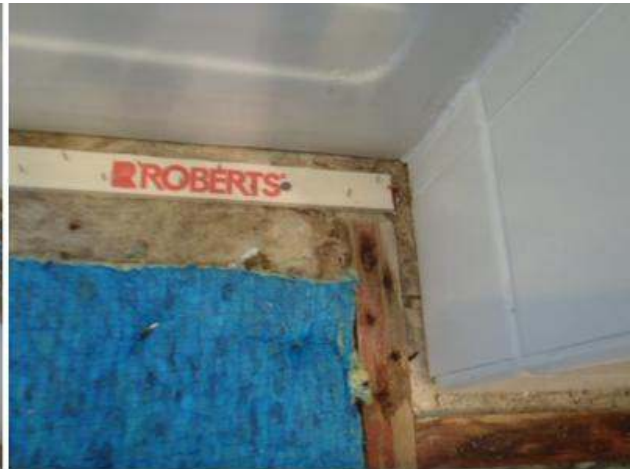
**Review of the subfloor is limited due to the presence of the carpet.** Carpet is not the best material for a bathroom floor as the material is absorbent and will tend to hold moisture against the subfloor sheathing. I probed the floor around the typical "problem" areas and no softness or damage could be found. Replacement of the carpet with a resilient or tile material is advised to protect the subfloor from moisture

**Wet and stained subfloor sheathing was found adjacent to the shower.** I suspect that the shower enclosure door will leak while showering. Review of the subfloor is limited due to the presence of the carpet. Carpet is not the best material for a bathroom floor as the material is absorbent and will tend to hold moisture against the sub floor sheathing. A section of subfloor has been replaced as well as some of the tack strips for the carpet. Replacement of the carpet with a resilient or tile material is advised to protect the subfloor sheathing from moisture damage.

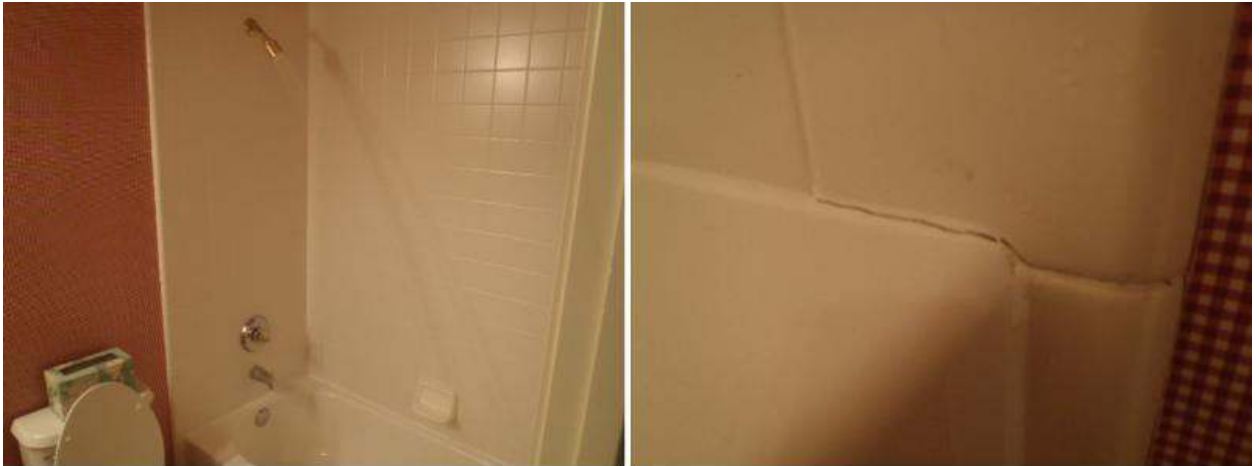
**Caulking at the perimeter of the tub surround is old.** Caulking should be removed and reapplied as a part of routine maintenance. I recommend the use of a mildew resistant caulk.
