Inspected for:
Ford Prefect
Arthur Dent
3316 Golgafrincham Dr.
Magrathea, CA

Re: 3316 Golgafrincham Dr.
Magrathea, CA

Full Circle Inspections, Inc.
122 Calistoga Rd. #196
Santa Rosa, CA 95409
(707) 528-7010

Report Highlights

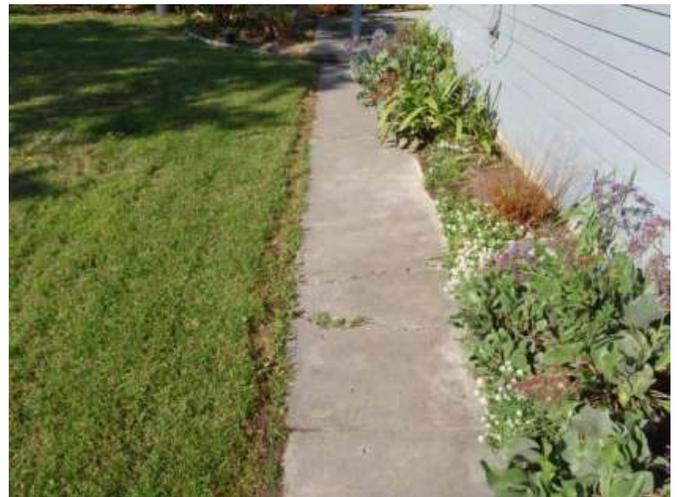
Concrete. Cracks are present in walkway.

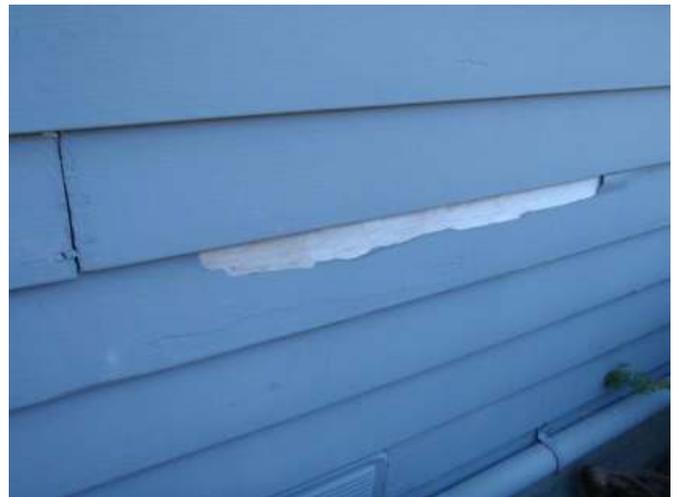
Exterior paint is deteriorated. Trim should be repainted to prevent damage to trim and structure.

Sealing all cracks/voids between siding and trim is recommended to prevent moisture intrusion to the interior surfaces of the wall.

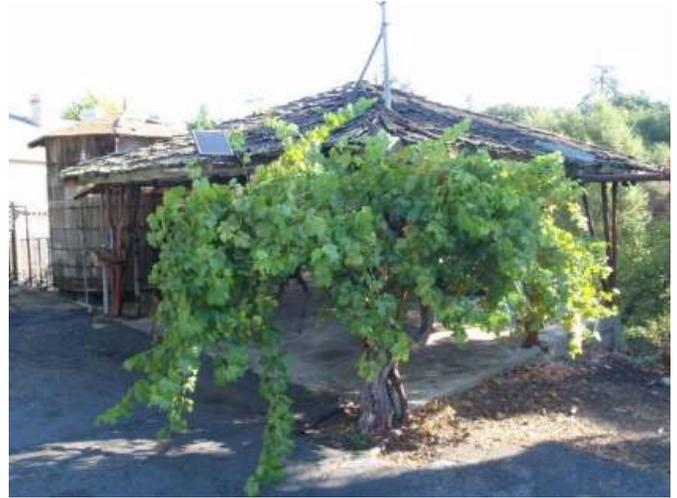
The roof is old and in generally deteriorated condition. I recommend replacement of the roof covering.

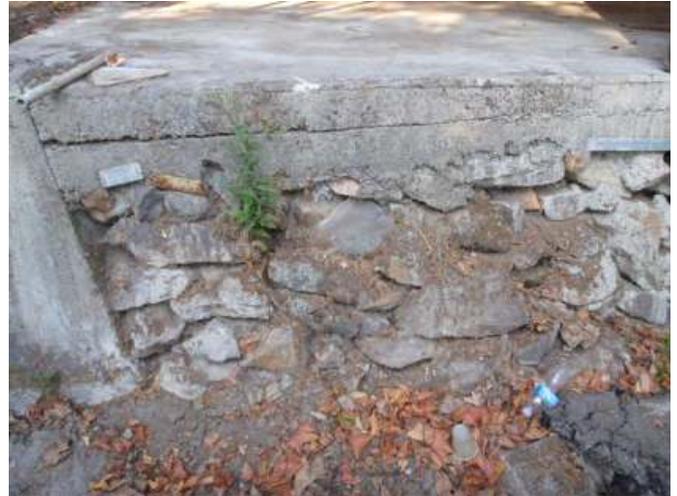
Concrete. Cracks are present in slab surface. These cracks are not uncommon and usually due to curing and/or normal soil movement/settling. Corrective measures should only be taken if concrete becomes uneven or damaged.

The rear of the slab has been supported on rock (rip-rap). This is more likely to settle than compacted fill. No evidence of excessive settling observed at time of inspection. Ideally, this rock would be replaced or supported with concrete.

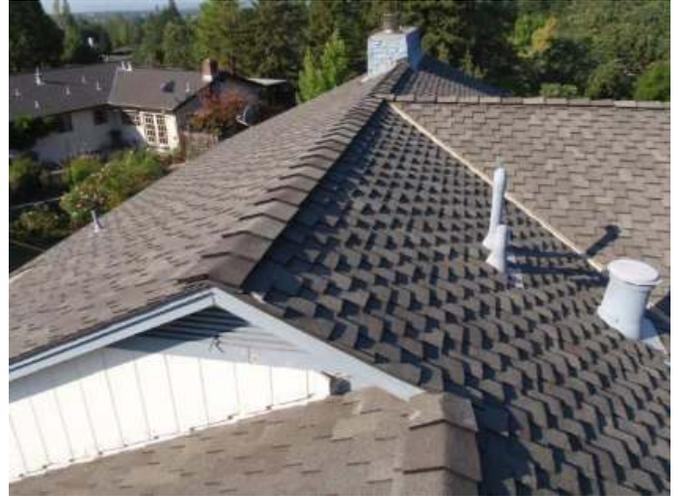
The construction of this roof is such that it has minimal eave protection for some of the exterior walls. As a result, these walls are more vulnerable to the effects of weather. Windows and doors can leak due to wind blown rain. Installation of awnings or covers can help to protect these areas. Keeping siding well sealed and painted is recommended to preserve the condition of the exterior surfaces.

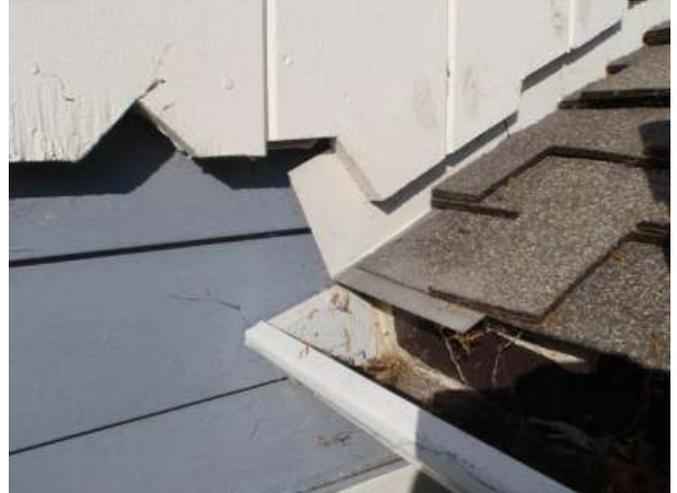
Roof/wall flashing at the garage/house connection is not complete. This installation will allow water to flow down the exterior siding. While this may not allow leaking to the interior of the house, it is likely to lead to moisture damage over time. Flashing should direct water away from the wall.

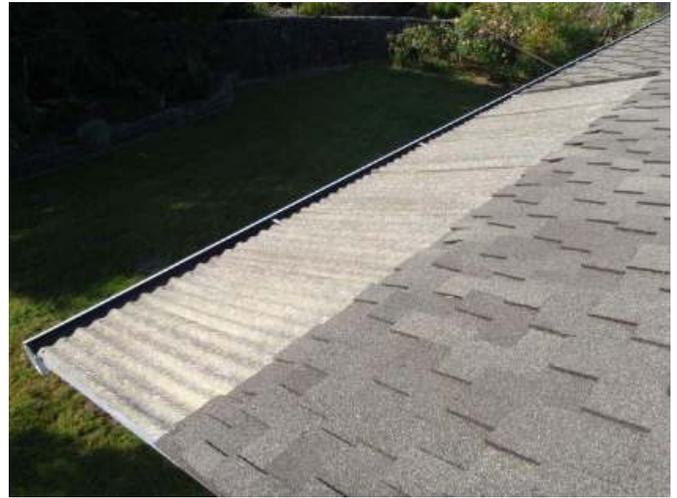
Condition:
These panels are aged and should be replaced.

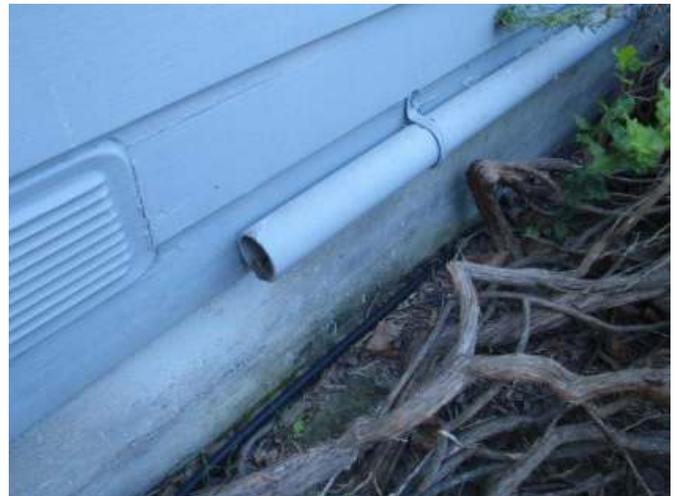
The gutter downspouts terminate adjacent to the foundation. Adding an extender system to move the roof water away from the perimeter of the house (preferably to the street or storm drain) is recommended to aid lot drainage.

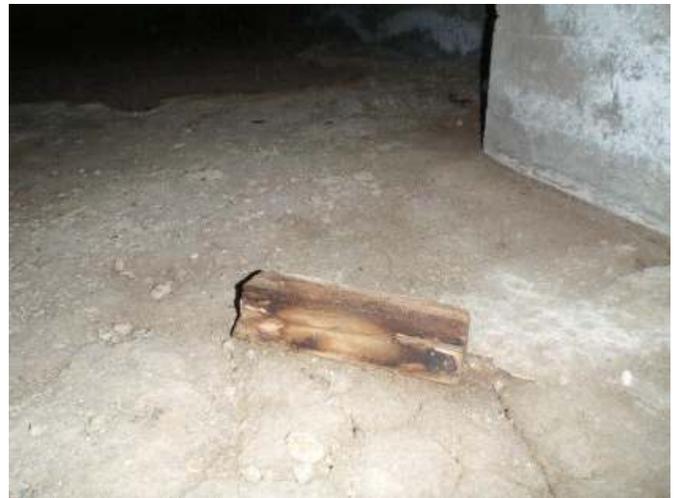
Wood scraps/debris is present on the soil under the house. As this can be misinterpreted by wood eating pests as an invitation to infest your home, I advise removal of all wood, cardboard, paper and other cellulose based material.

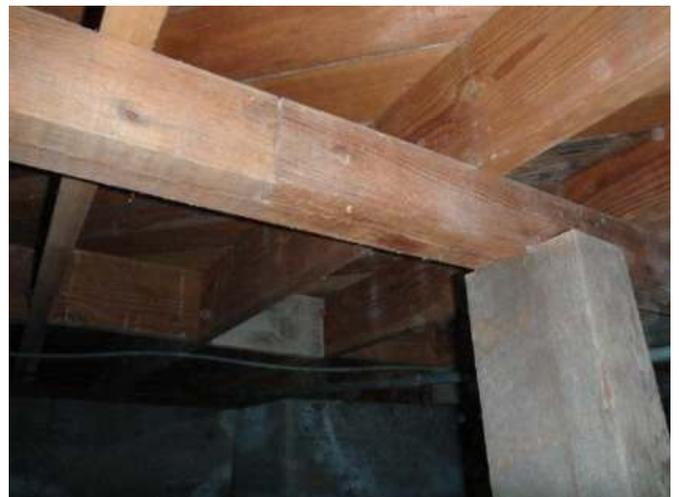
Doubled 2x4 wood girders.

These are undersized by modern construction standards. Minimum girder size, depending upon load and span, is typically 4x6. This is likely contributing to some of the cracked walls noted in the interior section of this report.

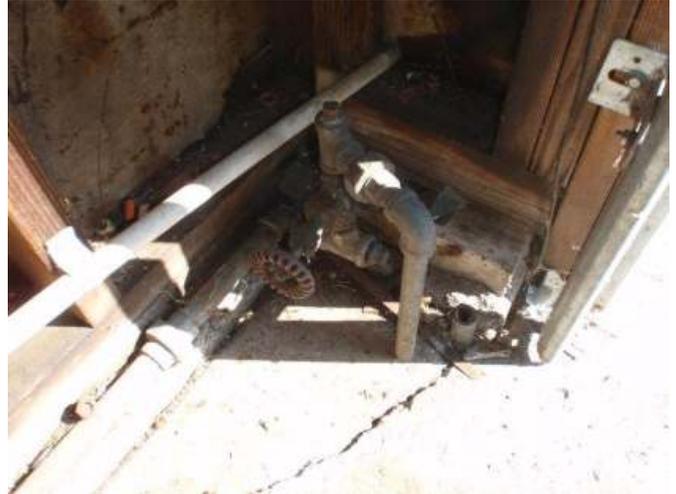
This is an older valve which may not function properly. Older valves commonly do not close completely and/or function properly. While not tested, preventative replacement is advised.

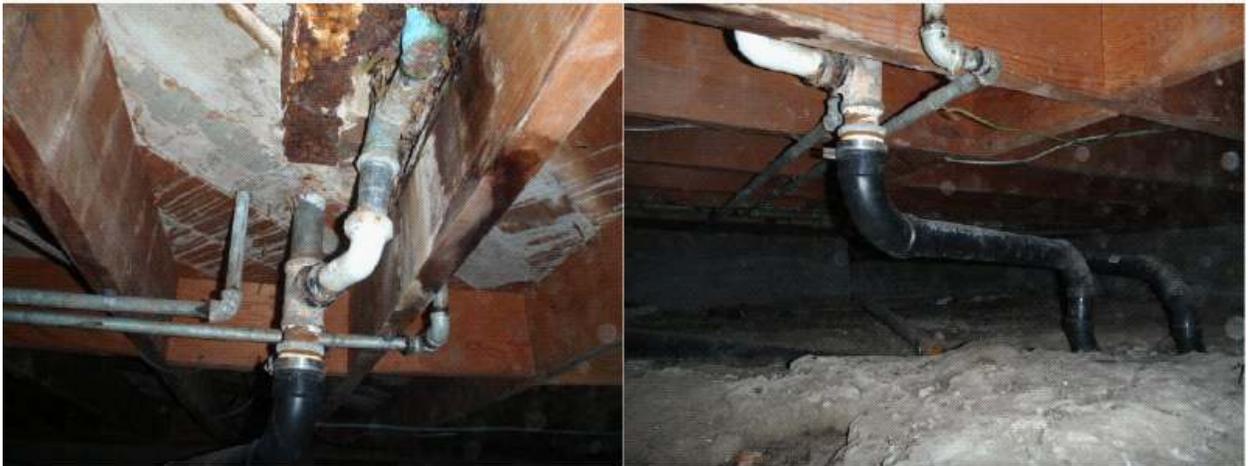
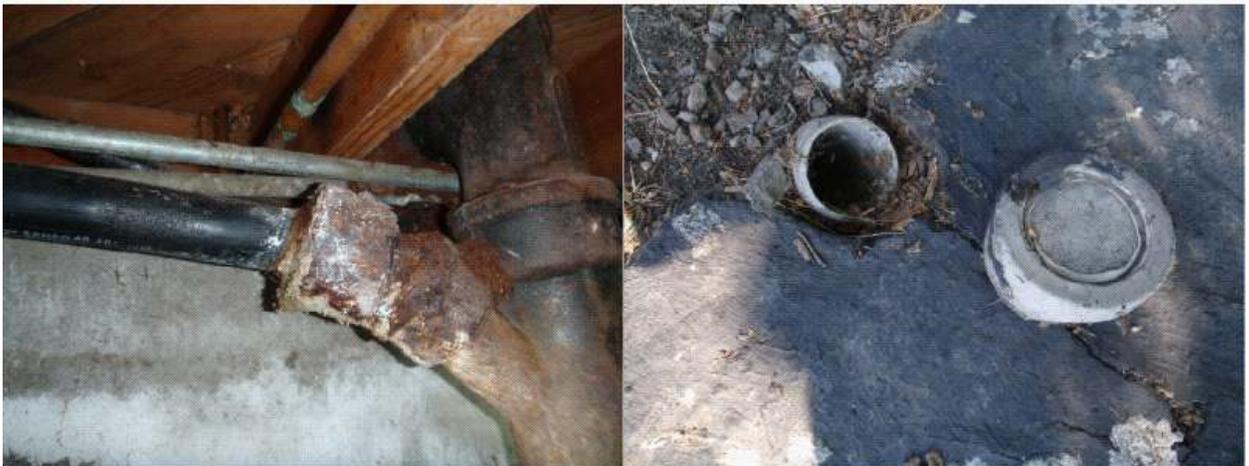
A slow leak was found at the drain pipe under the bathtub and no p-trap is present. Wood framing and sheathing were not wet at time of inspection; however damaged/decayed lumber was found adjacent to this area. A licensed plumbing contractor should be hired to make repairs or corrections, as needed. (Upper photos)

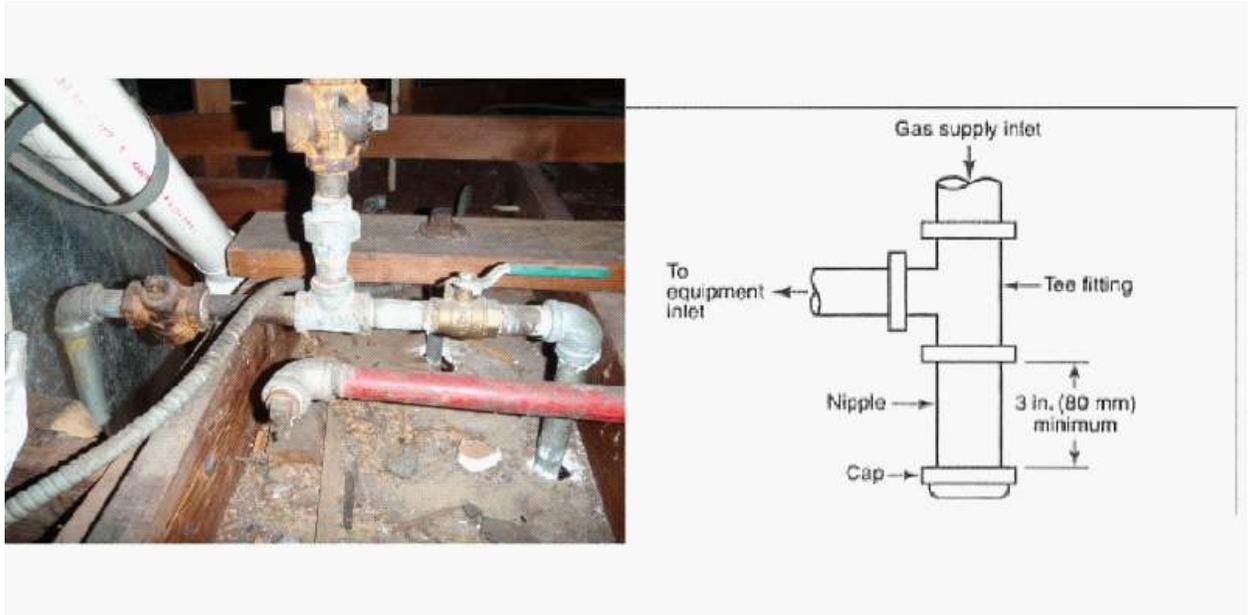
Not found. I recommend the gas meter be located.

Gas piping has been modified at a few locations. Some gas shutoff valves do not have handles. I recommend corrections by a licensed plumbing contractor.

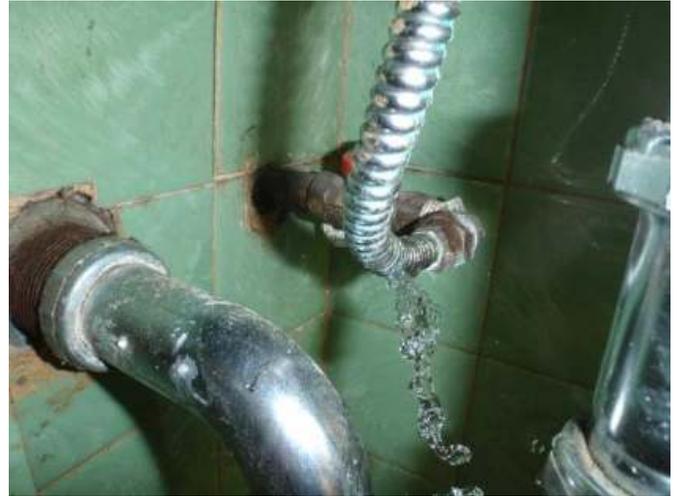
A leak was observed at the half bathroom sink supply. Repairs should be made by a licensed plumbing contractor to prevent damage to cabinet and/or structure.

Older shutoff valves and drain fittings are present at interior plumbing fixtures. Client is advised that older valves often do not function properly and fittings are more prone to leaking due to aged washers and packing. Replacement of older fittings should be undertaken as a part of routine maintenance and repairs.

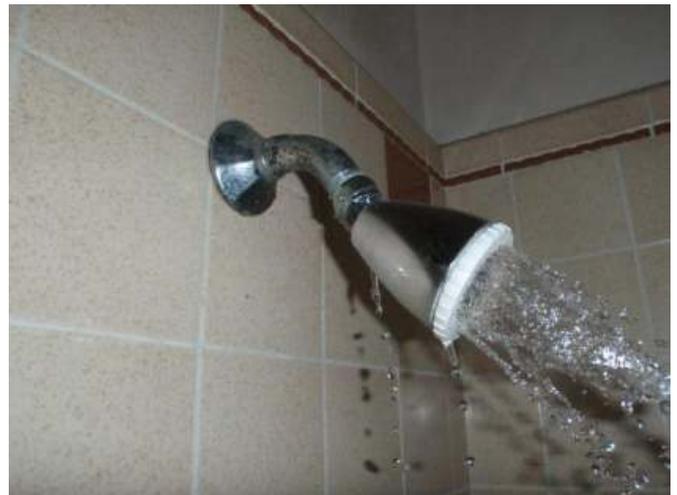
The shower head sprays the wall. This should be resealed or corrected to prevent water from penetrating to the interior of the wall cavity.

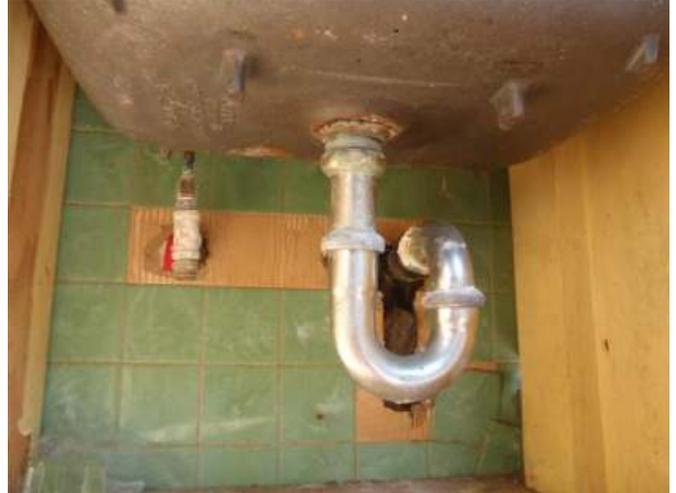
The supply valves were off at time of inspection.

These valves are shared with the sink and the washer supply and cannot be turned-on until a clothes washing machine is installed.

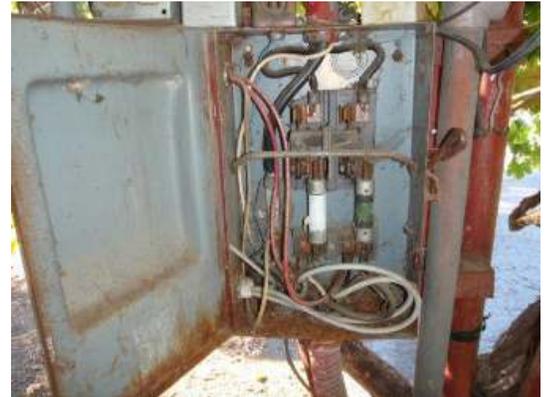
This panel is not designed for exterior locations. While located under the roof of the carport, it is still essentially in a damp location and my primary recommendation is replacement of this panel with one designed for exterior installation. At a minimum, a siding enclosure can be constructed to enclose the panel and adjacent wiring.

This panel can be easily opened and the electrical contacts and wiring are readily accessible. Locking or securing the cover is advised to prevent access to the interior of the box by children or other unauthorized person.

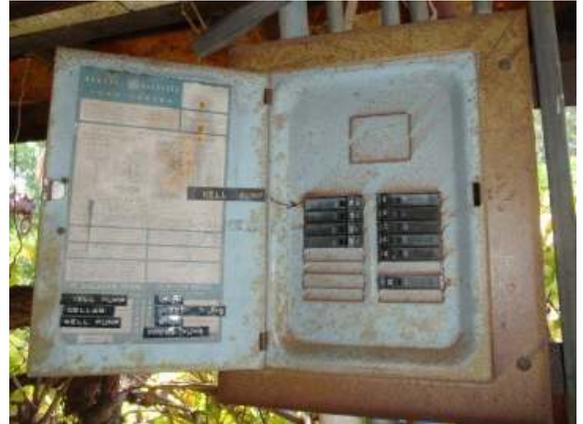
This panel is not designed for exterior locations. While located under the roof of the carport, it is still essentially in a damp location and my primary recommendation is replacement of this panel with one designed for exterior installation.

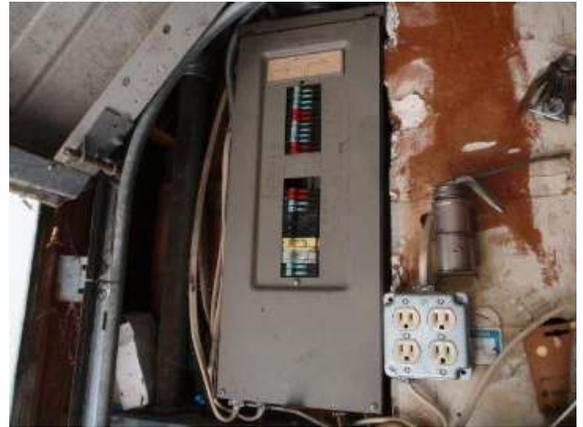
The dead-front is not properly secured. The dead-front is a sheet metal panel that allows access to the circuit breaker handles while covering the live/energized wiring within the panel. I recommend this be attached/secured to the panelbox with proper screws. The screws used should be similar to the screws originally supplied with the panel and should not be pointed/sharp.

Accurate and complete identification and labeling of all individual branch circuits is advised.

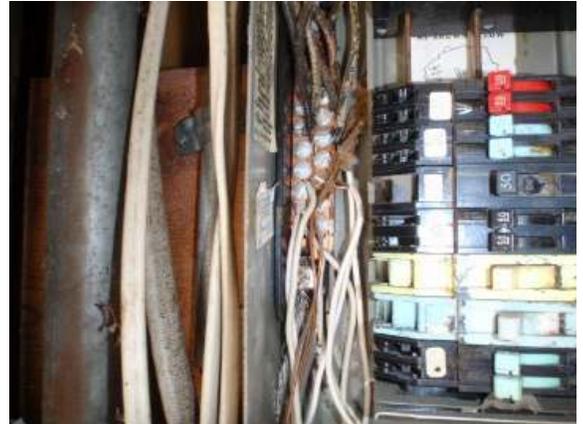
Multiple wires are connected to a single circuit breaker terminal where only one wire should be connected. This can prevent the wires from having positive contact with the connector which could lead to arcing or shorting. This is normally corrected by installing additional circuit breakers. Any corrections should be made by a licensed electrical contractor.

Neutral and ground wires are connected together in this panel. Current electrical standards require that the grounding circuit be separated from the "neutral" circuit. A separate grounding circuit should be provided back to the service equipment (main panel). Corrections should be made by a licensed electrical contractor.

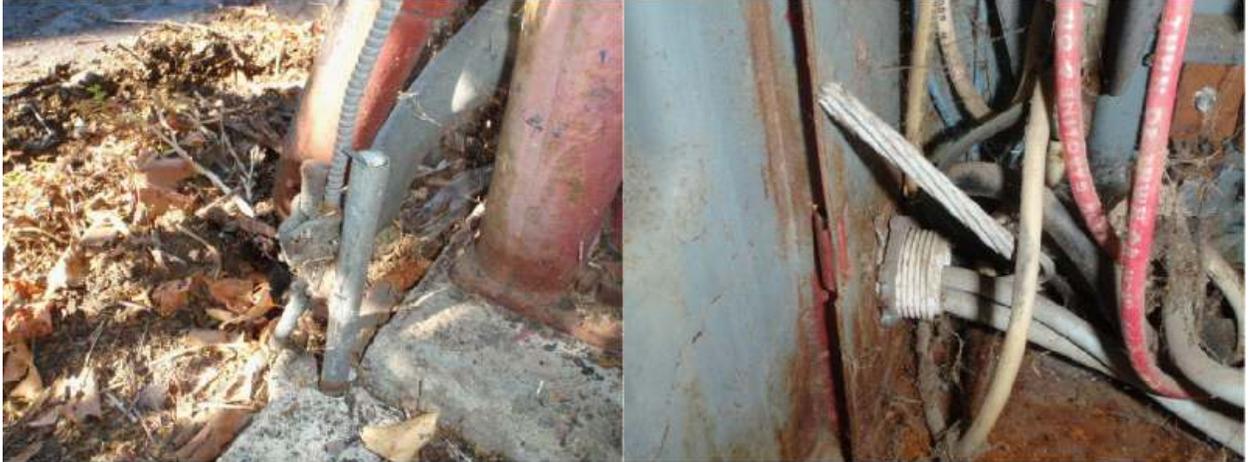
The carport and garage circuit breaker panels are not properly grounded. The grounding conductor for the carport panel is not connected and no grounding conductor has been provided for the garage panel. A grounding circuit should be installed.

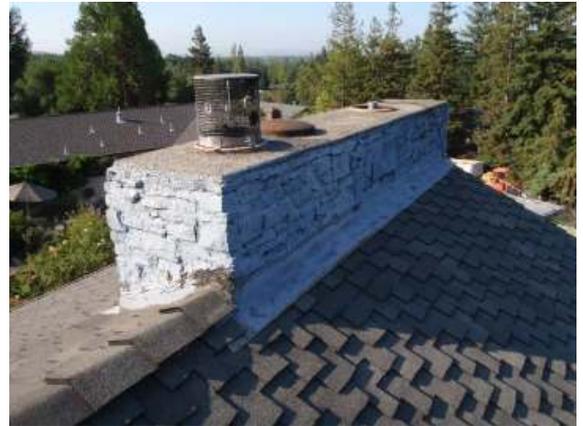
No strap anchors found in the attic. Straps are typically required to be embedded into the masonry as the chimney is constructed and attached/secured to the roof framing to help brace the chimney against seismic movement. I suggest consulting with a licensed and qualified masonry contractor for more information and installation of straps, as needed.

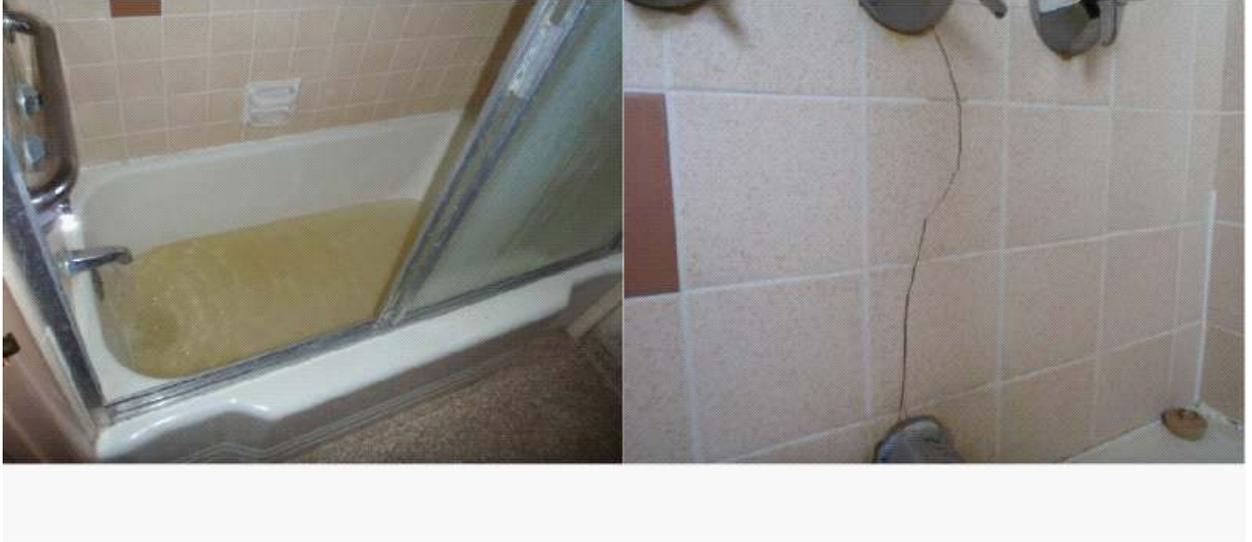
Cracked tiles and grout observed. Cracks should be sealed to prevent moisture from gaining entry behind the tile.

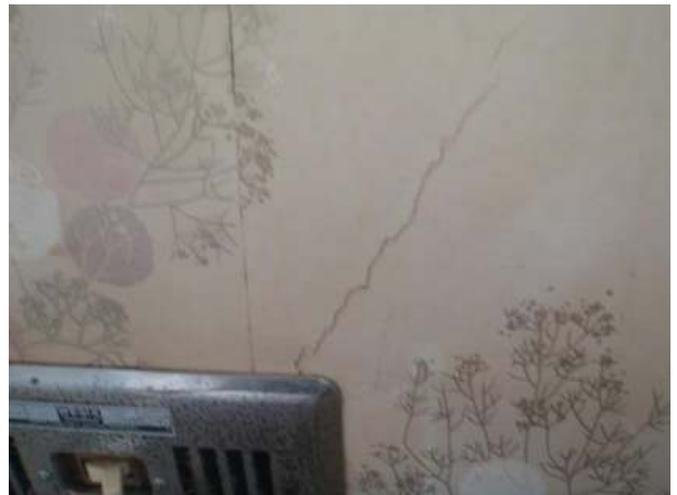
Cracks were observed in the walls at a few locations. Please refer to the interior section of this report for related information.

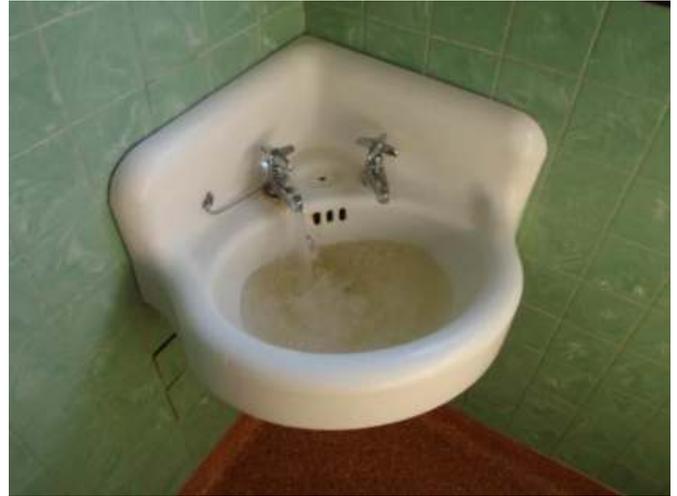
A leak was observed at the sink supply. Please refer to the plumbing section of this report for related information.

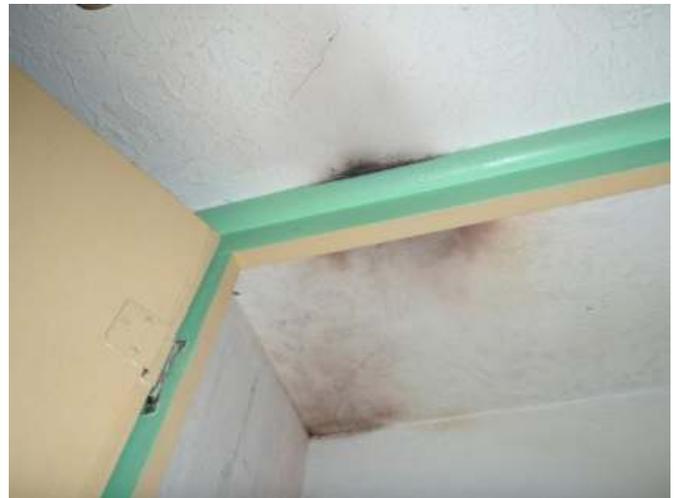
The hallway ceiling is scorched. Please refer to the attic and electrical sections of this report for related information.

Cracks are present in the ceilings.
