Inspected for:
Arthur Dent
3316 Golgafrincham Dr.
Santa Rosa, CA

Report Highlights

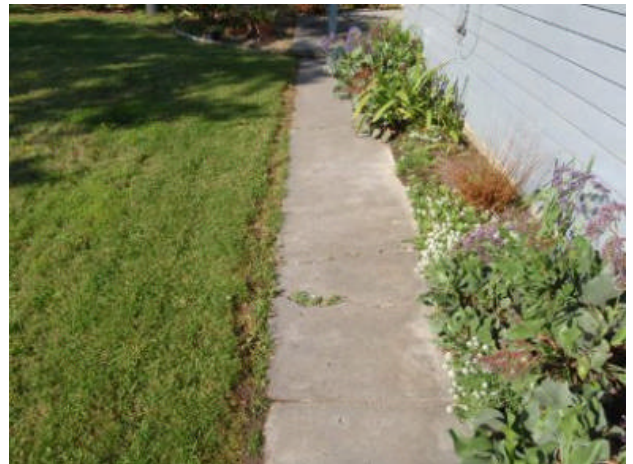
Concrete. Cracks are present in walkway.

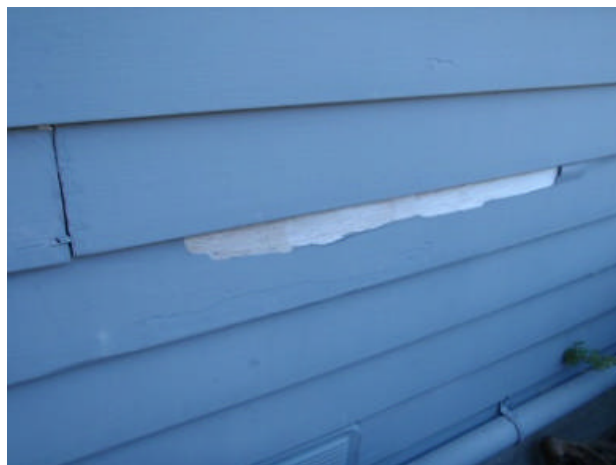
Exterior paint is deteriorated. Trim should be repainted to prevent damage to trim and structure.

Sealing all cracks/voids between siding and trim is recommended to prevent moisture intrusion to the interior surfaces of the wall.

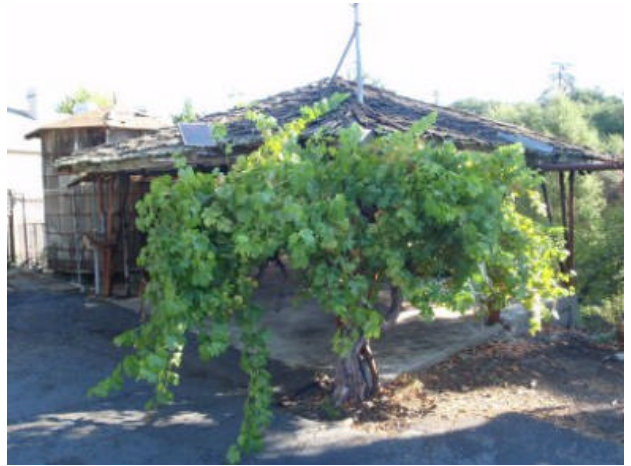
The roof is old and in generally deteriorated condition. I recommend replacement of the roof covering.

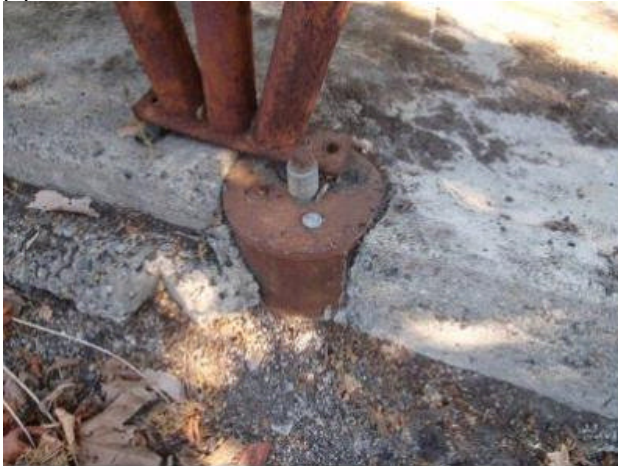
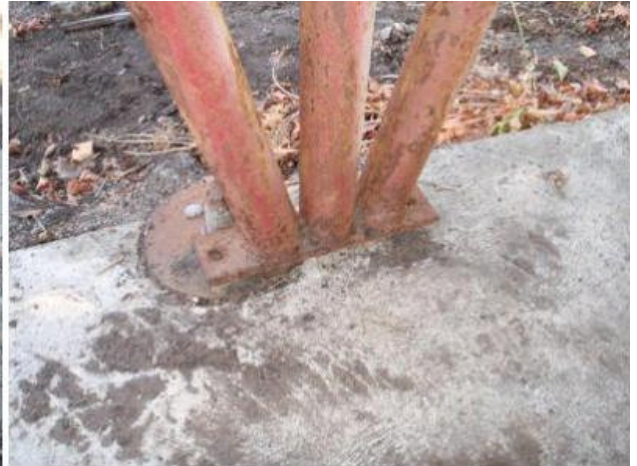
One of the posts has not been properly secured/bolted to the slab. Corrections are advised.

Concrete. Cracks are present in slab surface. These cracks are not uncommon and usually due to curing and/or normal soil movement/settling. Corrective measures should only be taken if concrete becomes uneven or damaged.

The rear of the slab has been supported on rock (rip-rap). This is more likely to settle than compacted fill. No evidence of excessive settling observed at time of inspection. Ideally, this rock would be replaced or supported with concrete.

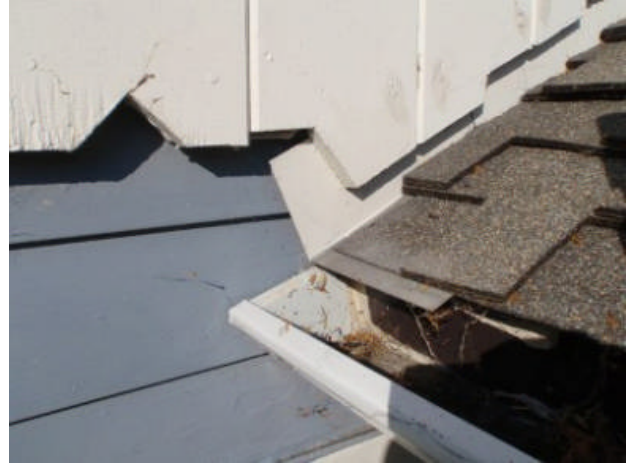
Roof/wall flashing at the garage/house connection is not complete. This installation will allow water to flow down the exterior siding. While this may not allow leaking to the interior of the house, it is likely to lead to moisture damage over time. Flashing should direct water away from the wall.

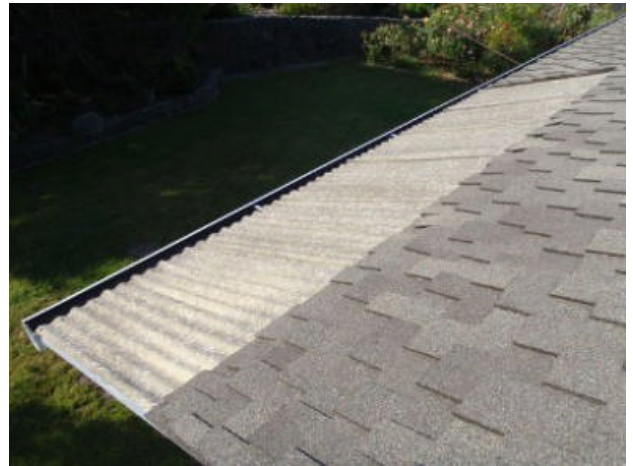
These panels are aged and should be replaced.

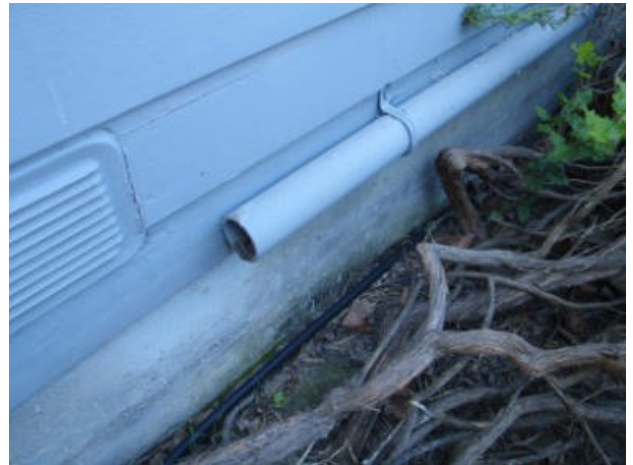
The gutter downspouts terminate adjacent to the foundation. Adding an extender system to move the roof water away from the perimeter of the house (preferably to the street or storm drain) is recommended to aid lot drainage.

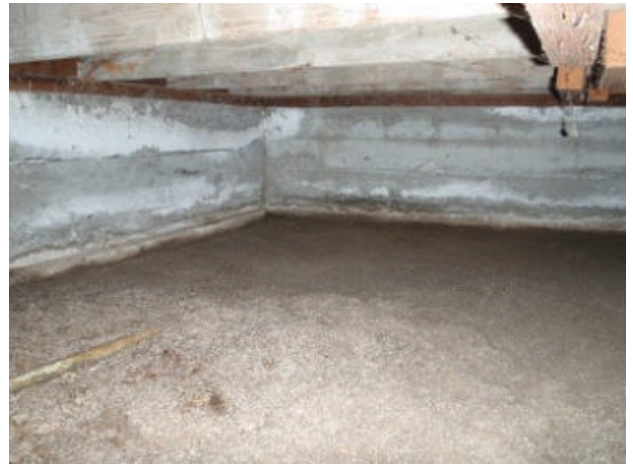
Areas of soil were dry to damp. The majority of this dampness was under the living/dining room. While seasonal moisture is not uncommon in foundation crawlspaces in this area, moisture during the dry summer months is commonly due to excessive landscape irrigation. Cutting back on irrigation and periodic review of the crawlspace for excessive moisture is advised.

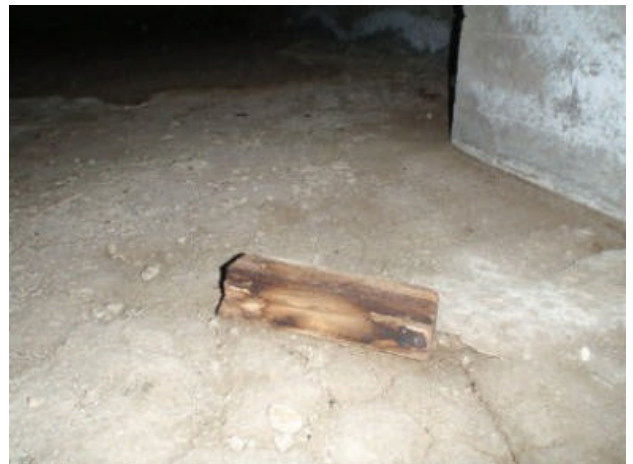
Wood scraps/debris is present on the soil under the house. As this can be misinterpreted by wood eating pests as an invitation to infest your home, I advise removal of all wood, cardboard, paper and other cellulose based material.

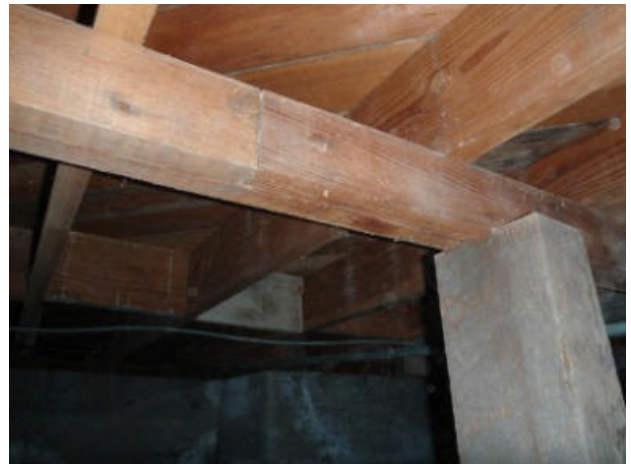
These are undersized by modern construction standards. Minimum girder size, depending upon load and span, is typically 4x6. This is likely contributing to some of the cracked walls noted in the interior section of this report.

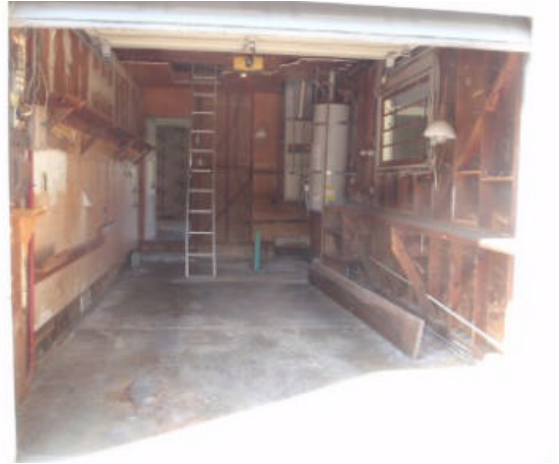
Concrete. Cracks are present in slab surface.

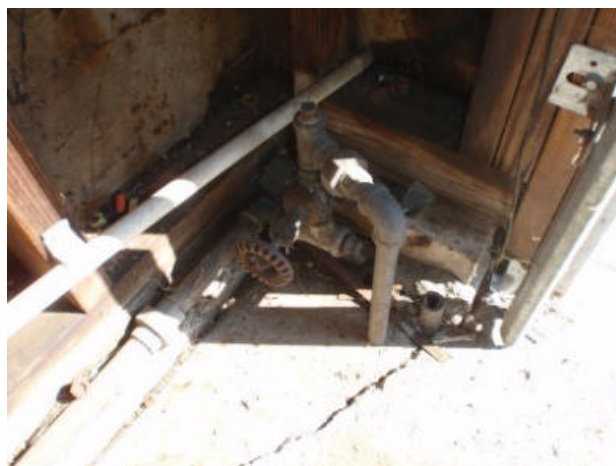
This is an older valve which may not function properly. Older valves commonly do not close completely and/or function properly. While not tested, preventative replacement is advised.

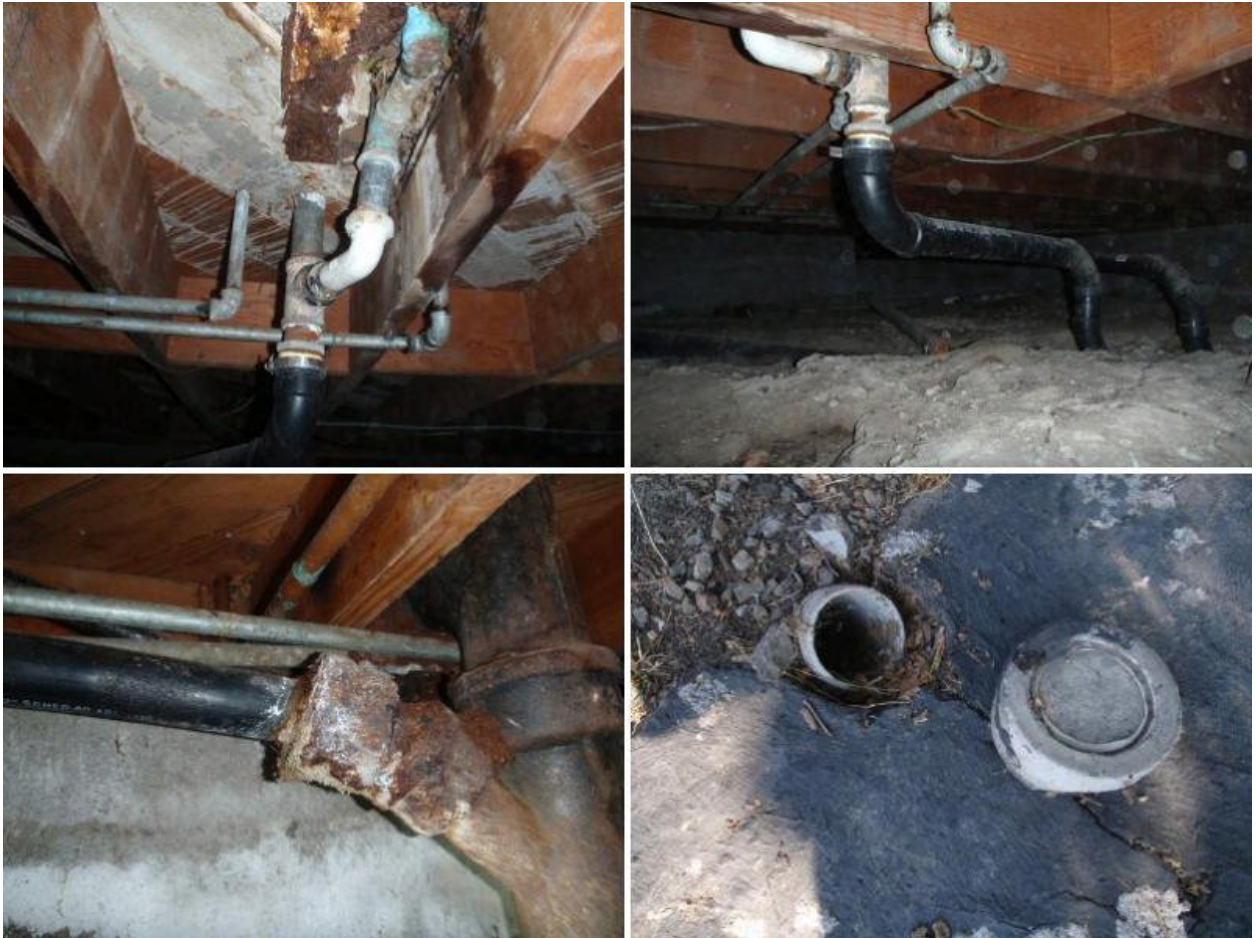
A slow leak was found at the drain pipe under the bathtub and no p-trap is present. Wood framing and sheathing were not wet at time of inspection; however damaged/decayed lumber was found adjacent to this area. A licensed plumbing contractor should be hired to make repairs or corrections, as needed. (Upper photos)

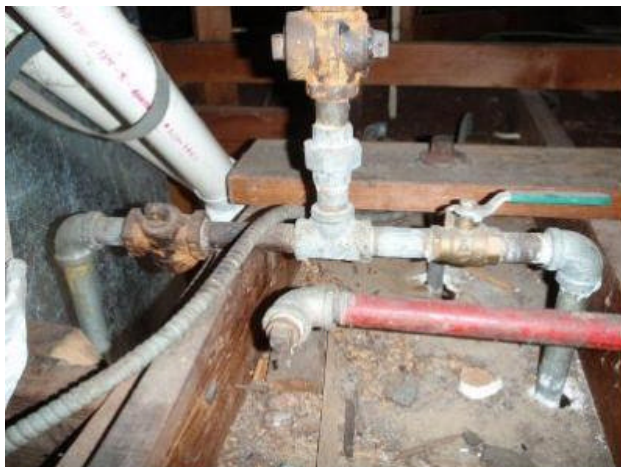
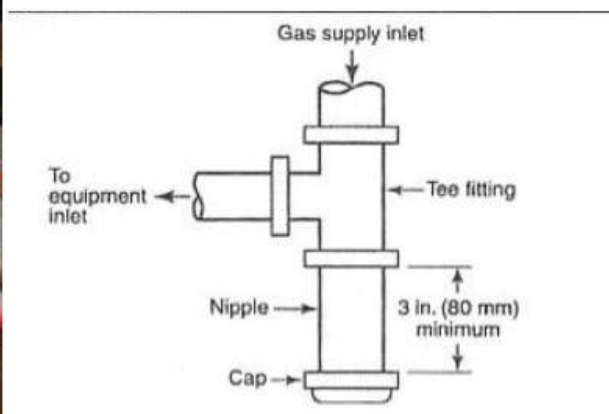
Not found. I recommend the gas meter be located.

Gas piping has been modified at a few locations. Some gas shutoff valves do not have handles. I recommend corrections by a licensed plumbing contractor.

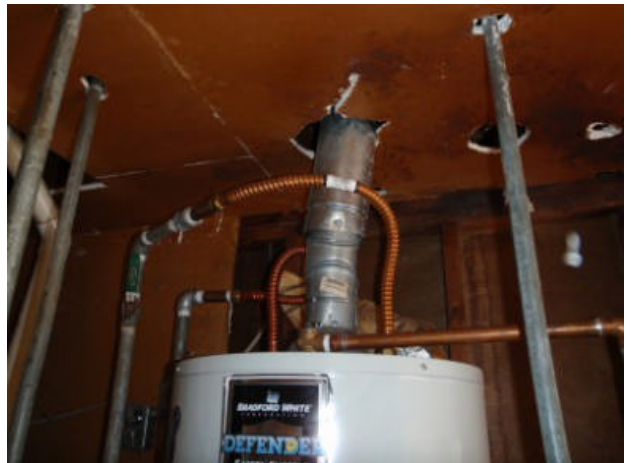
The flue pipe has inadequate clearance to the paper on the gypsum wall board ceiling. Normally, a minimum clearance of 1 inch to combustible material is required. While no evidence of scorching or charring was observed at time of inspection, isolating the flue from contact with the ceiling is suggested. This is typically achieved by cutting away some of the ceiling material and installation of a metal collar to close the gap.

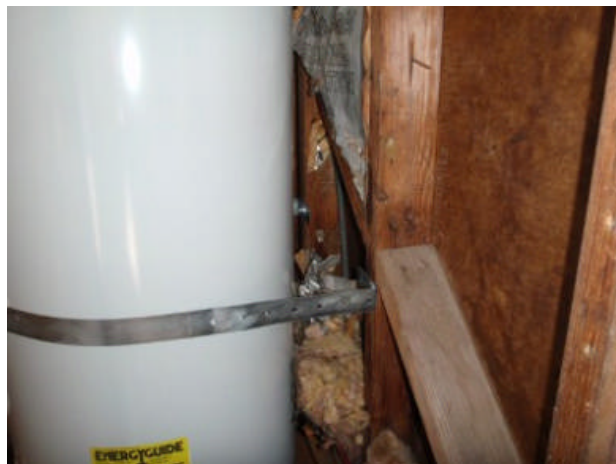
Two straps present. While these straps are attached to the wall framing and will provide some resistance to seismic movement, they do not appear to have been installed as specified and may not perform as intended. The intent of seismic bracing is to restrict the water heater from falling over in the event of an earthquake. The distance from the tank to the wall is greater than 1 inch, which will allow the tank to move laterally during an earthquake. Most manufacturers' instructions require this space be filled or a cradle installed to prevent movement. Complete instructions can be obtained from the manufacturer of the kit. These should be reviewed and corrections made, as needed.

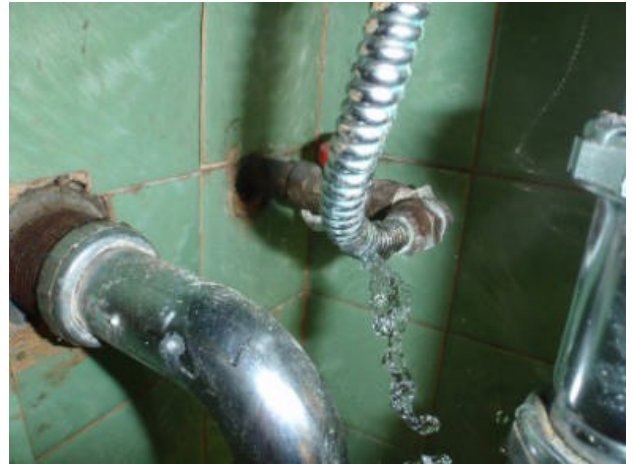
A leak was observed at the half bathroom sink supply. Repairs should be made by a licensed plumbing contractor to prevent damage to cabinet and/or structure.

Older shutoff valves and drain fittings are present at interior plumbing fixtures. Client is advised that older valves often do not function properly and fittings are more prone to leaking due to aged washers and packing. Replacement of older fittings should be undertaken as a part of routine maintenance and repairs.

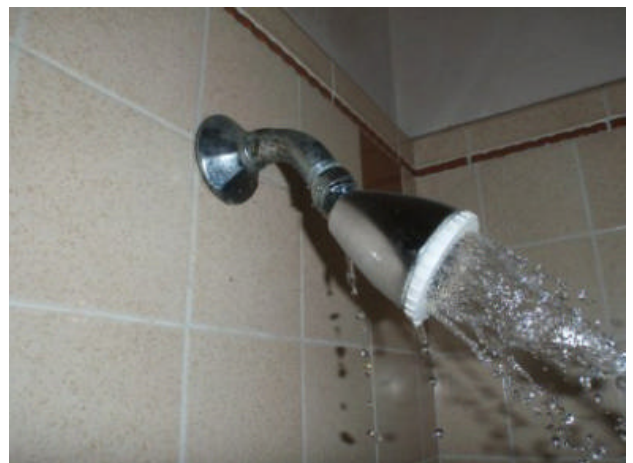
There is a leak at the half bathroom toilet flush valve. Adjustment or repair of the valve is advised to restore proper operation.

The shower head sprays the wall. This should be resealed or corrected to prevent water from penetrating to the interior of the wall cavity.

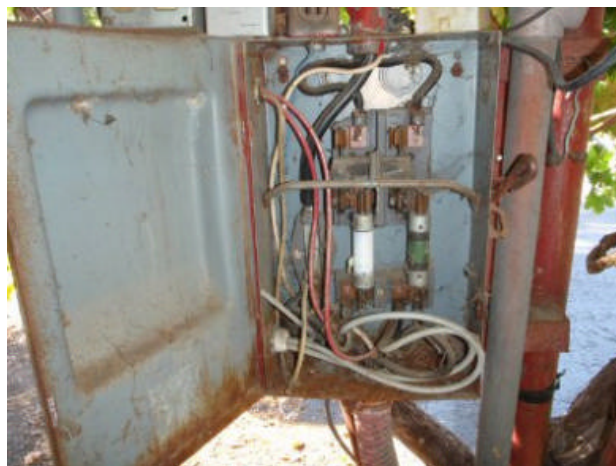
This panel is not designed for exterior locations. While located under the roof of the carport, it is still essentially in a damp location and my primary recommendation is replacement of this panel with one designed for exterior installation. At a minimum, a siding enclosure can be constructed to enclose the panel and adjacent wiring.

This panel can be easily opened and the electrical contacts and wiring are readily accessible. Locking or securing the cover is advised to prevent access to the interior of the box by children or other unauthorized person.

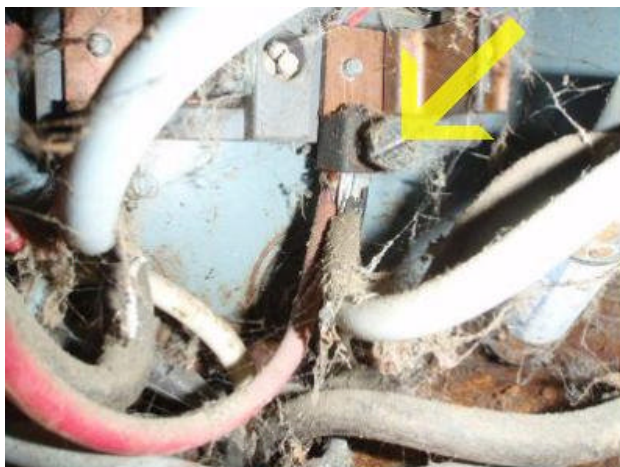
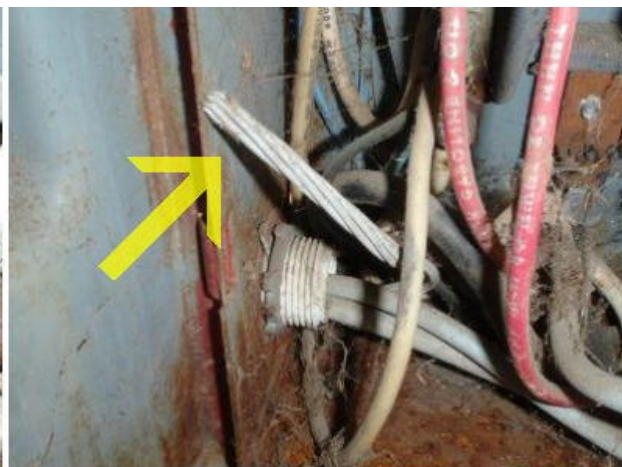
Multiple wires are connected to a single circuit breaker terminal connection where only one wire should be connected. This can prevent the wires from having positive contact with the connector which could lead to arcing or shorting. This is normally corrected by installing additional circuit breakers. Any corrections should be made by a licensed electrical contractor.

The grounding conductor from the carport panel is not connected. This should be connected to the grounding terminal in this panel and a grounding terminal in the carport panel.

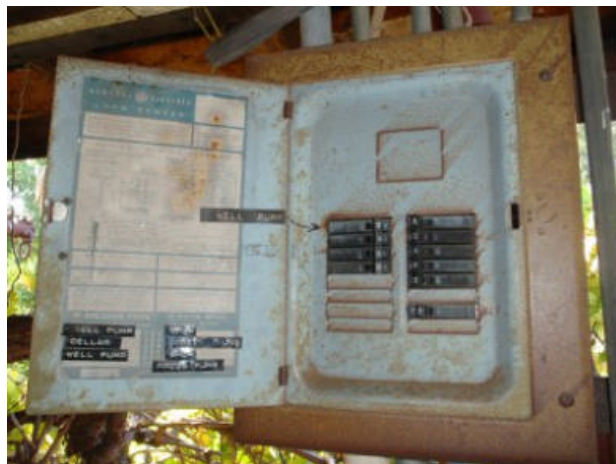
This panel is not designed for exterior locations. While located under the roof of the carport, it is still essentially in a damp location and my primary recommendation is replacement of this panel with one designed for exterior installation.

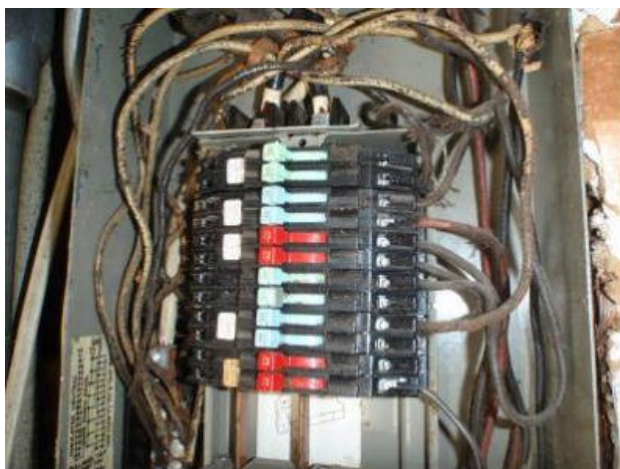
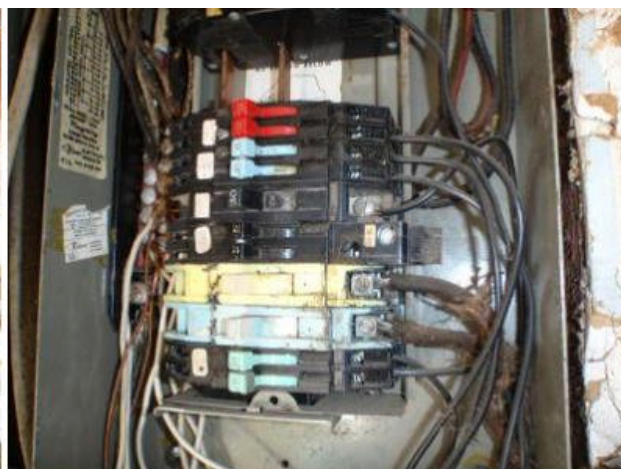
The 60 amp circuit breaker handles are not connected together. 240 volt, double pole breakers are typically connected together to allow both of the breakers to be turned off or tripped simultaneously. Installation of handle ties is recommended to allow the breakers to function properly.

Multiple wires are connected to a single circuit breaker terminal where only one wire should be connected. This can prevent the wires from having positive contact with the connector which could lead to arcing or shorting. This is normally corrected by installing additional circuit breakers. Any corrections should be made by a licensed electrical contractor.

Neutral and ground wires are connected together in this panel. Current electrical standards require that the grounding circuit be separated from the "neutral" circuit. A separate grounding circuit should be provided back to the service equipment (main panel). Corrections should be made by a licensed electrical contractor.

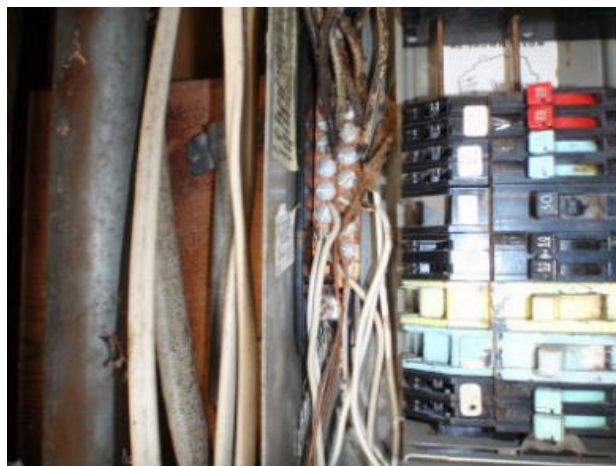
Conditions have been reported with this brand of electrical panel (Zinsco/Sylvania) that include arcing at the circuit breaker/buss bar connections. This is likely due to way the circuit breaker attaches to the buss bar. As a result of this design, this panel is more likely to fail than a newer panel. This brand of panel was very commonly used in structures built between the early 1960s through the mid 1980s. Consequently, I find this brand of panel in the vast majority of similarly aged homes that I inspect. Some electrical contractors are reluctant to perform work on these panels, typically citing liability concerns. Other electrical contractors suggest examining the connections between the circuit breakers and the buss bars for loose connections and/or arc damage and having all electrical connections in these panels tightened, as needed, to ensure that the proper contact is being maintained. The most prudent course would be to replace the panel. At a minimum, some preventative maintenance seems reasonable as replacement of a panel can be costly. As these panels are no longer being manufactured, upgrade/replacement parts can be difficult and expensive to obtain should the need arise. While no evidence of arcing was observed within this panel at time of inspection, positive determination can only be made by having an electrician remove the circuit breakers in order to inspect the buss bars. If more information or further review is desired, a licensed electrical contractor should be consulted. Requiring documentation or other hard evidence is suggested should an electrician advise replacement.

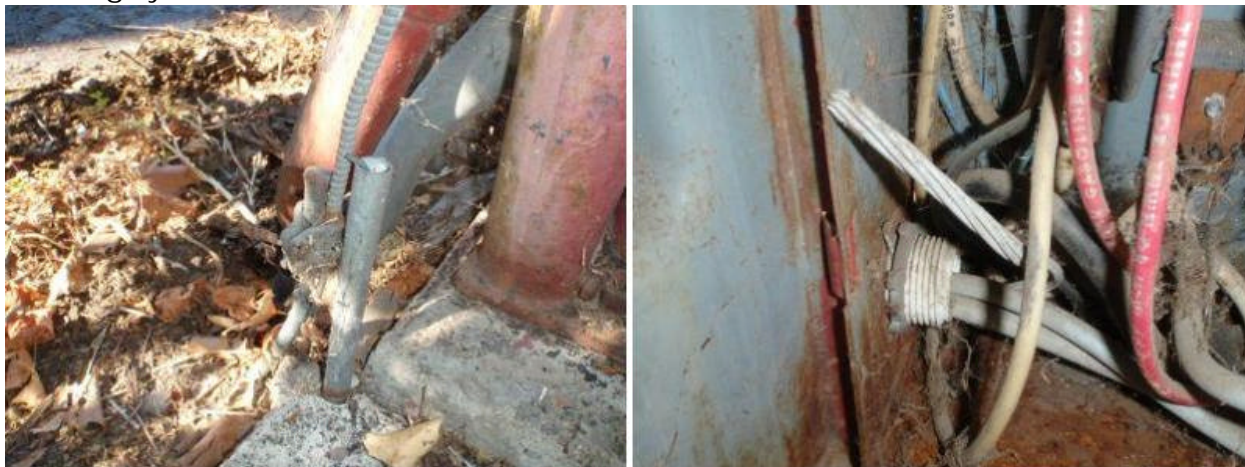
The carport and garage circuit breaker panels are not properly grounded. The grounding conductor for the carport panel is not connected and no grounding conductor has been provided for the garage panel. A grounding circuit should be installed.

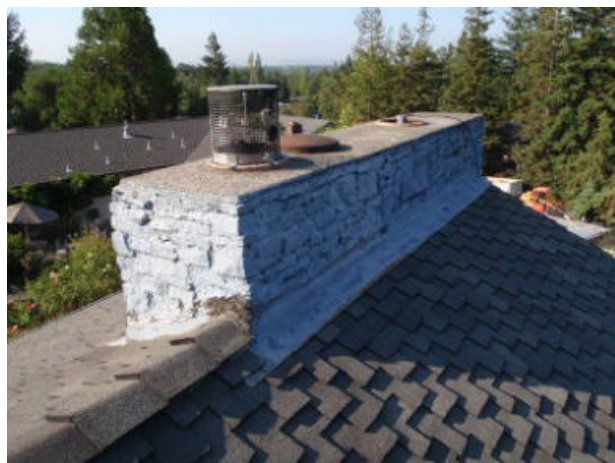
No strap anchors found in the attic. Straps are typically required to be embedded into the masonry as the chimney is constructed and attached/secured to the roof framing to help brace the chimney against seismic movement. I suggest consulting with a licensed and qualified masonry contractor for more information and installation of straps, as needed.

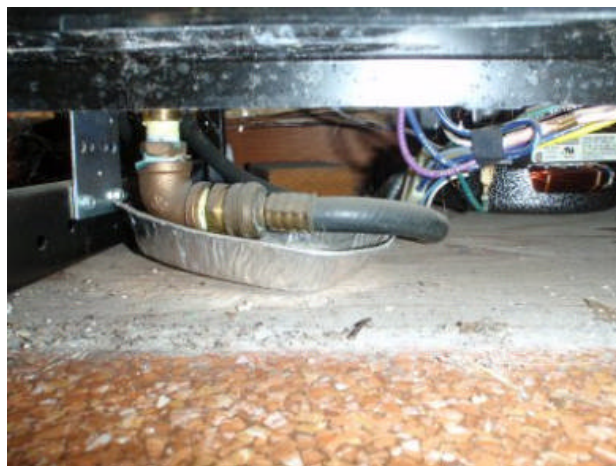
A pan is present under the water supply connection under the dishwasher. No active leaking found while testing this appliance.

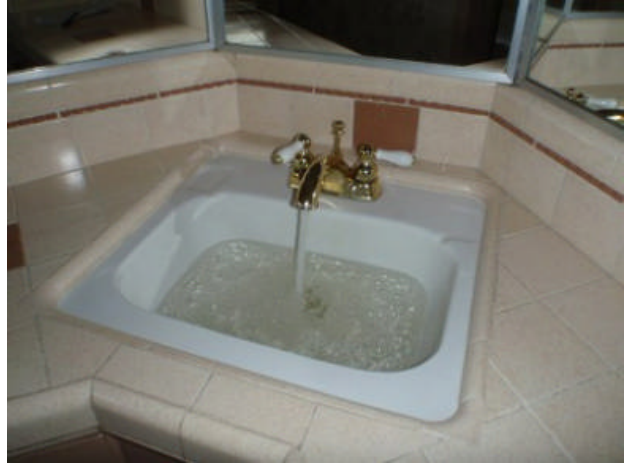
Plumbing fittings and valves are older. Please refer to the plumbing section of this report for related information.

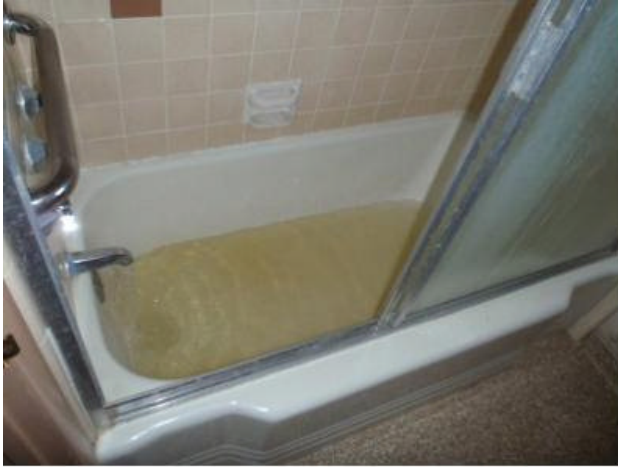
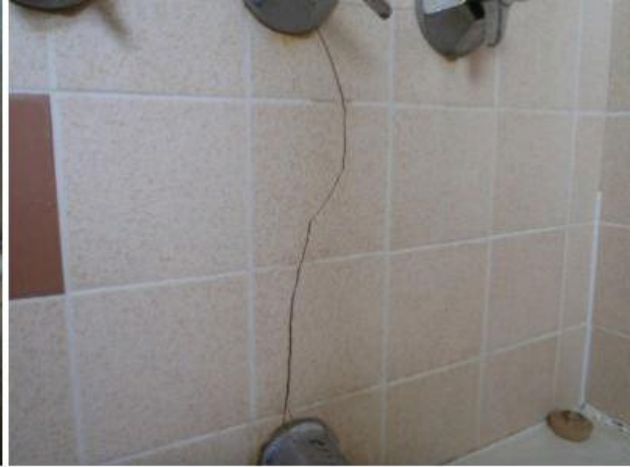
Cracked tiles and grout observed. Cracks should be sealed to prevent moisture from gaining entry behind the tile.

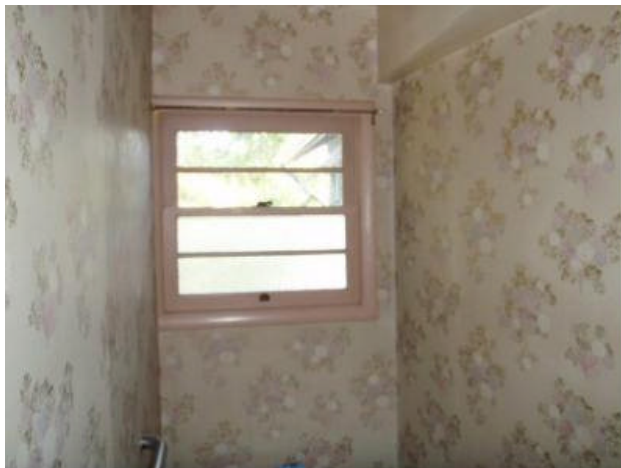
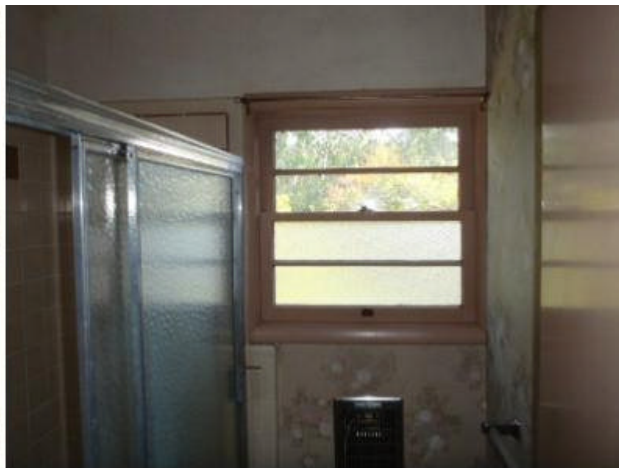
Windows are stuck shut.

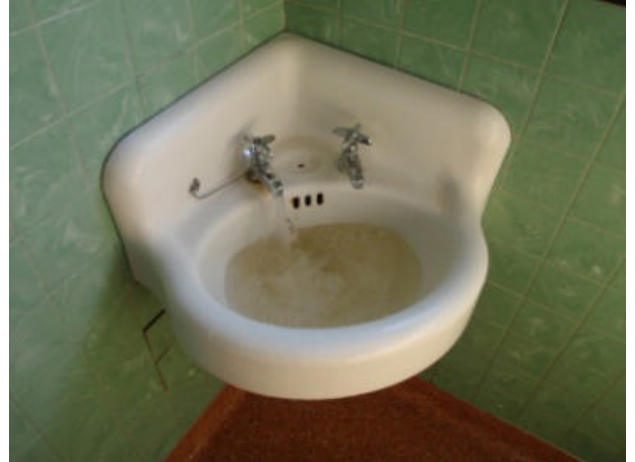
A leak was observed at the sink supply. Please refer to the plumbing section of this report for related information.

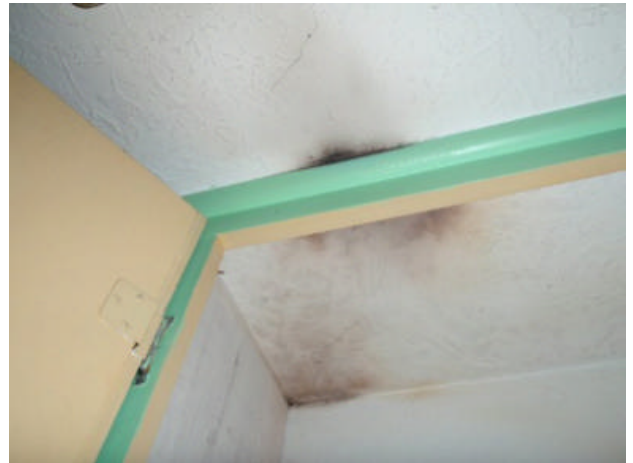
Cracks are present in the ceilings.
